Influence of Salt Residues on BGA Head in Pillow (Hip)

J. Servin, C. Gómez,
M. Domínguez, A. Aragón
CONTINENTAL CUAUTLA
Av. Ignacio Allende Lote 20
Parque Industrial Cautla
Cd. Ayala, Morelos 62749, México
E-mail: jose.servin@continental-corporation.com
cynthia.gomez@continental-corporation.com

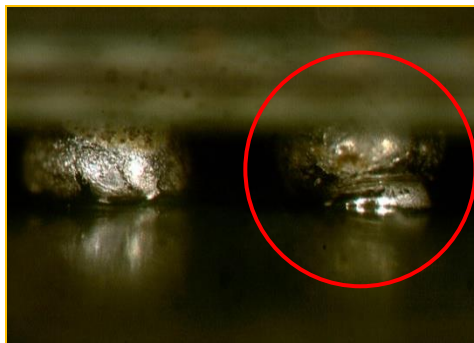
Head in Pillow is a BGA solder joint defect in which the solder paste wets the pad but does not fully wet the ball, see Figure 2. The solder ball physically touches the solder paste deposit but there is not a metallurgical joint. The improper electrical connection situation becomes more severe because many of these type of connections would be electrically intermittent. This is due to a lack of solderability between the ball surface and solder paste alloy due to oxidation, contamination or a mechanisms that prevents the solder alloy to form a joint with the solder balls. One of the main possible causes is excessive oxidation even though the excess oxidation has mainly been attributed to external control problems of solder paste handling or reflow profile.

Figure 2. Head In Pillow Defect in a BGA connection (See the red circle)

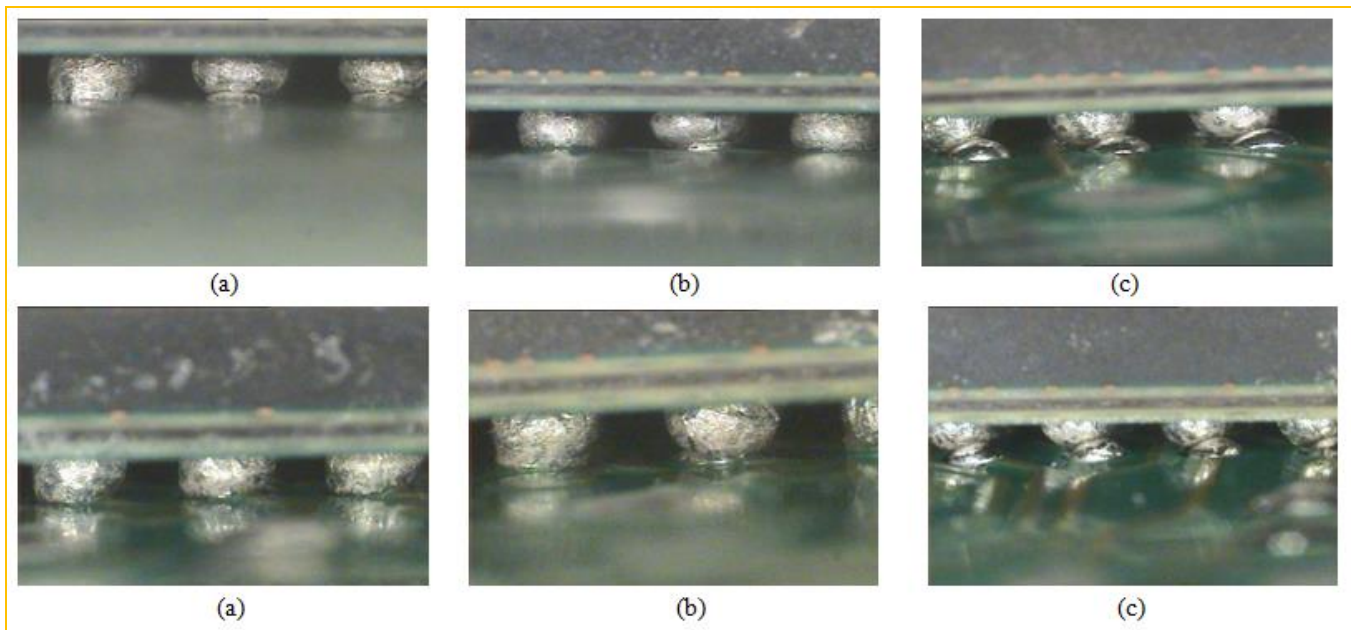
The images in Figure 5 show the HiPs resulted in DOE 1. The images, Figure 5(a), are the test at a time of 4 hours and did not have many defects of HiP. The Figures 5(b) are the components with a steam time of 8 hours, and more defects are seen. Finally, Figure 5(c) are the components at 16 hours of steam. These components got misplaced due to the number of HiPs. According to the results and comparisons, we can consider that the longer the time, the more defects.

Figure 5. DOE 1 Results: (a) Components at 4 hrs of steam, (b) Components at 8 hrs of steam, and (c) Components at 16 hrs of steam, the components are misplaced due to number of HiPs

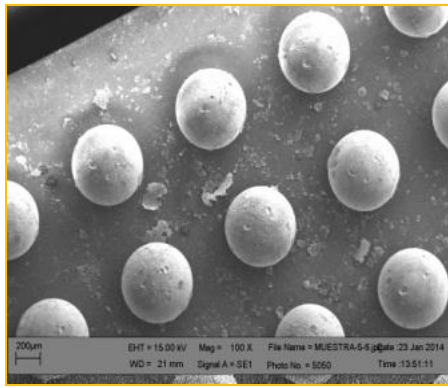
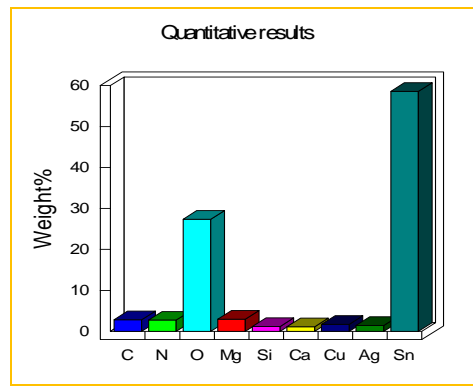
In the analysis of SEM/EDX, components have the presence of several elements on the surface. Figure 6 shows the results for the components at 16 hrs steam. Several elements are found (Mg, Ca, Al) beside Na and Cl. It is interesting to mention the solder balls have specific spots of the elements. Only components with 16 hrs of steam show more uniform distribution of the elements on the surface.

Figure 6. SEM Images of components at 16 hrs of steam, Samples 1 and 2 (A and B), EDX results (a and b)

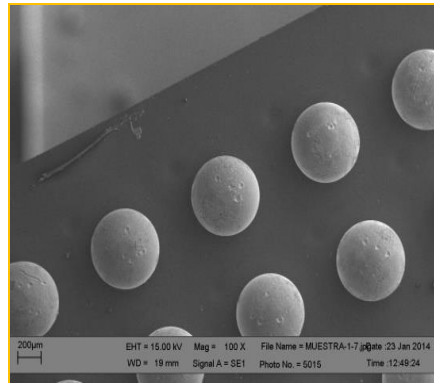
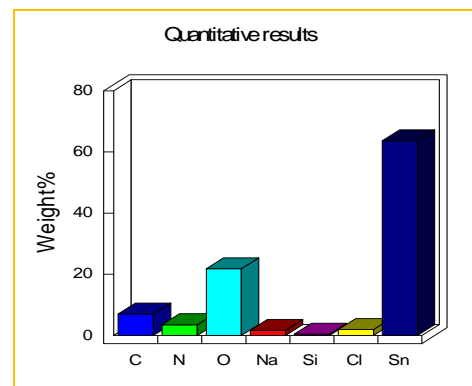
Several components were analyzed before soldering with SEM/EDX. The results are in Figure 10. The BGA images are in “raw” material after steaming. The EDX results are from specific areas where salt was detected and not general analysis. SEM images do not see the presence of NaCl presence until it is too high a value. This means analyzing images is not so reliable as expected to detect Cl presence because the NaCl presence exist but the detection is too low as would expect. However, we can get HiPs with low amount of NaCl under experiment conditions. In case of EDX analysis, Cl presence (in the form of salt) is dispersed and not uniformly distributed over the solder ball surfaces. The analysis had to be done checking specific points where Cl (NaCl) presence is detected. This means NaCl is accumulated in specific spots. In case of components steamed with only DI water, no Cl or Na presence was detected.

Figure 10. DOE 2. SEM Analysis Influence of NaCl in several conditions

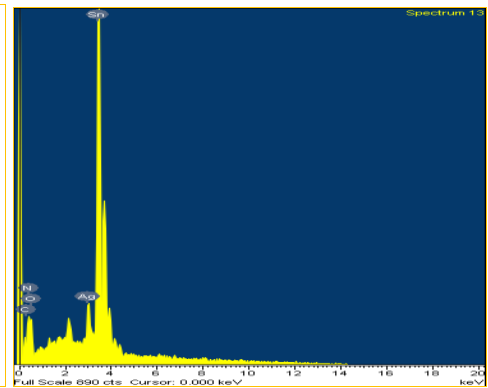
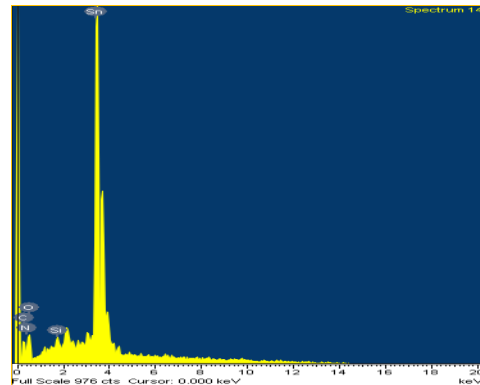
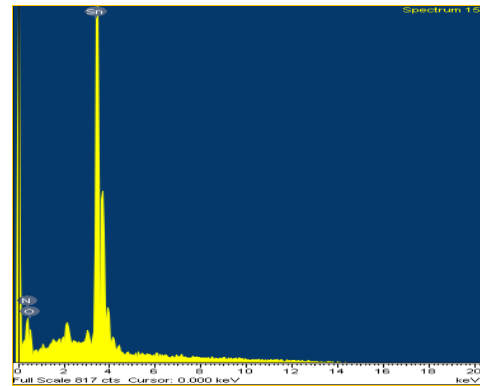
Figure 15. (A) shows three red numbers representing the punctual areas. (1) corresponds to the analyzed point 1, (2) to the analyzed point 2, and (3) to the analyzed point 3. The sample comes from 16 hrs test and DI water

The BGA sample has no NaCl presence. Point 1, 2 and 3, Figure 15, contain only tin, nitrogen and silver. The surface, Figure 16, has similar elements to the analyzed specific points.

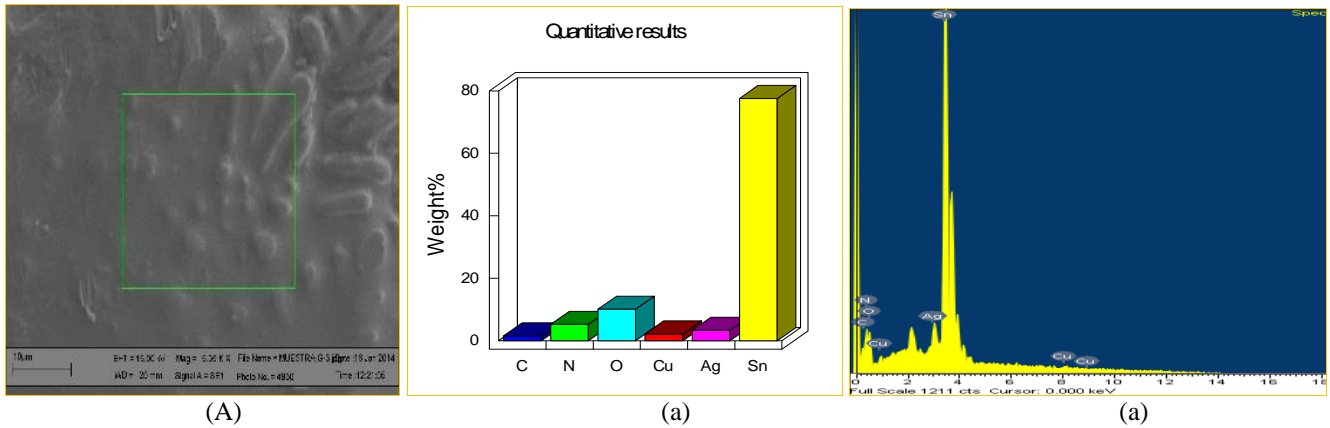
(A) (a) (a)
Figure 16. (A) is a general SEM Analysis. Sample comes from 16 hrs and DI water

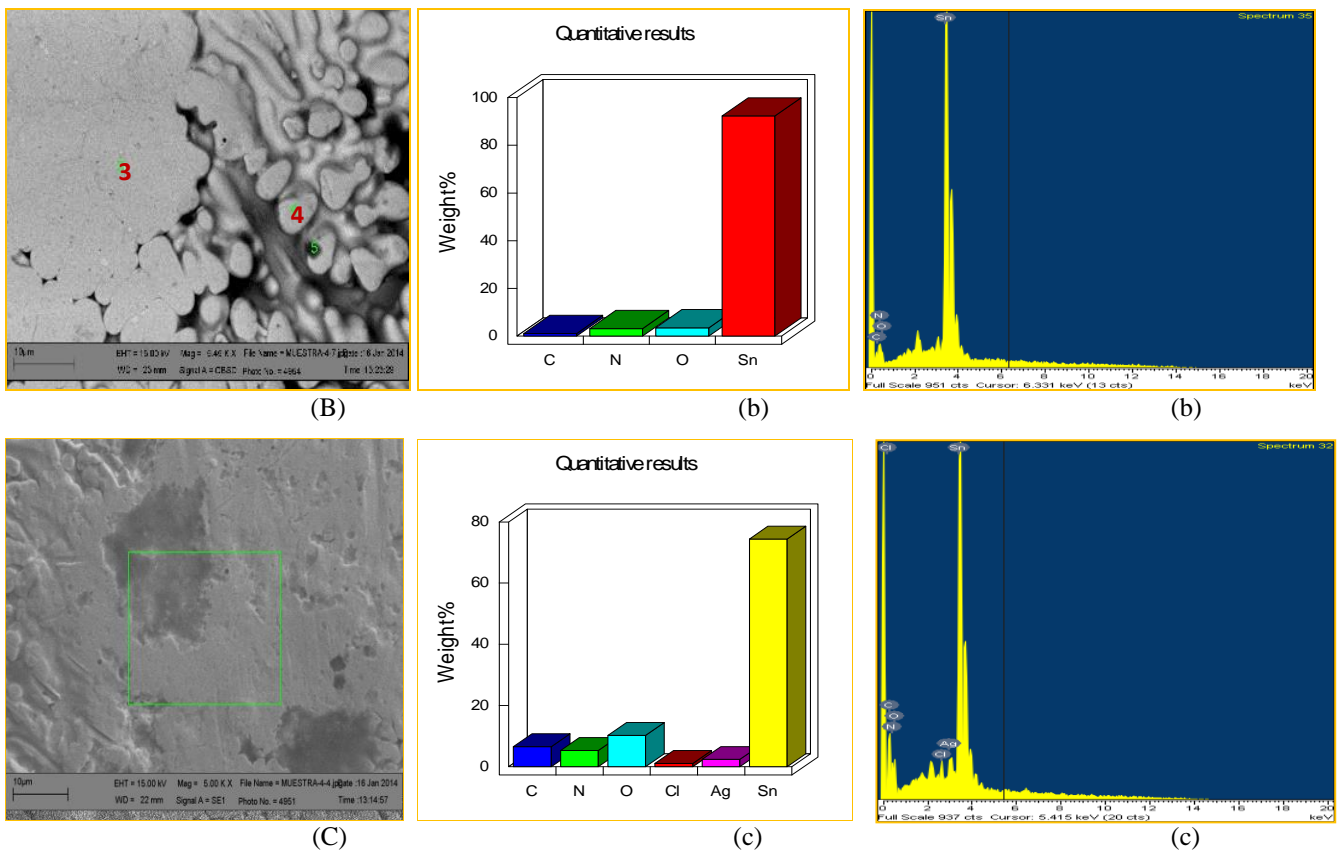
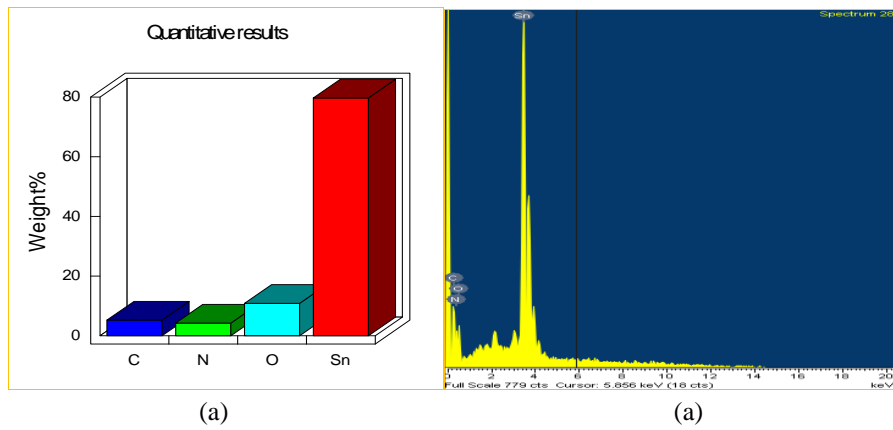
In this case, the results show a small concentration of chloride on the surface of the tin, see Figure 17; however, the presence of these chlorides is not evenly distributed across the surface of the ball but is found at specific points around the same; these points are located randomly.

Figure 17. The Images (B) and (C) are analyses of the sample with deionized water and 0.5% NaCl for 4 hrs

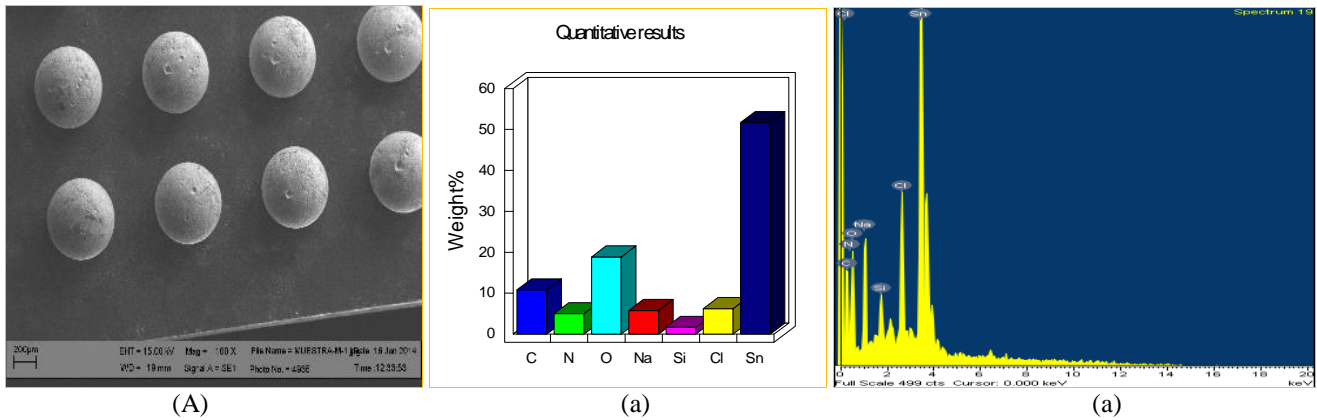
In Figure 18, the sample of analysis comes from deionized water and 1% NaCl at 4 hrs of steam. The samples are more contaminated with NaCl than BGA in Section III.4.2. The results show higher sodium chloride concentrations at specific points around the ball.

Figure 18. (A) Results SEM Analysis (NaCl), Sample deionized water at 4 hrs

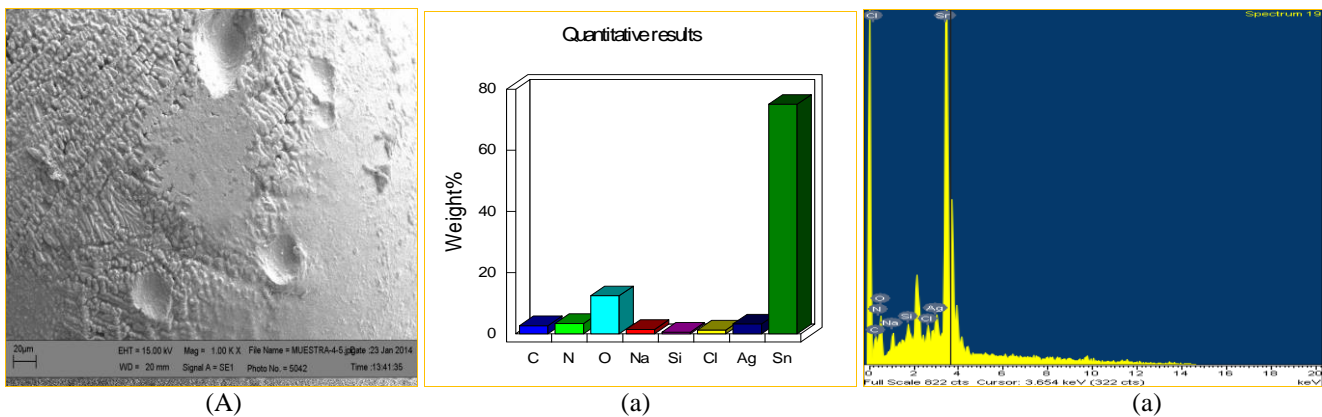
Although the component is exposed to a longer time, see Figure 19, than the component shown in the figure above, the sodium chloride concentrations are not substantially increased but the specific points with sodium chloride increases its presence in number.

Figure 19. (A) Results of test-deionized water at 1% for 16 hrs. The sample presents disperse areas with NaCl

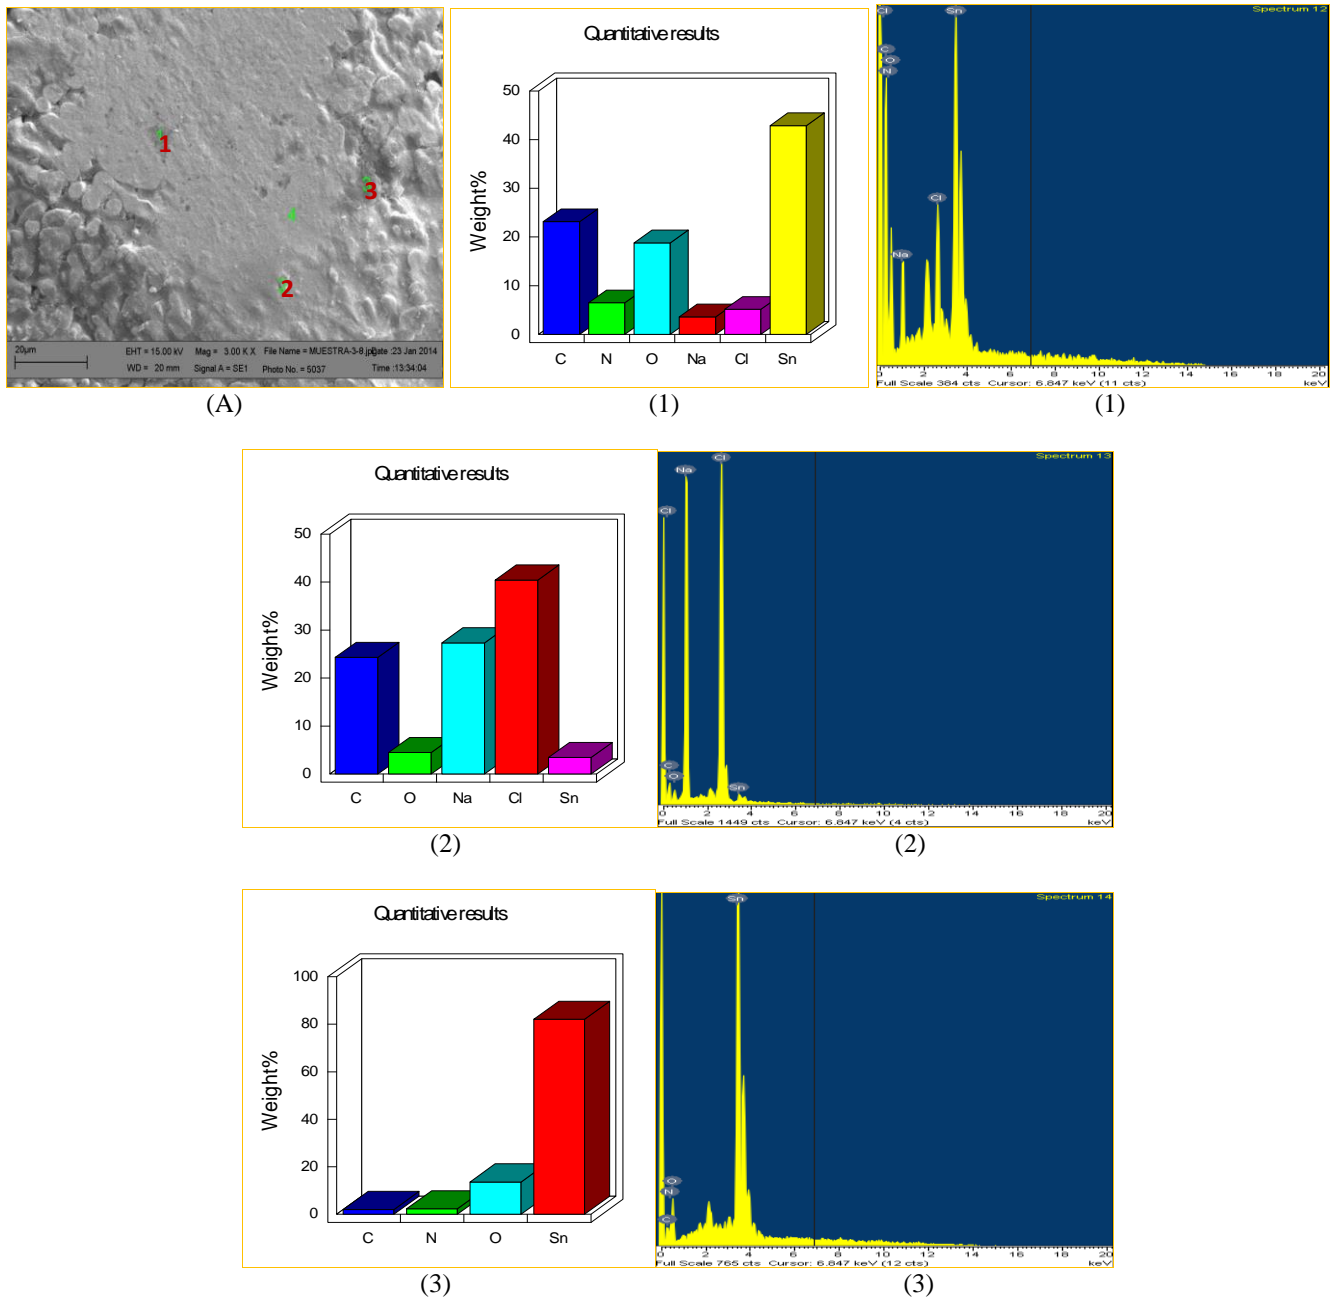
The results, Figure 20, show similar behavior to the previous sample, in which stains on the surface area increase. These areas are those containing a higher concentration of sodium chloride but do not cover the entire area of the ball but certain regions.

Figure 20. (A) Presents analysis showing three analyzed points. The analysis was performed with deionized water at 5% (NaCl) for 16 hrs

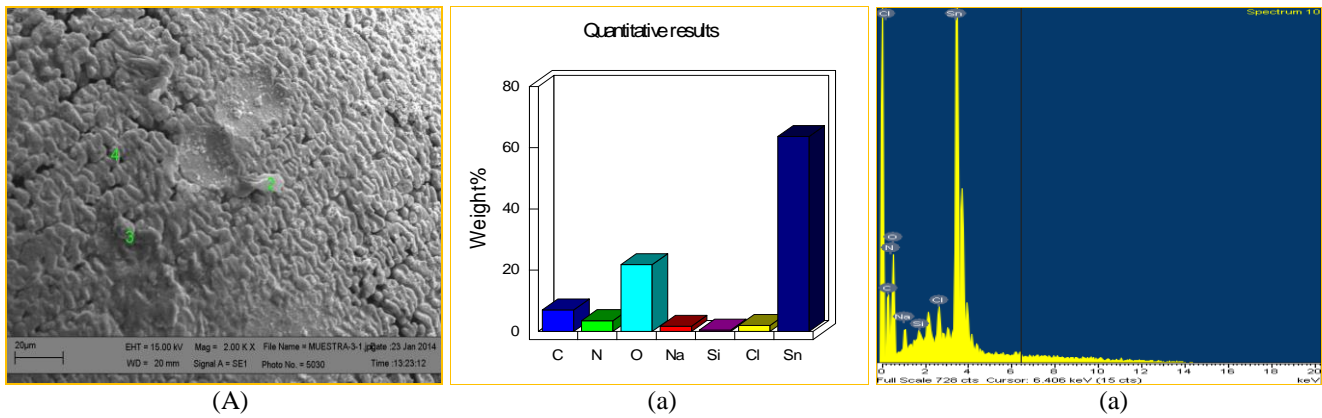
Figure 21. (A) is a general Analysis SEM. The sample was steamed with deionized water at 5% (NaCl) for 16 hrs

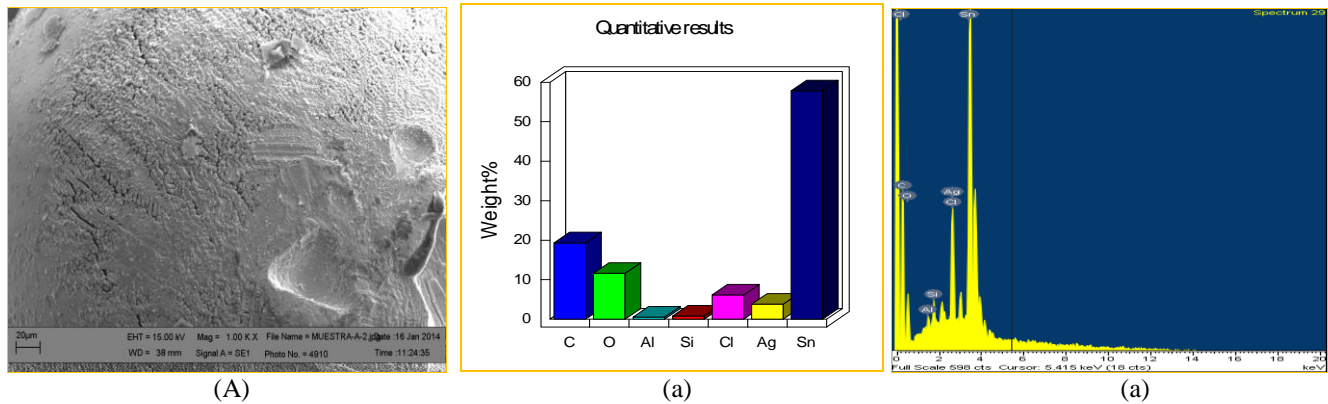
This sample, Figure 22, presents spots in larger surface areas. Additionally the presence of NaCl looks very marked in the component body. This case would be inadmissible in normal production, further the level of defects created with this NaCl concentration is very high.

Figure 22. (A) is a general analysis with SEM. Test in tap water at 10% (NaCl) for 4 hrs. The sample presents Cl and a high percentage of Oxygen

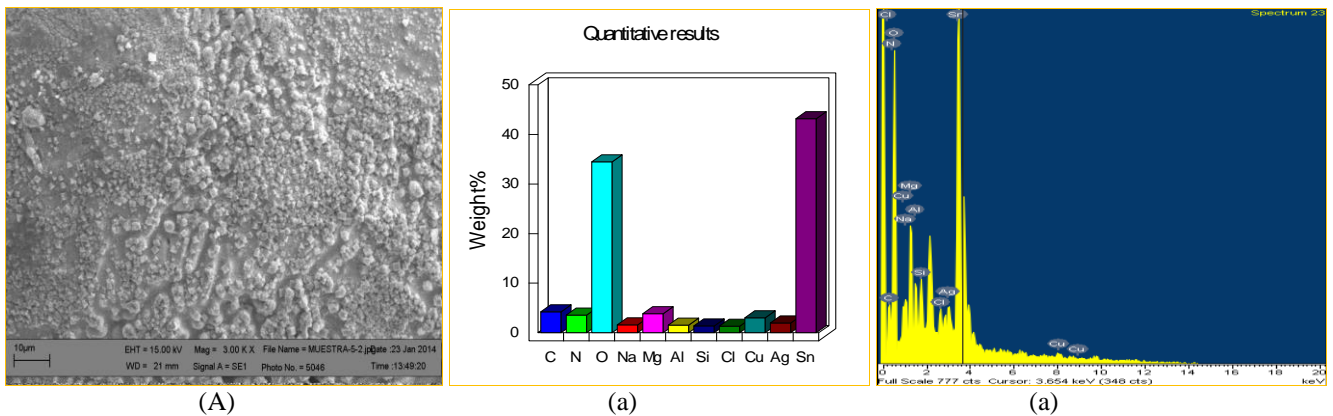
The analysis of this sample presents a large concentration on the surface of the ball in several chemical elements not only NaCl. See Figure 22 (A). These elements are Aluminum and Magnesium which also decrease the solderability of the balls.

Figure 23. (A) Sample in tap water at 10% for 16 hrs. Aluminum and Magnesium are present elements, which can affect the solderability

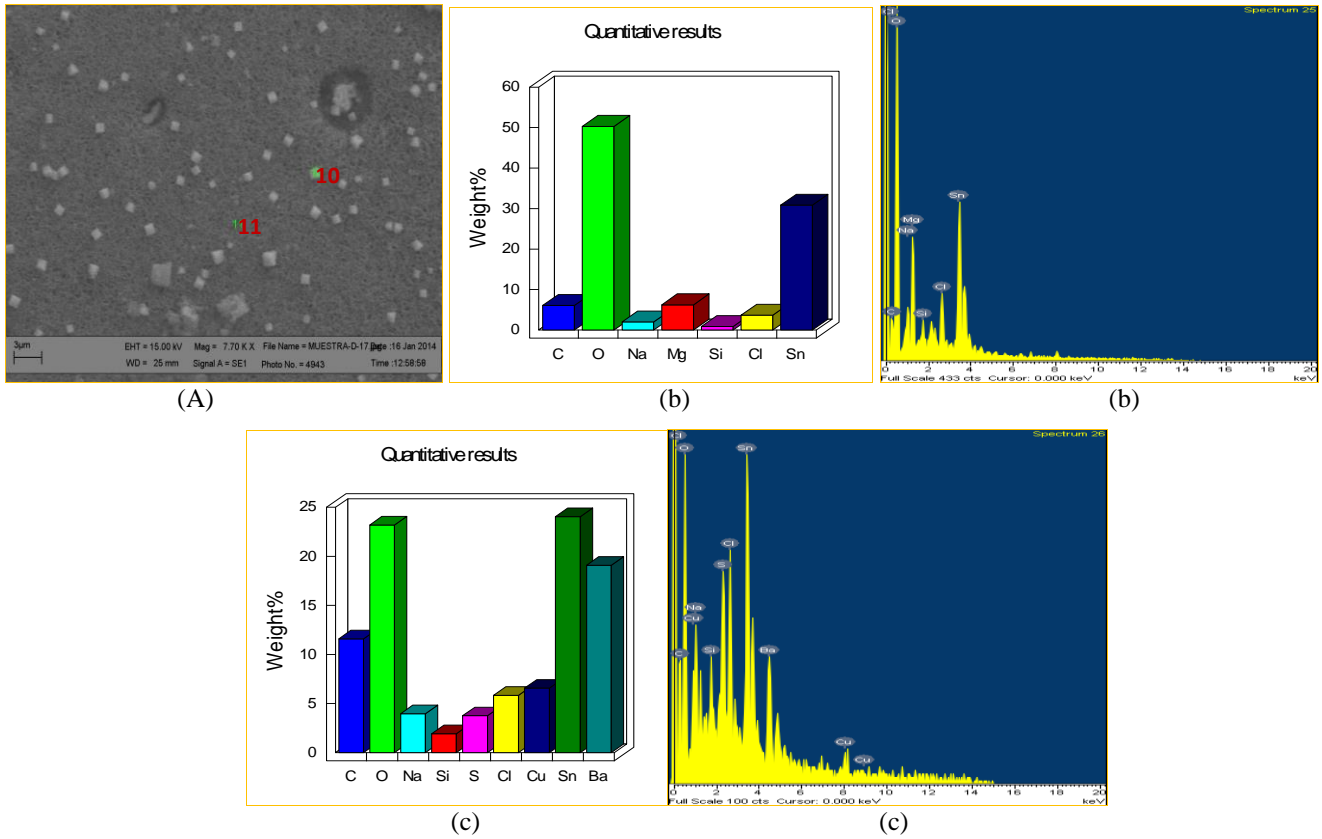
The SEM analysis shows contamination of NaCl in the BGA body in this case, see Figure 24. The contamination is in the form of small squares..

Figure 24. (A) General analysis body component (b) corresponds at point 10, and (c) at point 11

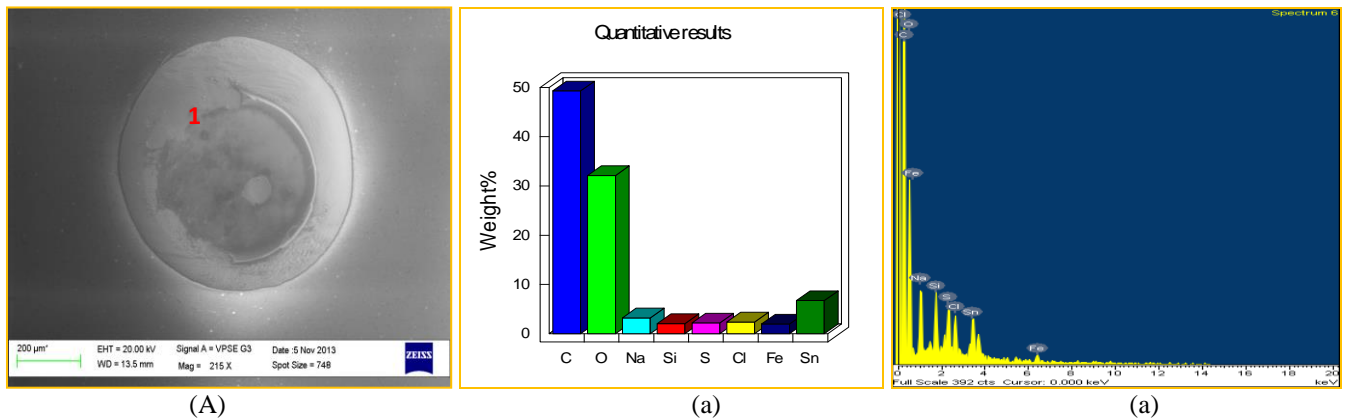
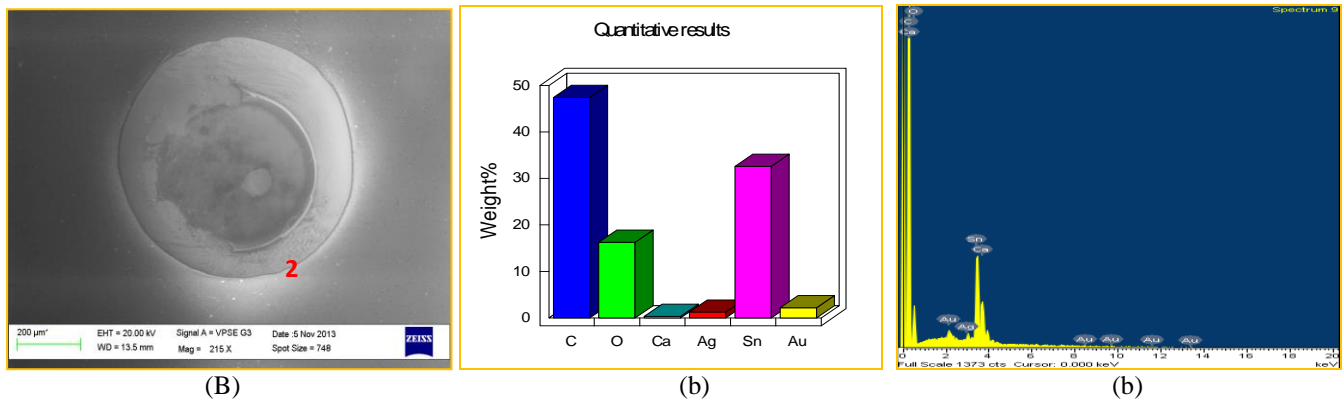
Ball 1: HiP defect

The next analysis points out an actual HiP rejection from production lines. The analysis shows that in some areas Cl concentrations are present and in other areas do not show similar to cases analyzed above. Cl concentrations are found around the component in specific areas. Although the reject would be related to other possible causes, it is interesting to mention the relationship between the experiments and this real case.

Figure 25. (A) The analysis of analyzed point 1 presents Cl; (B) is the analyzed point 2 which does not show Cl in a real HiP

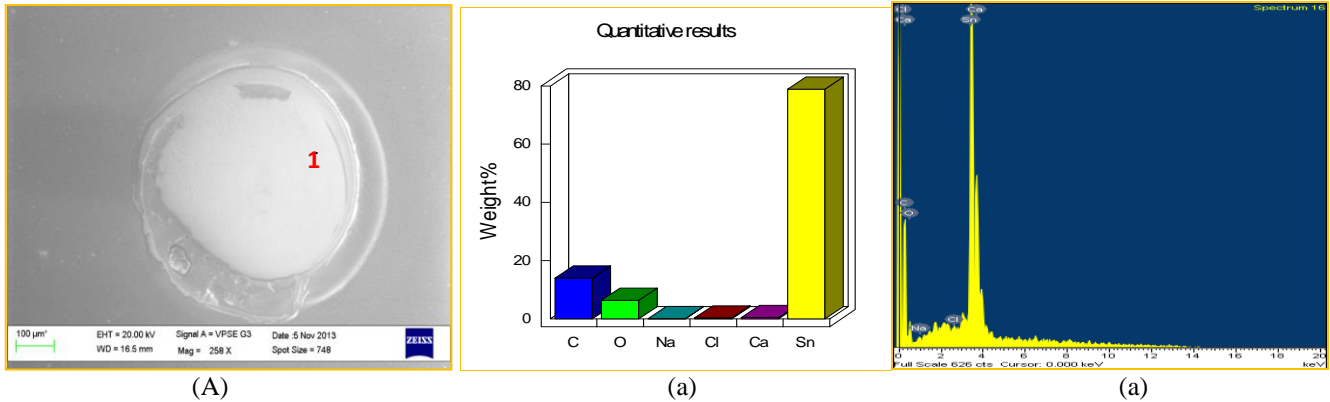
The following images show HiP SEM/EDX Analysis made on the pad. There are only small residues of NaCl left on the surface.

Figure 26. (A) There is NaCl presence on the pad

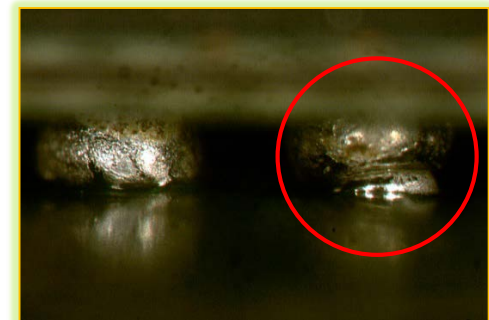
Figure 1. Head In Pillow Defect in a BGA connection (See the red circle)

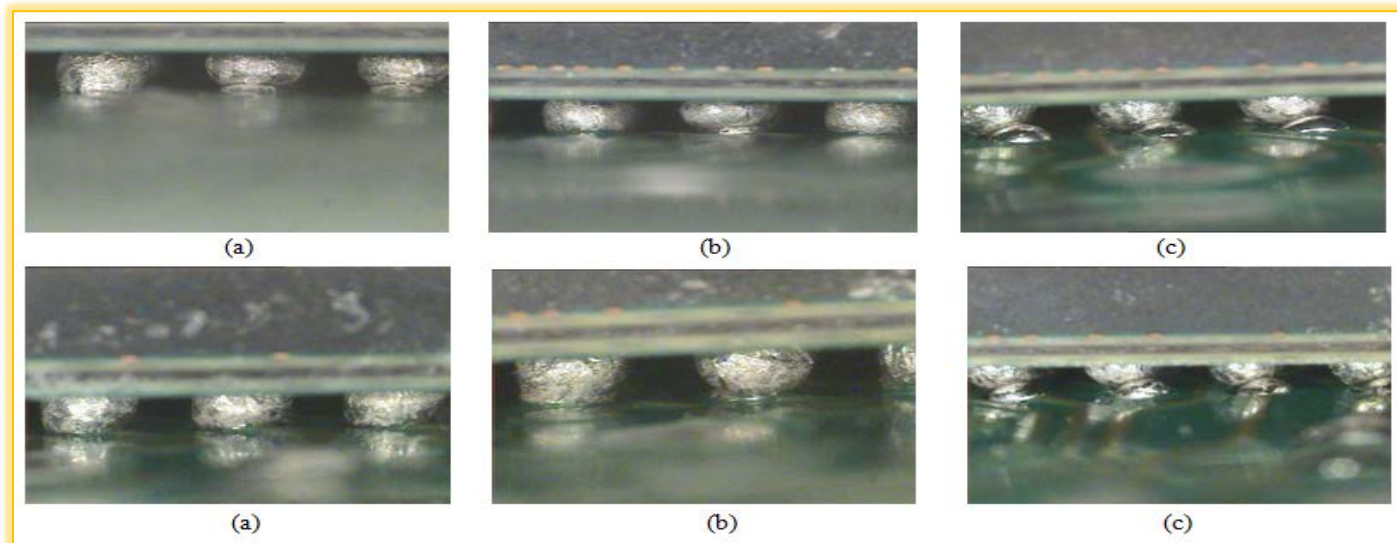
The images in Figure 4 show the HiPs resulted in DOE 1. These components got misplaced due to the number of HiPs. According to the results and comparisons, we can consider that the longer the time, the more defects.

Figure 4. DOE 1 Results: (a) Components at 4 hrs of setaming, (b) Components at 8 hrs of steaming, and (c) Components at 16 hrs of setaming, the components are misplaced due to number of HiP's.

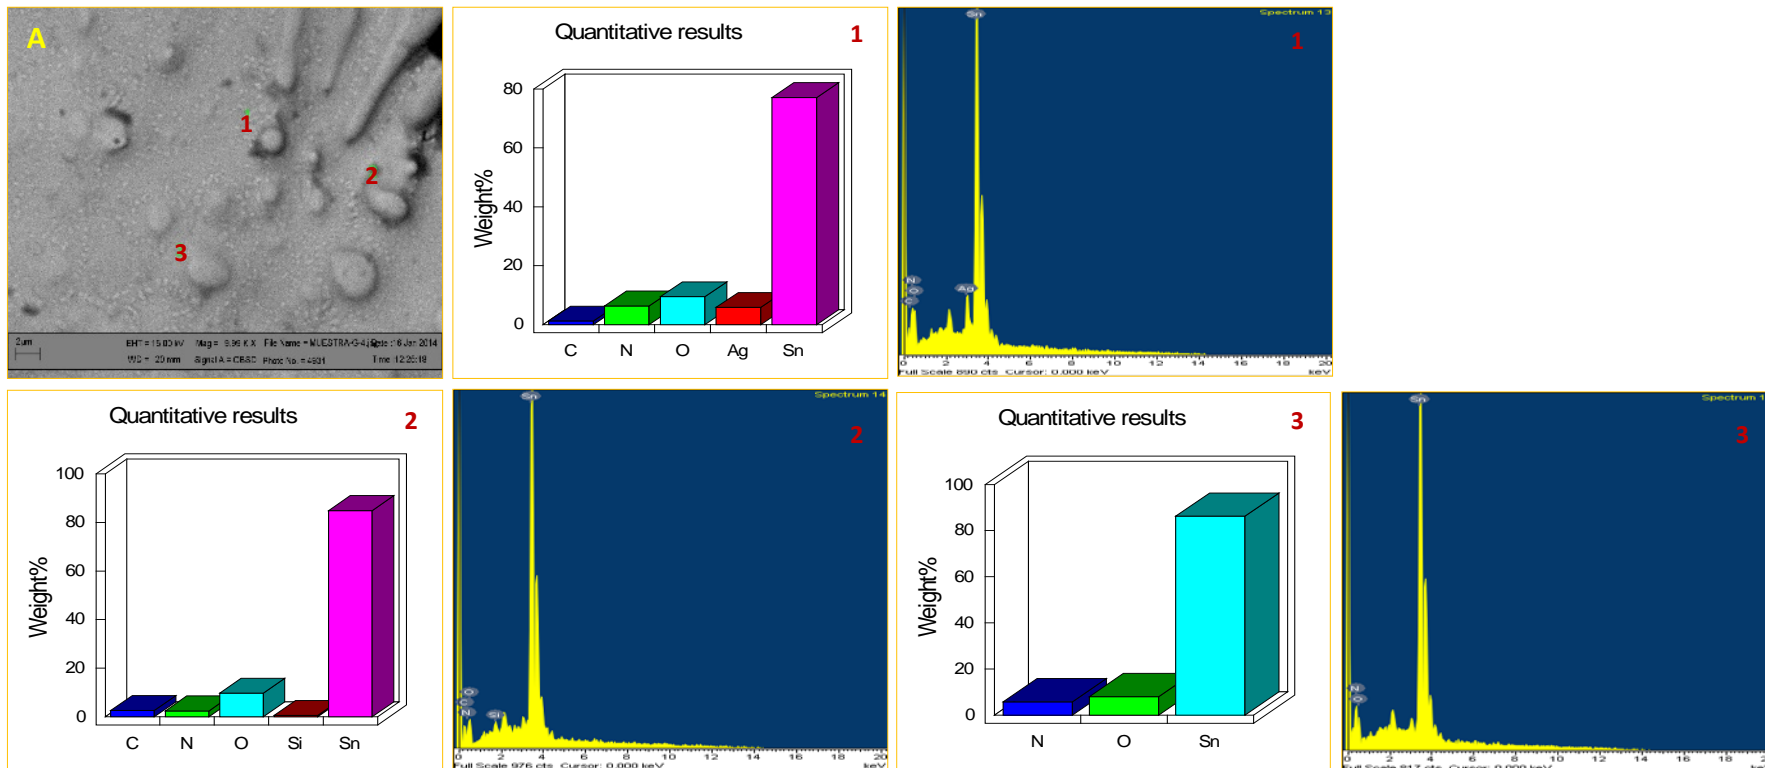
Figure 13. The (A) shows three red numbers representing the punctual areas. The (1) corresponds to the analyzed point 1, (2) to the analyzed point 2, and (3) to the analyzed point 3. The sample comes from 16 hrs test and DI water.

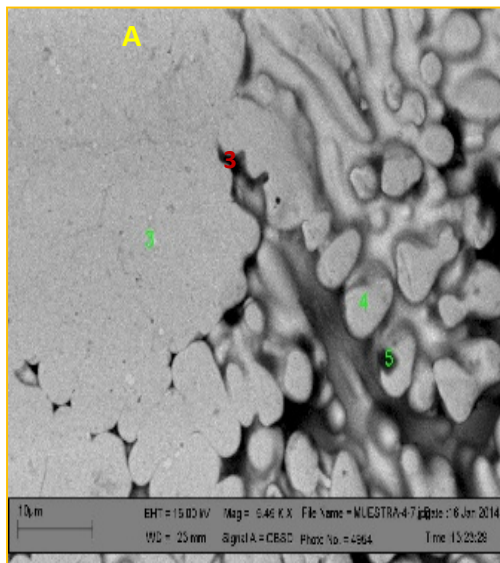
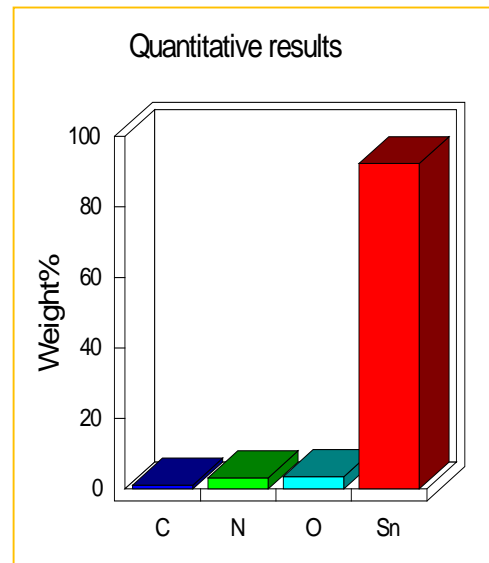
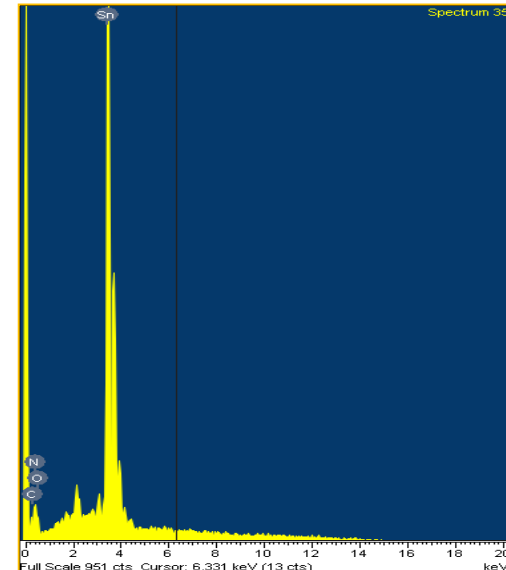
In this case, the results show a small concentration of chloride on the surface of the tin, see Figure 14; however, the presence of these chlorides is not evenly distributed across the surface of the ball but is found at specific points around the same; these points are located randomly.

Figure 14. The Images (A) is analyses of the sample with deionized water and 0.5% NaCl for 4 hrs

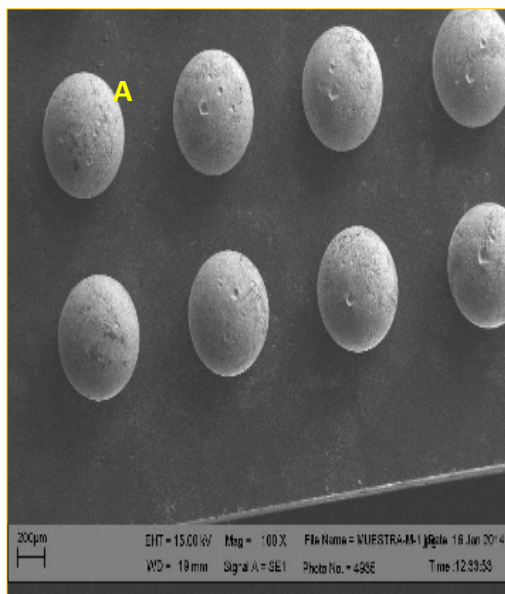
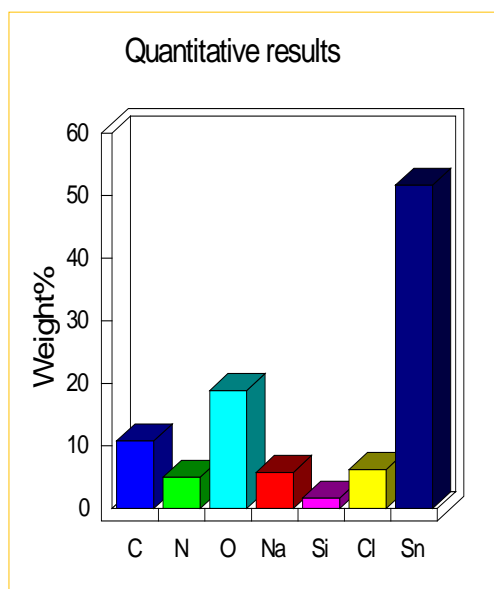
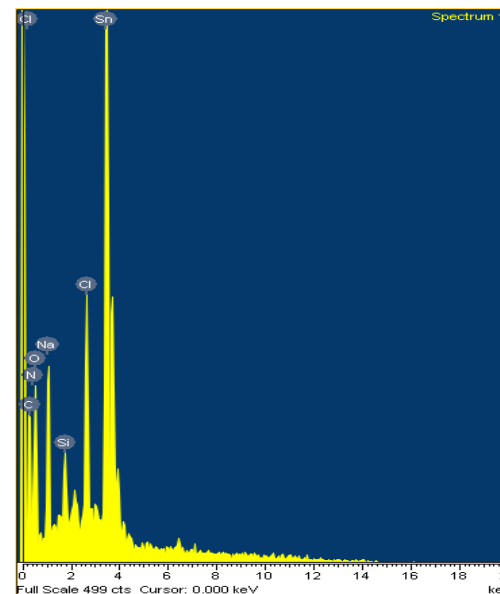
The results show higher sodium chloride concentrations at specific points around the ball.

Figure 15. (A) Results SEM Analysis (NaCl), Sample deionized water at 4 hrs.

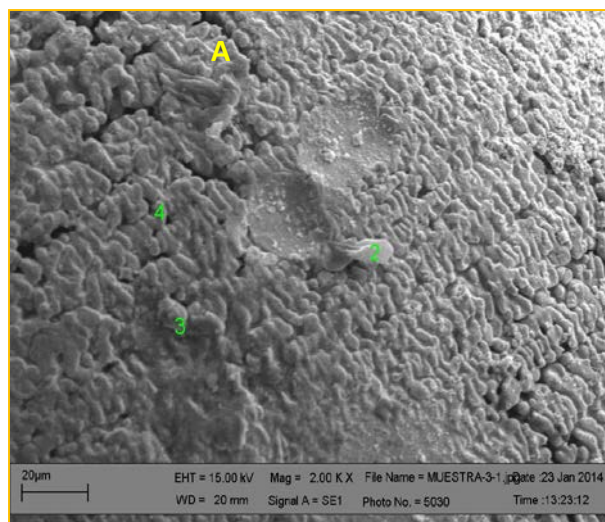
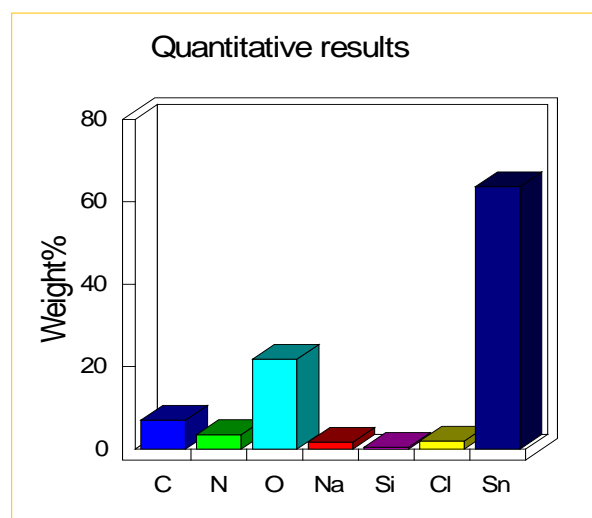
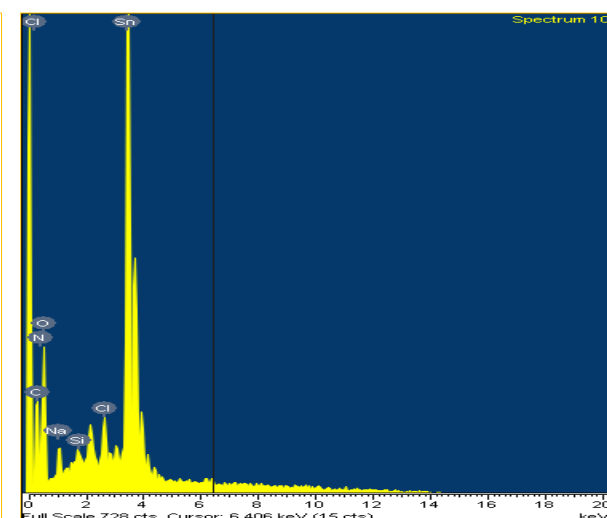
The results, Figure 16, show similar behavior to the previous sample, in which stains on of surface areas increases.

Figure 16. The (A) is a general Analysis SEM. The sample was steamed with deionized water at 5% (NaCl) for 16 hrs

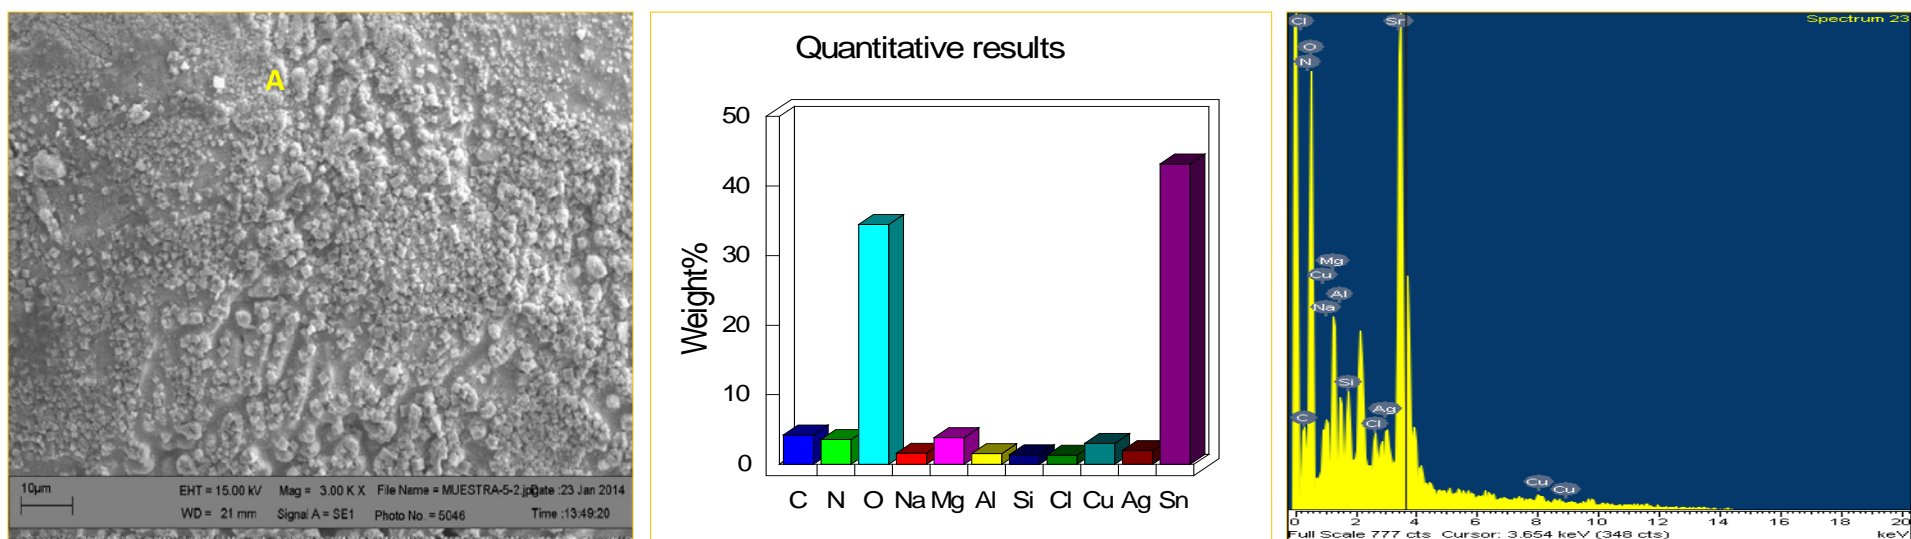
Figure 17. (A) Sample in tap water at 10% for 16 hrs. Aluminum and Magnesium are presented elements, which can affect the solderability.

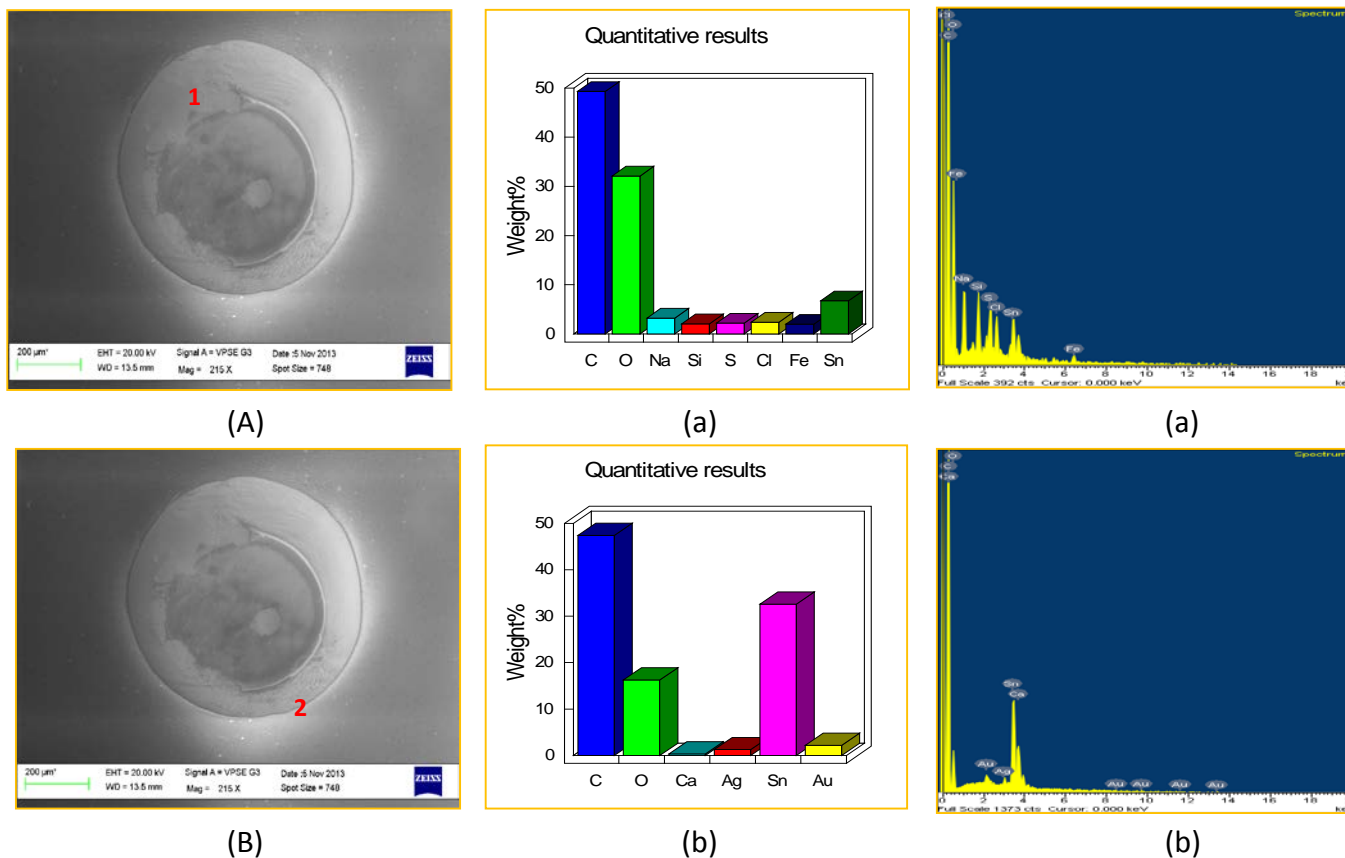
Ball 1: HiP defect

Figure 19. (A) The analysis of analyzed point 1 presents Cl; (B) is the analyzed point 2 not shows Cl.

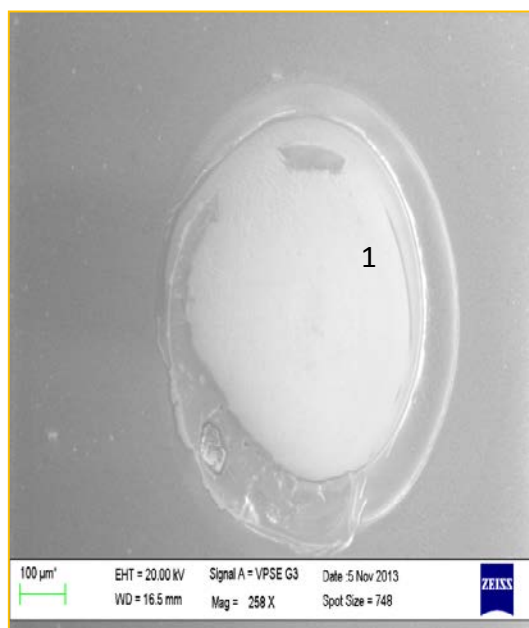
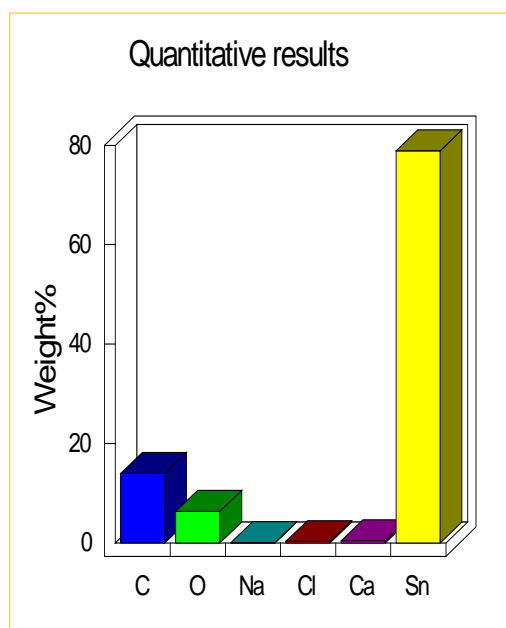
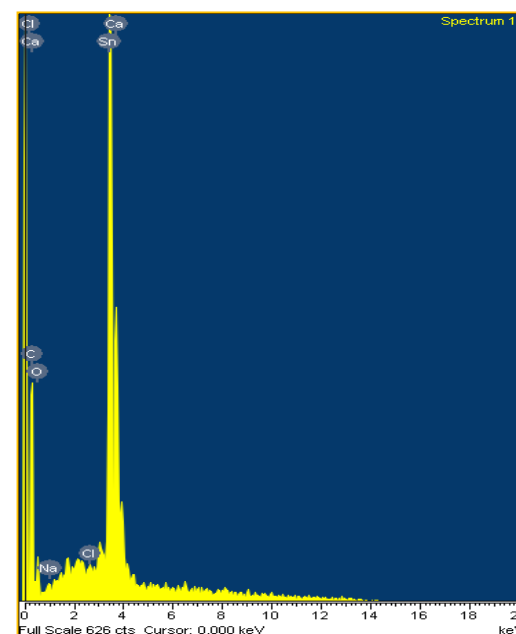
Figure 20. (A) The sample presents NaCl on the pad
