Improving PCBA Yield

Title: Improve the Yield of P	CBA from 82% to	92% at PCBA functiona	al Test Stage.
Current situation: Presen Sigma	•		
Scope of Project: Vendor	PCB Assembly to F	unctional Testing of PCBA	
Characteristics	Measure	Defect Definition	
Yield at PCBA functional testing	Percentage	Yield < 92%	
Project Black Belt: Subrat Praja	apati

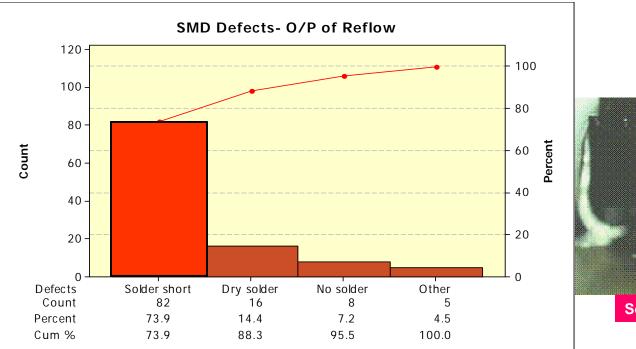
Pareto Chart

Defects at Test Jig stage related to Solderibility has been transformed to Pareto as below-

Solder short in IC leads

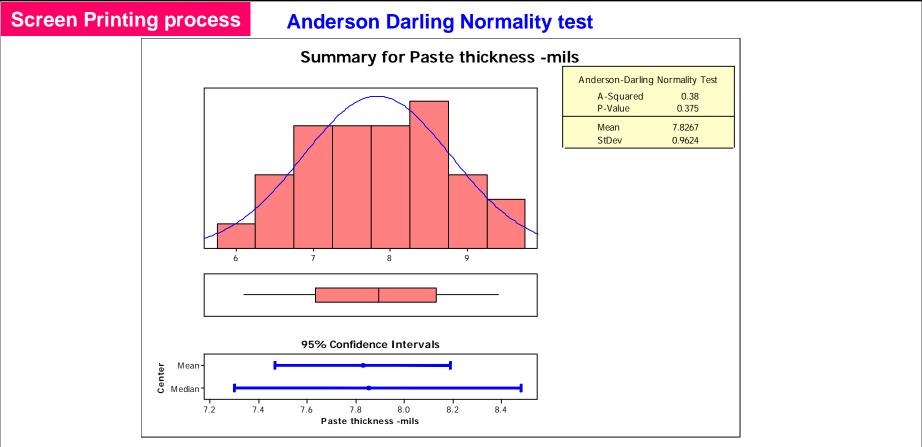
Data Plotting- Solder Paste Height measurement

Observation : From Normal Distribution Summary shows Mean of Paste thickness observed is 7.8 mil (198 micron).

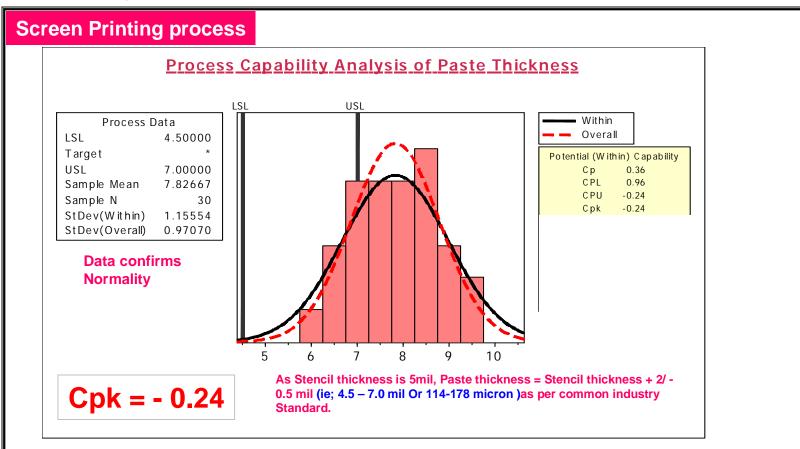
Cpk Analysis of Solder Paste Thickness

Concludes 80% of process is running outside USL, with Cpk= - 0.24 Mean Paste thickness = 7.8

Paste Thickness running out of Specification

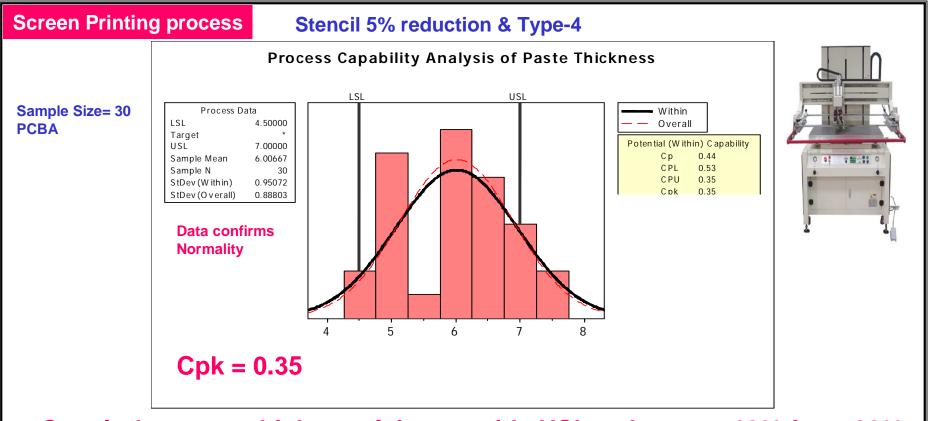
Concludes paste thickness lying outside USL reduces to 13% from 80%, with Cpk= 0.35 from -0.24 Mean Paste thickness = 6.0 from 7.8 mil

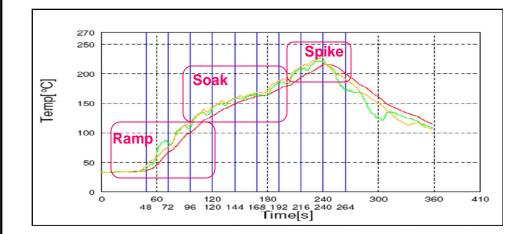
New RSS - Ramp Soak Spike Profile Deployed

Benefit: Due to Soak time it is facilitating flux to get activated which is useful for expired IC, obsolesce IC(As in our case) for getting good Solderibility. BGA checked in X-ray/Video scope

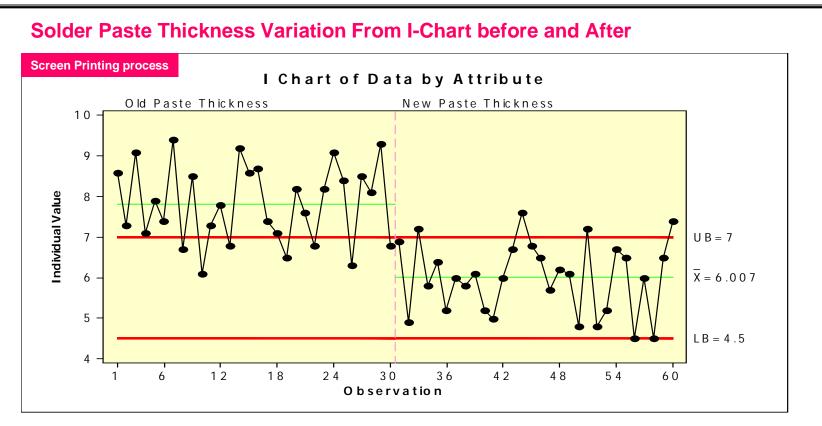
I-mR Chart implemented at Vendor for monitoring of Paste thickness
