Pad Cratering

A customer contacted the Helpline to perform analysis on a lead-free assembly which exhibited intermittent functionality. The lead-free assembly exhibiting intermittent functionality when pressure was applied to the ball grid array (BGA) packages. Industrial adaptation of a Restriction of Hazardous Substances (RoHS) compliant solder standard has created a new host of failure modes observed in lead-free assemblies. Pad cratering occurs when fractures propagate along the epoxy resin layer on the underside of the BGA connecting pads. While originating from process, design, and end use conditions, it is the combination of a rigid lead-free solder with inflexible printed circuit board (PCB) laminates that has advanced the prevalence of this condition. Pad cratering is simply the result of mechanical stress exceeding material limitations.

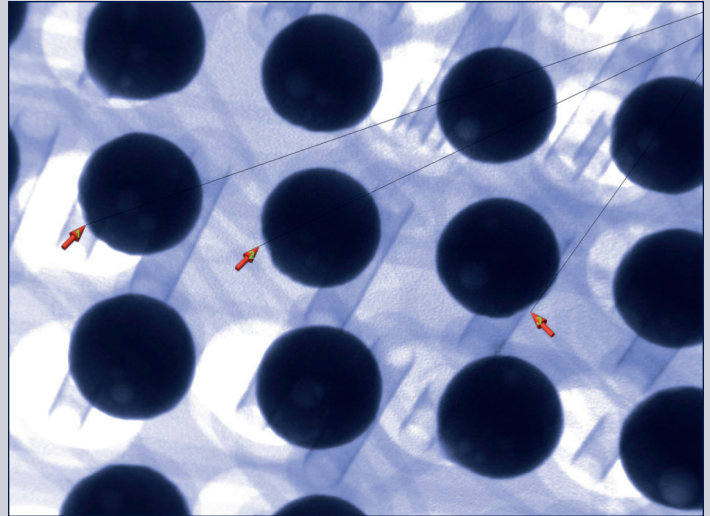
An X-ray inspection revealed subtle anomalies at the interface where a ragged and flattened appearance of several solder balls was observed (Figure 1). An endoscopic examination further confirmed that gapping at the interface had indeed occurred (Figure 2). To confirm this condition, microsection failure analysis was performed using enhanced scanning electron microscopy (SEM) magnification. Pad cratering was observed throughout the BGAs. In addition, fractures at the solder joint/gold pad interface and within the PCB were observed indicating an overstress condition (Figure 3).

Figure 1: X-ray inspection of BGA showing flattened appearance of several solder balls.

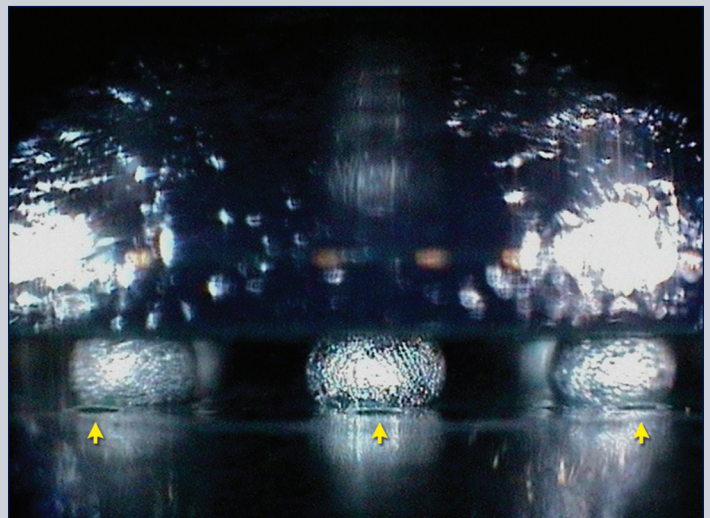
Figure 2: Endoscopic examination confirms gaps at the interface as indicated by the yellow arrows.

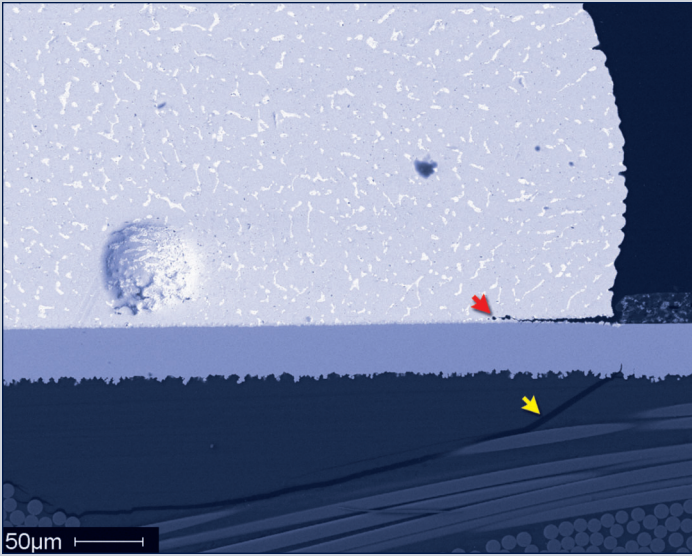
While it is unlikely that this specific occurrence was the root cause of the assembly failure, it may be indicative that a complete separation has occurred elsewhere; creating intermittent failures. Solder fracturing along the path of these “craters” can compromise connecting traces and vias resulting in an electrical failure. An examination of the metallurgical structure of the fractured solder joint was found to be consistent with a well-controlled lead-free soldering process. This further strengthened the conclusion that the solder fracture resulted from pad cratering.

Figure 3: SEM micrograph showing fractures at the solder/gold pad interface (red arrow) and within the PCB (yellow arrow).

Prevention of pad cratering requires measures that either reduce the stress on the interconnect site or mitigate the effects of stress. Reducing stress may require layout modification of the PCB or redesign of the next higher assembly. Adhesives can be applied as underfills or as external package perimeter bonding to provide additional mechanical strength, but this application may not be practical and has not yet proven to be enough in certain situations.

Changes to the material specification for the PCB laminate can also be an effective strategy to prevent pad cratering.
