FCT Assembly Solves Bridging Issues at Reflow

Root Cause

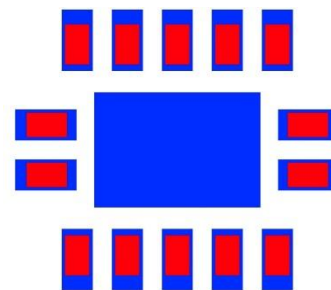
MLP 12-Pin

Just recently, Bob Dervaes, V.P. of Technology, performed a post reflow analysis on an assembly having bridging problems at reflow. The MLP 12-pin and SOT762 14-pin components, below, were bridging from termination-to-termination and from termination to the center GND/thermal pad, requiring post reflow rework.

(red: termination, blue: SMT pad)

For the bridging from termination-to-GND, the smallest clearance between the land pads for the terminations and the center GND pad is 0.006" for the MLP and 0.007" for the SOT762. This clearance is extremely small and can easily be bridged as the solder paste heats up and spreads during reflow.

The bridging from termination-to-termination is a result of stencil apertures that are too wide. The assembly has 1 oz copper, prior to through-hole plating, on the outer layers. There will be a size reduction, at the top of the PCB land pad, due to the copper etching process. For 1 oz copper, the reduction will be between 0.002" and 0.003". If the stencil aperture width is not reduced accordingly, solder paste can squeeze out between the stencil and PCB and create bridging on fine pitch devices.

To eliminate the bridging, the clearance between the solder paste bricks on the termination land pads and center pad needs to be increased. The stencil aperture width also needs to be decreased to compensate for the land pad size reduction, due to etching. However, solder volume is extremely critical on small components and large reductions in the width can cause insufficient solder volume problems at reflow. The stencil aperture length needs to have a corresponding increase to ensure sufficient solder volume. For leadless components, length should always be increased on the outer edge of the PCB land pad. Increasing the length to the inside increases the possibility of flux migrating along the component body, causing bridging.

- MLP 12-Pin: 0.0295" x 0.015" (40% volume reduction for thermal pad)
 - Stencil apertures shifted 0.002" to the outside to increase the clearance between the solder paste bricks and the center GND pads
 - Clearance between the solder paste brick and center pad is a minimum of 0.0125"
- SOT762 14-Pin: 0.030" x 0.009" (40% volume reduction for thermal pad)
 - Stencil apertures shifted 0.0027" to the outside to increase the clearance between the solder paste bricks and the center GND pads.
 - Clearance between the solder paste brick and center pad is A minimum of 0.0093"
