## Investigation of Through-Hole Capacitor Parts Failures Following Vibration and Stress Testing

Recently, an ACI Technologies (ACI) customer called to discuss failures that they had observed with some through-hole capacitor parts. The components were experiencing failures following vibration and accelerated stress testing.

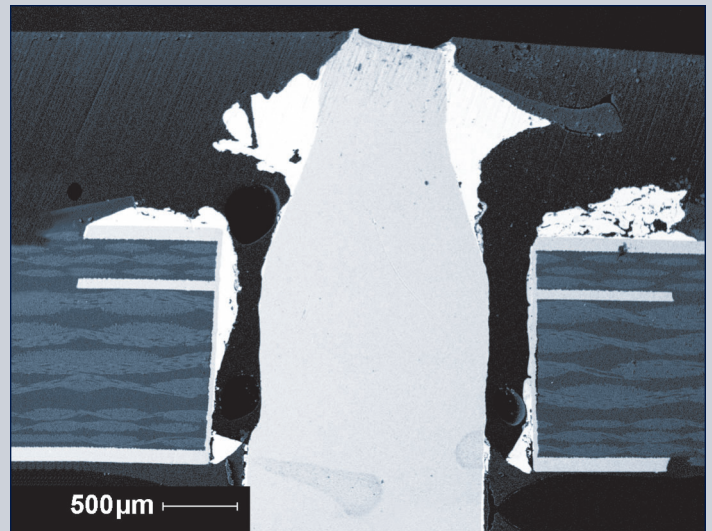
The assemblies were then cross sectioned and placed in a Scanning Electron Microscope (SEM) to examine the failures under high power magnification (over 100x). This tool allowed ACI to look for micro-cracks in the solder and the proper formation of intermetallic layers at the solder to copper junction. After cross-sectioning, it was evident that insufficient solder fill was the failure mechanism for these capacitors. The plated through-hole appeared to have very little solder on either side (Figure 1), allowing a large gap between the lead and the barrel. In addition, the opposite lead of capacitor C12, which appeared to

*Figure 1: Insufficient hole fill caused capacitor solder joint failure (SEM image).*

- The plated through-hole diameter/lead diameter ratio for the electrolytic capacitors needs to be re-evaluated. Low clearance for the capacitor lead in the plated through-hole may inhibit the solder flow to fill the hole. ACI referenced the IPC-2222 design guidelines for rigid printed board with standards for hole/interconnections (Section 9). The manufacturer specification should also be consulted for the appropriate plated through-hole diameter/lead diameter ratio.
- The solder process should be re-evaluated. Insufficient solder fill in plated through-hole indicates that there are several areas to investigate. Increasing the pre-heat temperature, lengthening the solder dwell time, and increasing the amount of flux application can improve the solderability of the capacitor leads and achieve the IPC target hole fill of 100%.

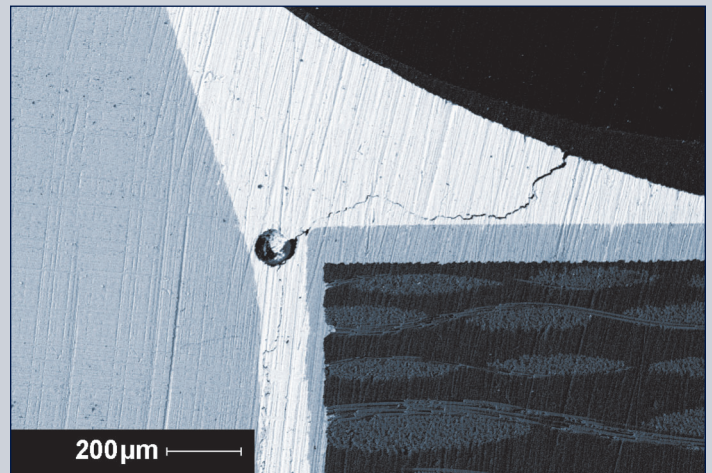
*Figure 2: Hairline crack viewed in the SEM.*

be intact during visual inspection, was found to be damaged with a micro-fracture (Figure 2). Multiple voids were observed from the cross-section in both optical and SEM images which showed several micro-fractures bridging together.

The IPC-A-610 standard requires a minimum of 75% solder fill for Class 3 products. The opposite lead of capacitor C12 (Figure 2) which showed adequate vertical solder fill, but displayed a micro-fracture, had been examined during visual inspection for circumferential wetting. This capacitor lead passed the IPC-A-610 standard for circumferential wetting on the solder source side, in that there was 360° wetting present [Note: the minimum wetting requirement for Class 3 is 330°]. Also, the percentage of land area covered by wetted solder on the solder source side was 100% (which exceeds the minimum 75% land area requirement). [Note: the micro-fracture was not witnessed under visual inspection with the naked eye and was found only under magnification during later inspection.]

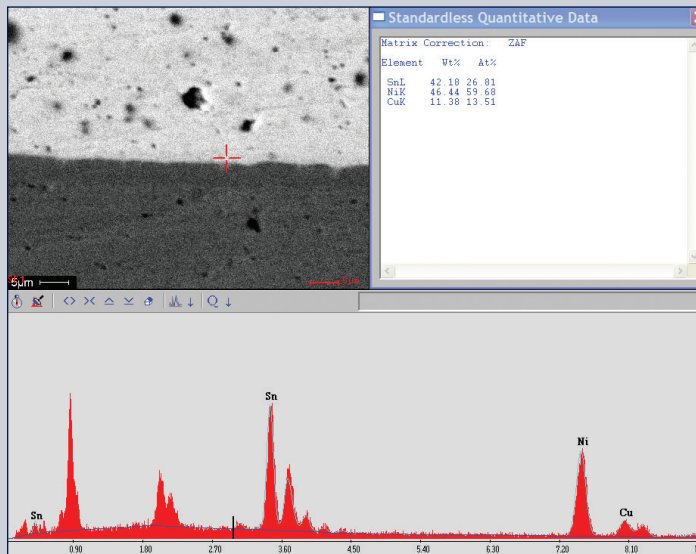
Figure 3: The EDS analysis shows an intermetallic layer from the Cu-Sn-Ni composition between the interface of the bulk solder and the plated through-hole.

ACI analyzed each micro sectioned sample using Energy Dispersive Spectroscopy (EDS) to determine the composition of the intermetallic bond in the solder joints. EDS showed the existence of a Cu-Sn-Ni intermetallic layer between the interface of the bulk solder and the plated through-hole (Figure 3). This underdeveloped intermetallic layer could be another sign that the solder dwell time was insufficient to allow the solder to wick into the plated through-hole for maximum fill.
