# Challenges on ENEPIG Finished PCBs: Gold Ball Bonding and Pad Metal Lift

Young K. Song and Vanja Bukva  
Teledyne DALSA Inc.  
Waterloo, ON, Canada

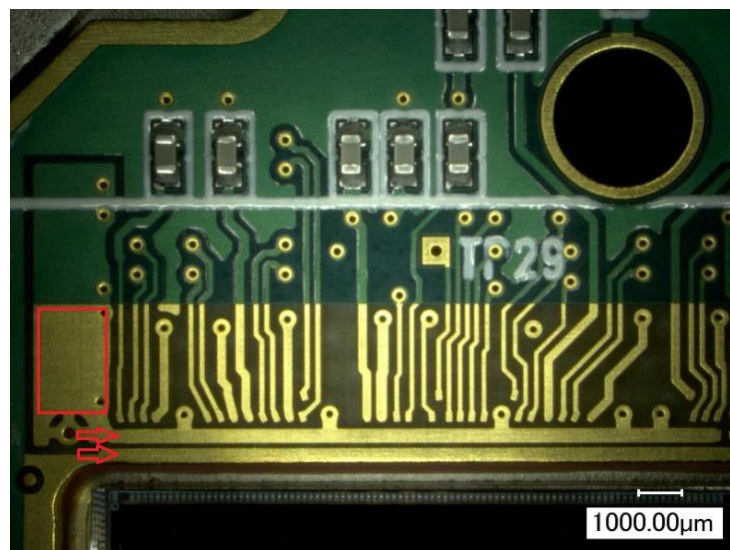
**Figure 1- Partial View of Sample PCB**

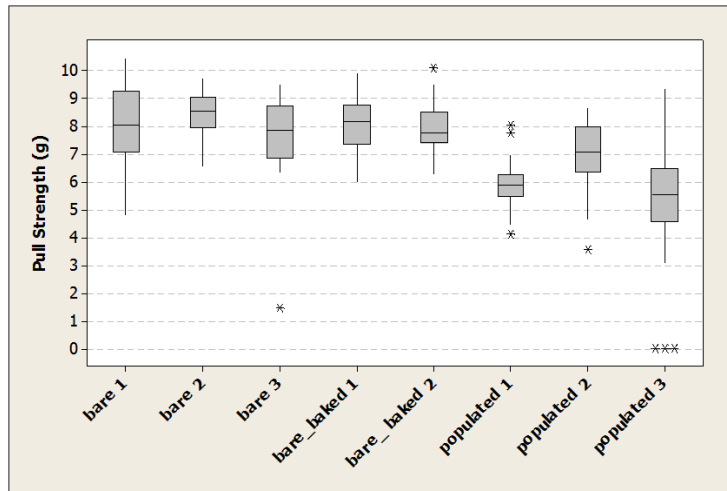
Figure 4 - Wire Pull Strength Comparison Between Bare and Populated Boards from Sample A

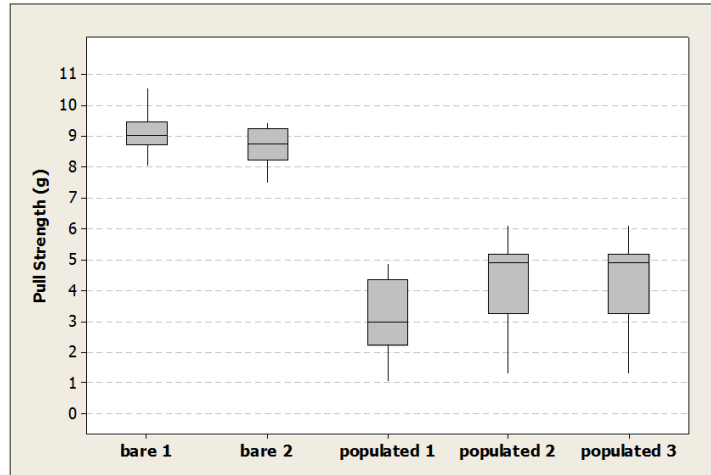
Figure 5 –Wire Pull Strength Comparison Between Bare and Populated Boards from Sample B

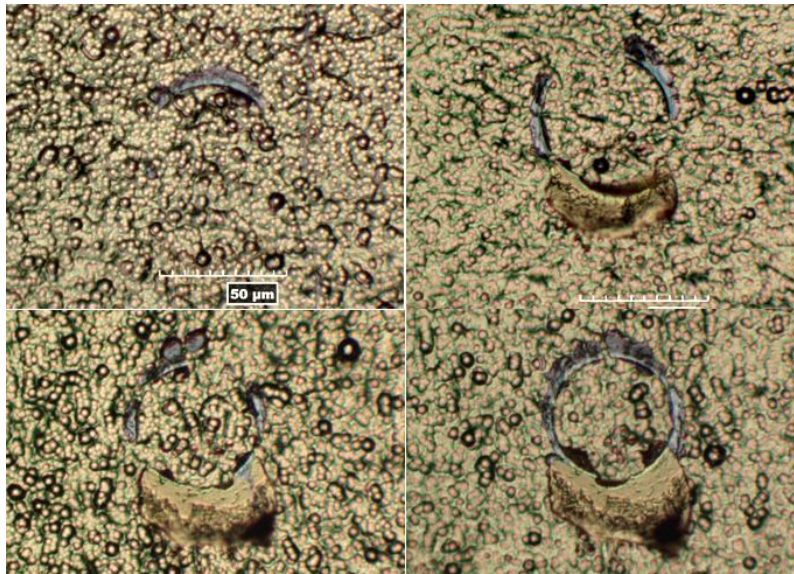
**Figure 6 - Variation in Tool Marks**

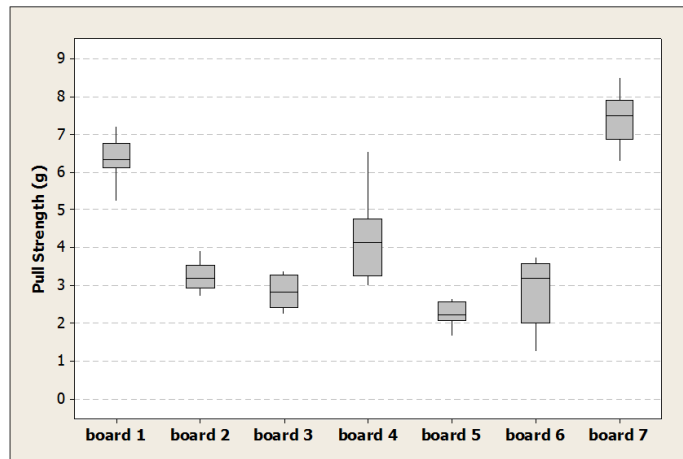
**Figure 7 - Wire Pull Strength from Mixed Batches of Populated Boards from Sample C**

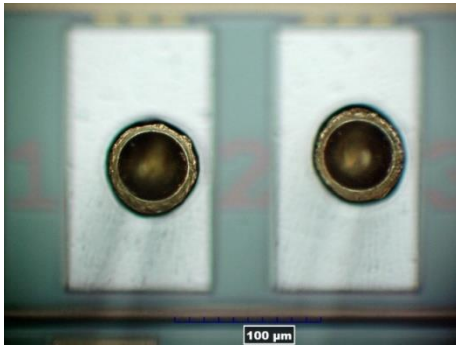
**Figure 8 - Ball Bonds for Security Bump Process**

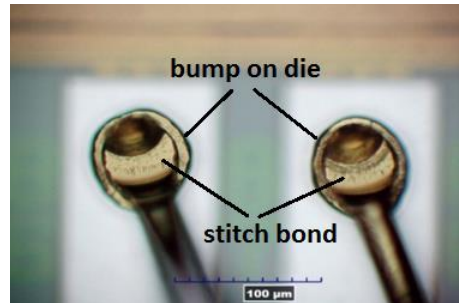
**Figure 11 - Stitch Bonds Made on Bumps for SSB Process**

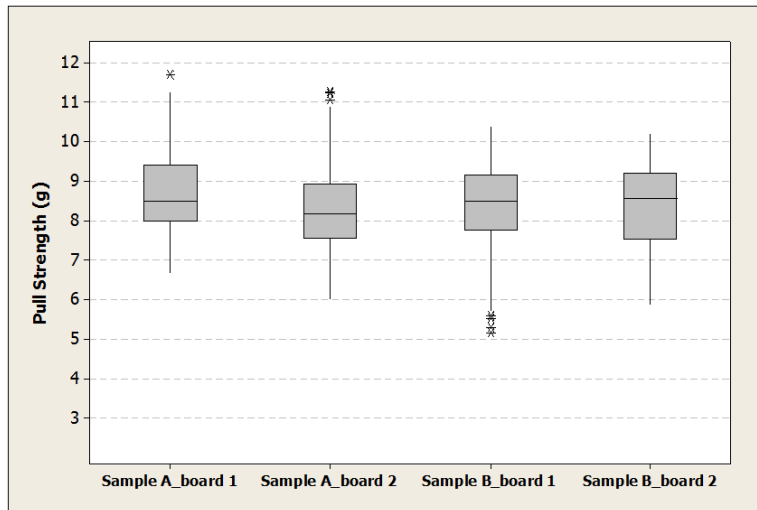
**Figure 12 - Wire Pull Strength from Populated Boards with SSB Process**

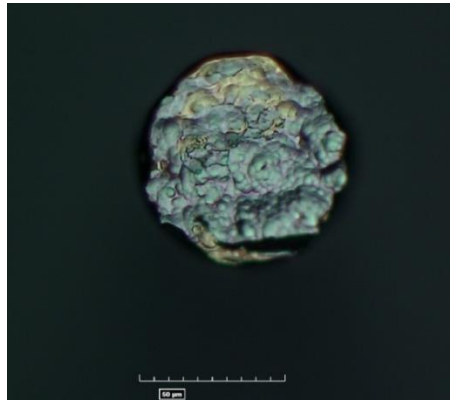
**Figure 13 - Bottom of a Lifted Bond**

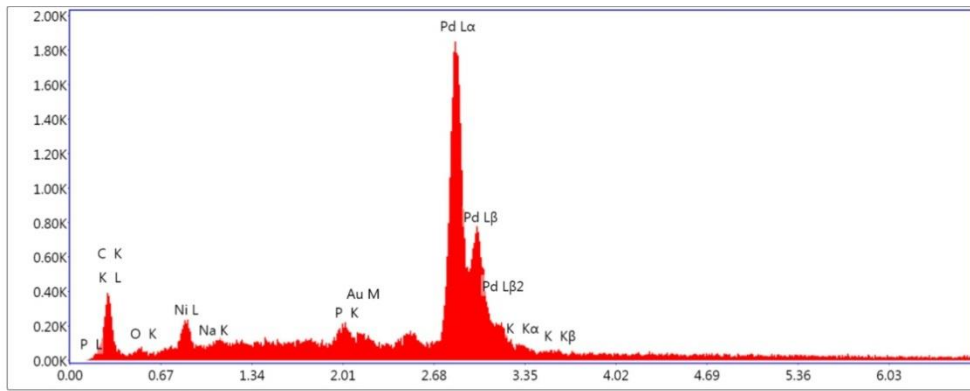
**Figure 15 - EDS Analysis Spectrum Obtained from The Bottom of Lifted Bond**

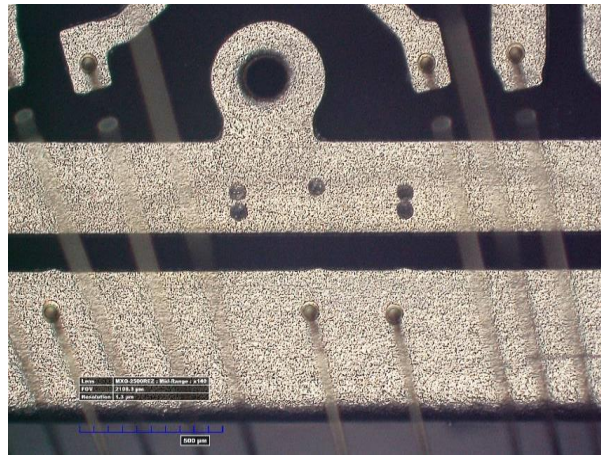
**Figure 16 - Five Black Circles Represent PML Including Attempts to Repair**

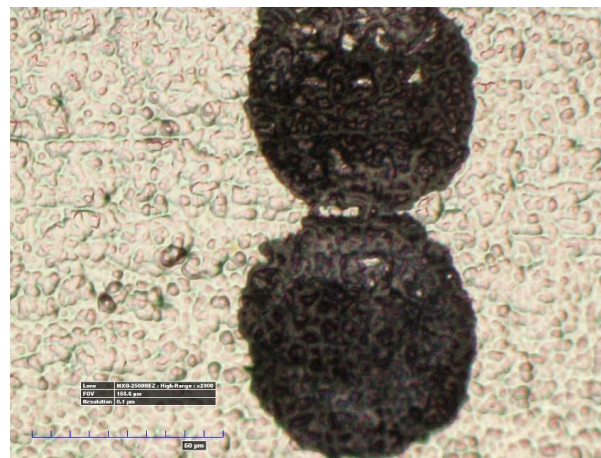
**Figure 17 – Zoom in on PML Area**

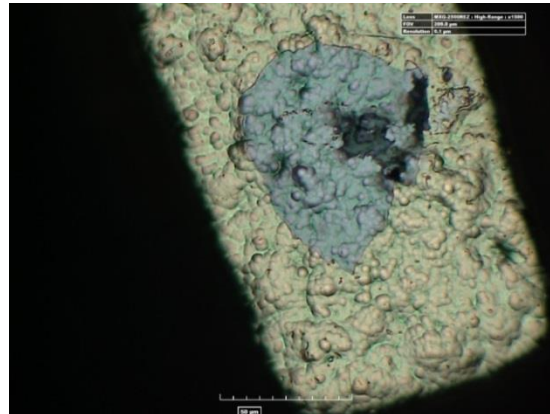
**Figure 18 - PML from Sample D**

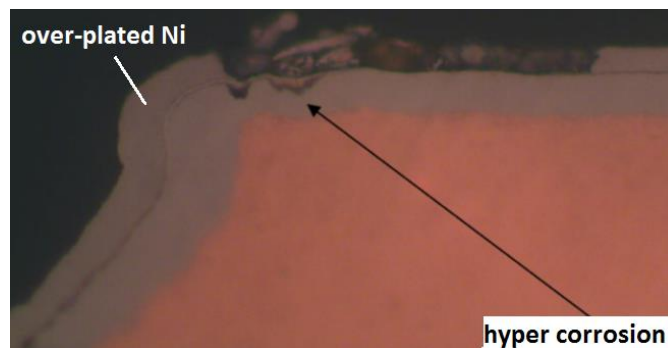
**Figure 19 –Image of Edge Hyper Corrosion at Lens 1000x (ignore top, over-plated layer for sample preparation)**

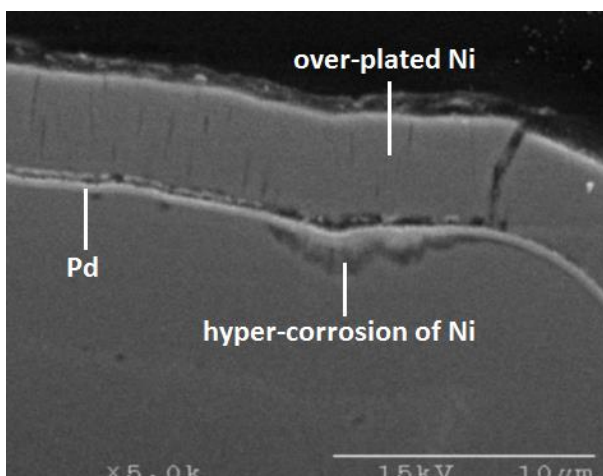
**Figure 20 – SEM Image of the Edge of the Pad Showing Hyper Corrosion of the Ni Beneath the Pd**

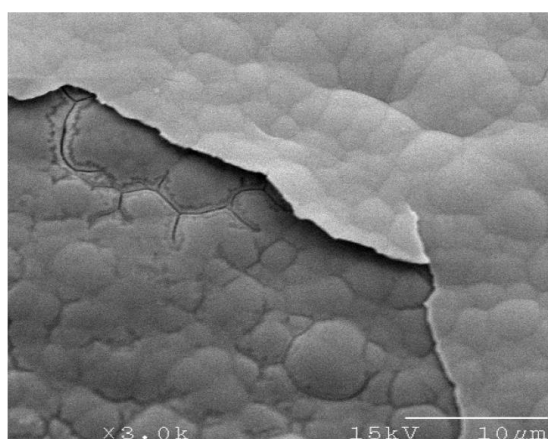
**Figure 21 – SEM Image of the Same Failed Site Showing Lifted Pd and Hyper Corrosion of the Ni**

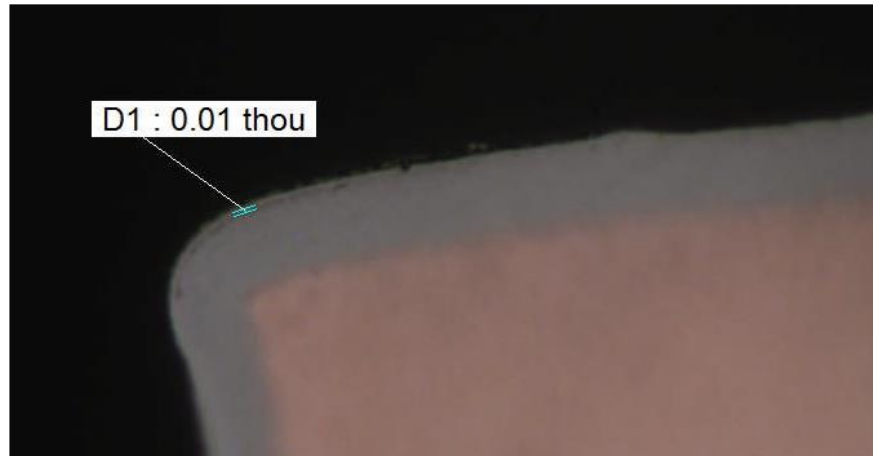
**Figure 22 - Edge of the Pad Showing Demarcation Line at 1000x Lens.**

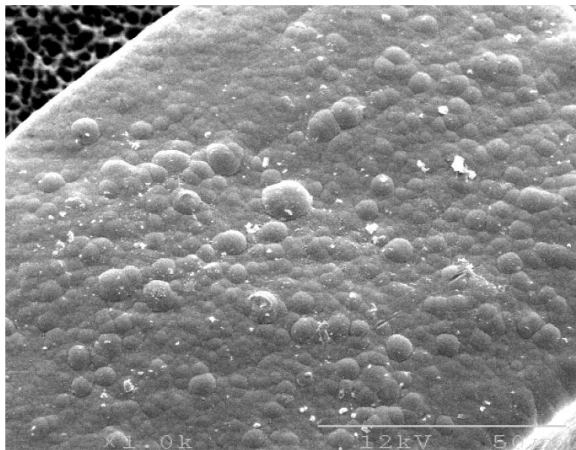
**Figure 23 – SEM Image of Wire Bond Pad Showing Variation in the Grain Size of Ni Deposit at 1000x**

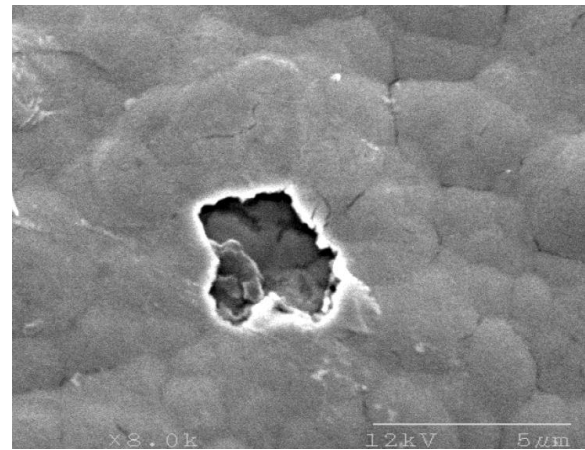
**Figure 24 – SEM Image Showing Missing Pd at 8000X**

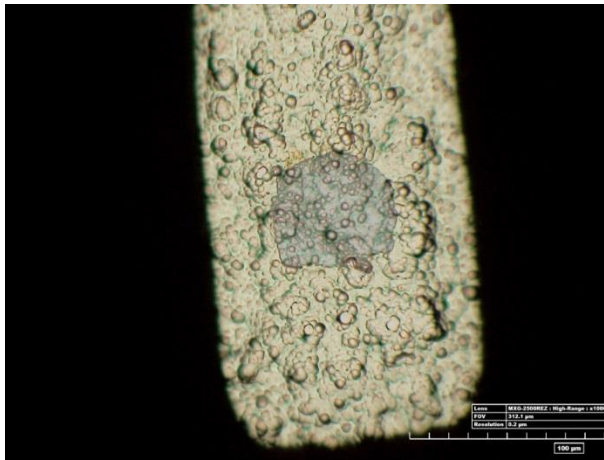
**Figure 25 – Optical Microscope Image of PML**

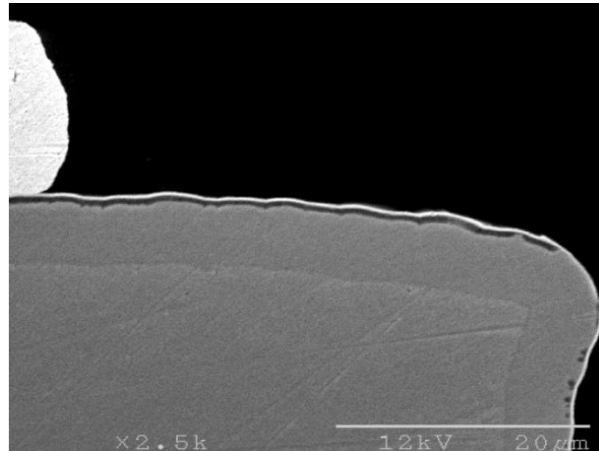
**Figure 26 – SEM Image at 2500X Showing Extensive Hyper Corrosion**

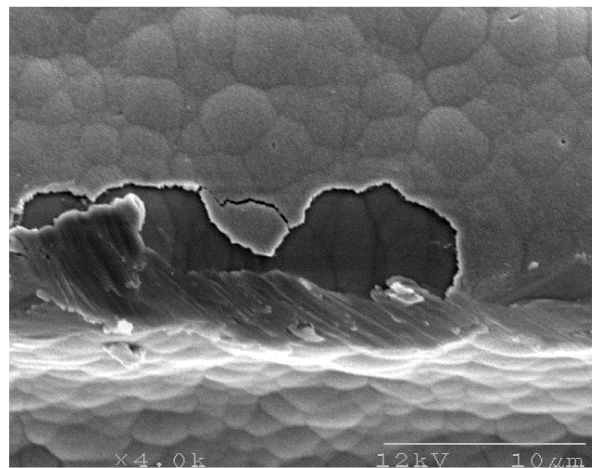
**Figure 27 –SEM Image at 4000X Showing the Lifting Pd Layer**

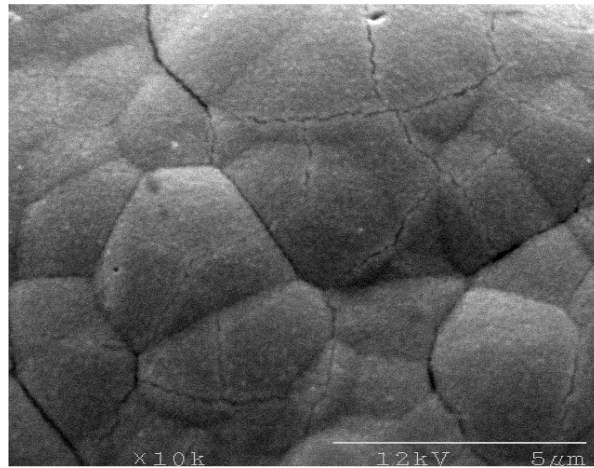
**Figure 28 – SEM Image of the Pd Surface Showing the Trans-granular Cracking of the Pd**

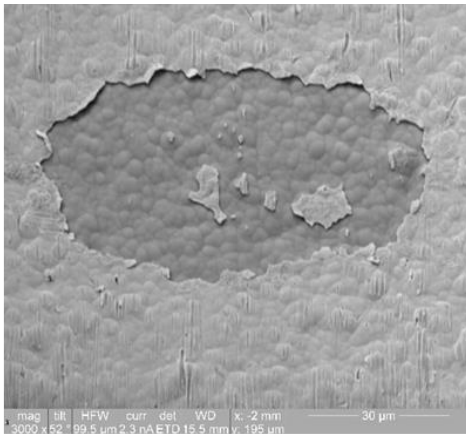
**Figure 29 - SEM Image of the Lifted Bond at 3000x**

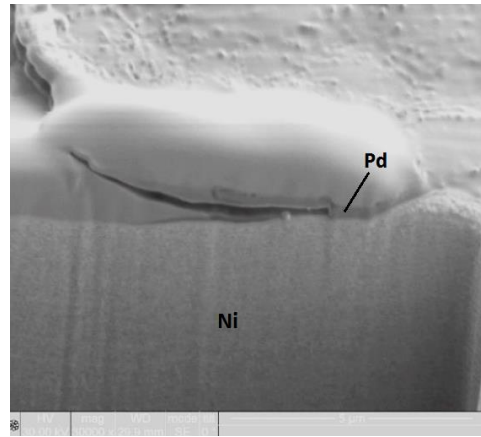
**Figure 30 - FIB Image of the Lifting Pd from Ni at 30,000X**

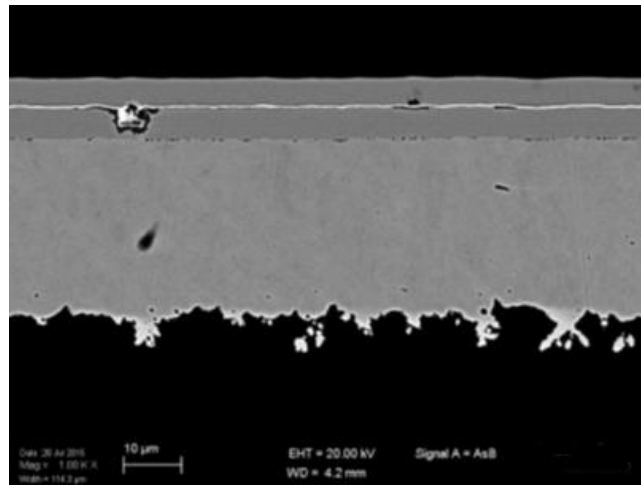
**Figure 31 -Inclusion in Ni layer and Ni Hyper Corrosion**

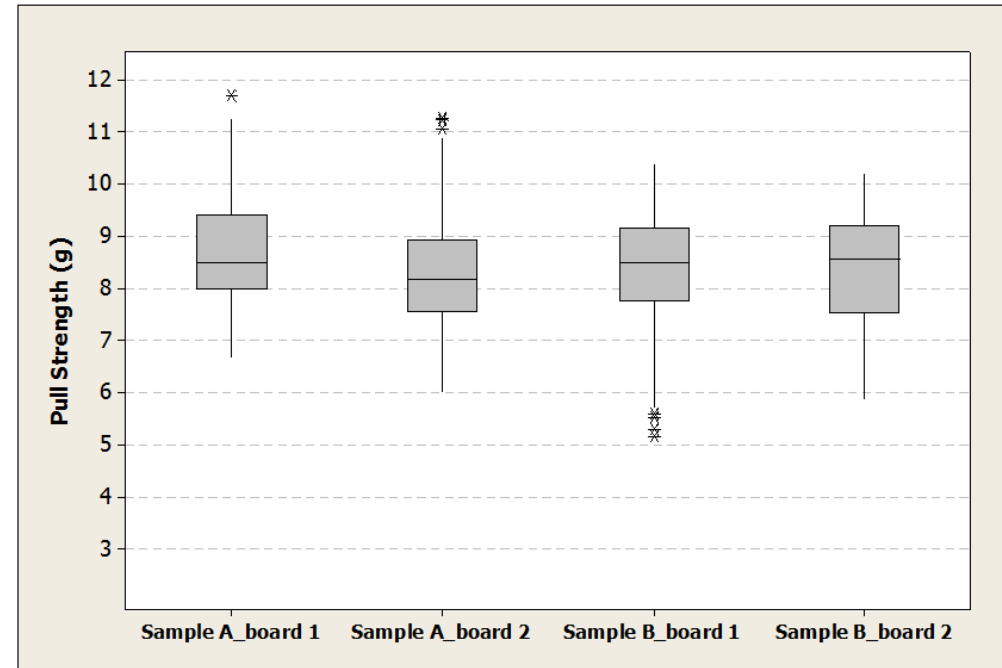
**Figure 12 – Wire Pull Strength from Populated Boards with SSB Process (Sample A and Sample B)**

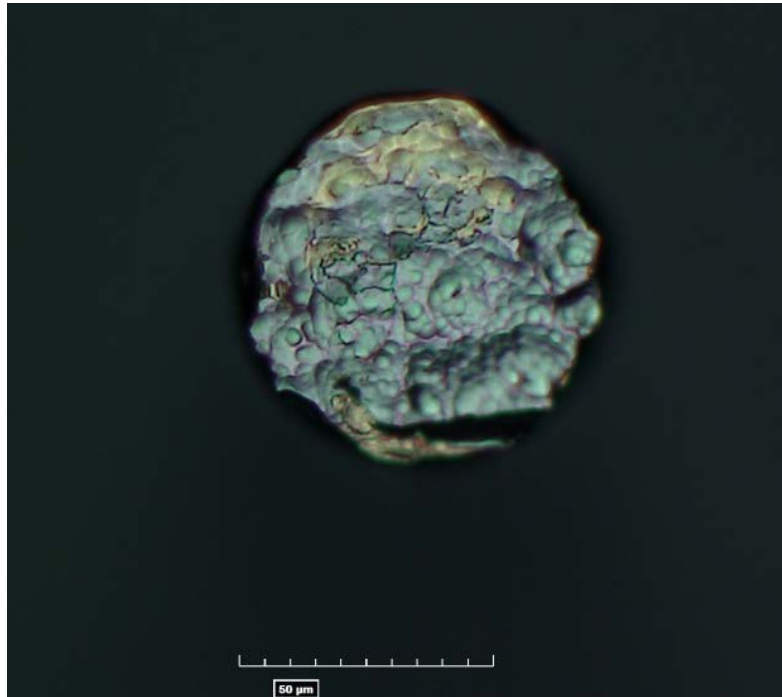
Figure 13 - Bottom of a Lifted Bond

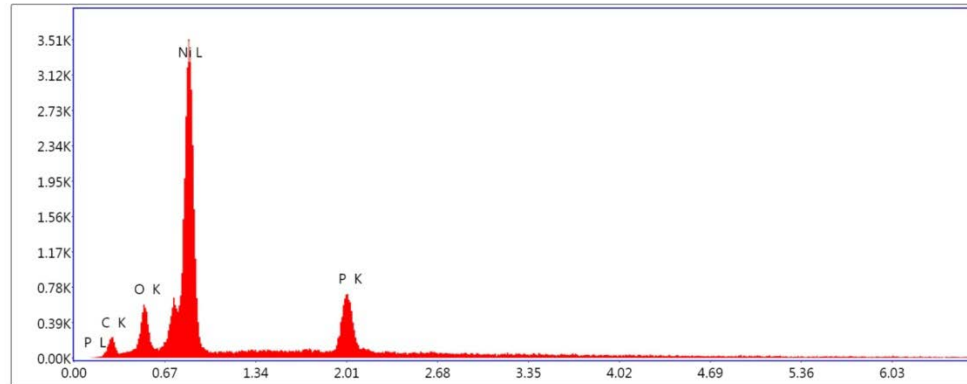
**Figure 14 - EDS Analysis Spectrum Obtained from The Area on Bonding Pad with Lifted Bond**

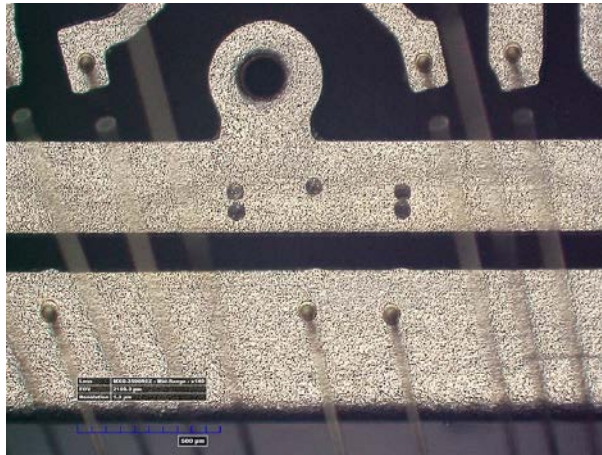
**Figure 16 - Five Black Circles Represent PML Including Attempts to Repair**

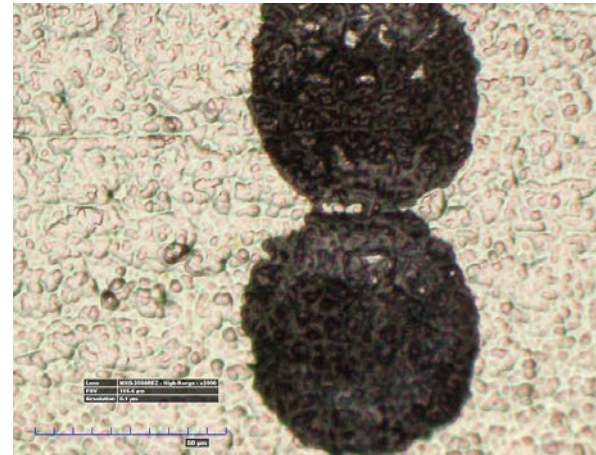
**Figure 17 – Zoom in on PML Area**

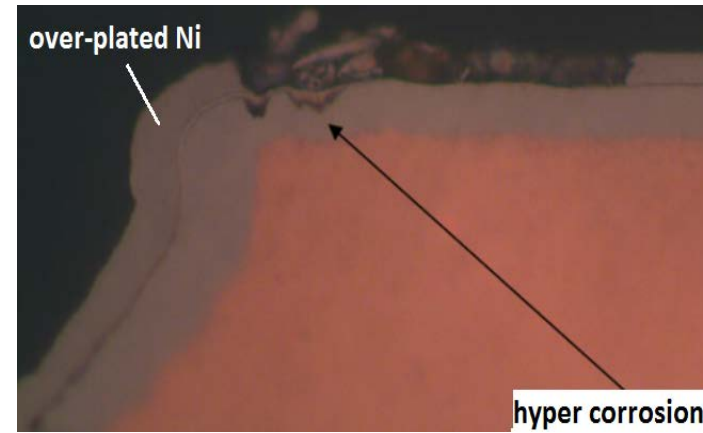
Figure 19 – Image of Edge Hyper Corrosion at Lens 1000x (ignore top, over-plated layer for sample preparation)

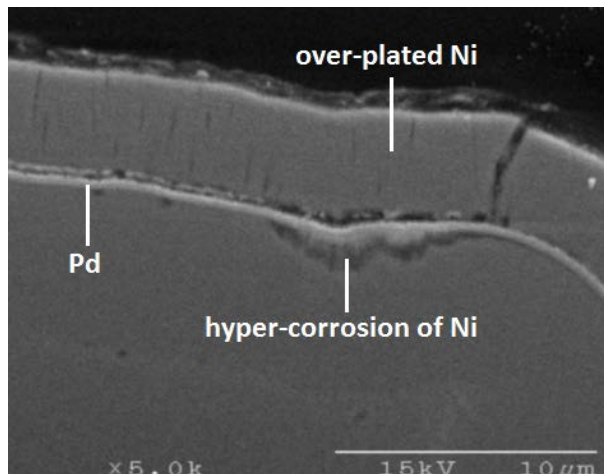
Figure 20 – SEM Image of the Edge of the Pad Showing Hyper Corrosion of the Ni Beneath the Pd

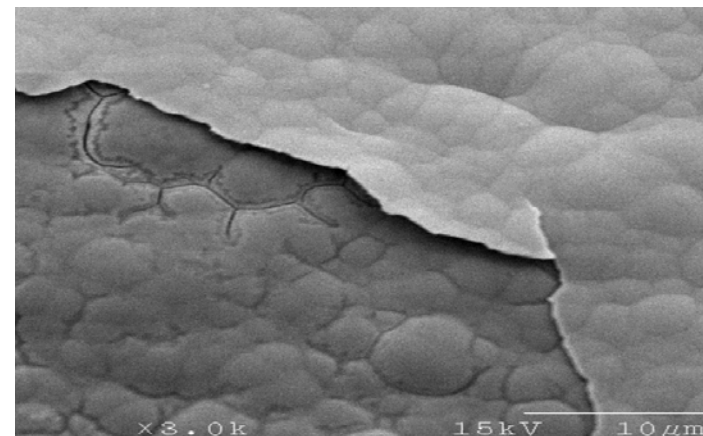
Figure 21 – SEM Image of the Same Failed Site Showing Lifting Pd and Hyper Corrosion of the Ni

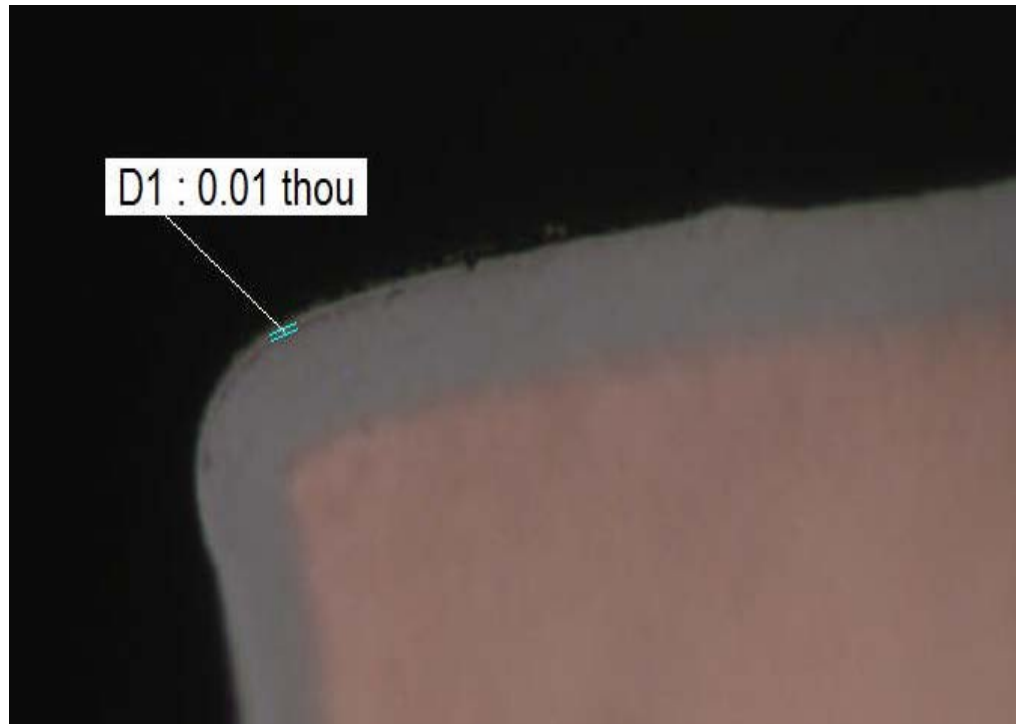
Figure 22 - Edge of the Pad Showing Demarcation Line at 1000x Lens.

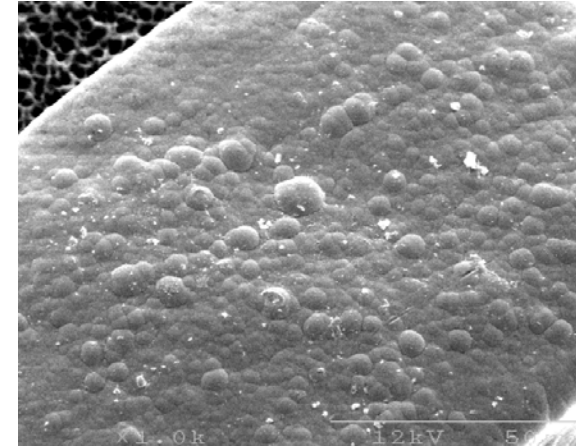
Figure 23 – SEM Image of Wire Bond Pad Showing Variation in the Grain size of Ni Deposit at 1000x -> Not responsible for PML

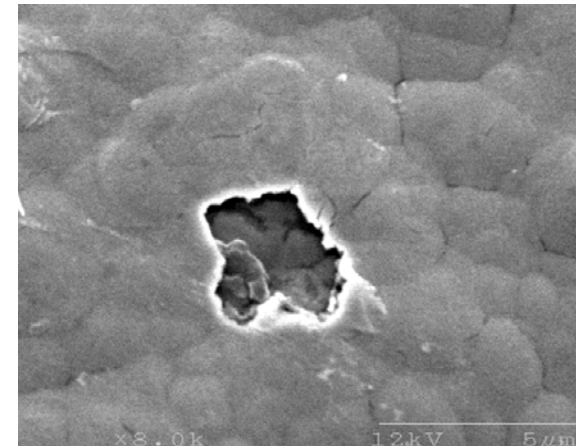
Figure 24 – SEM Image Showing Missing Pd at 8000X

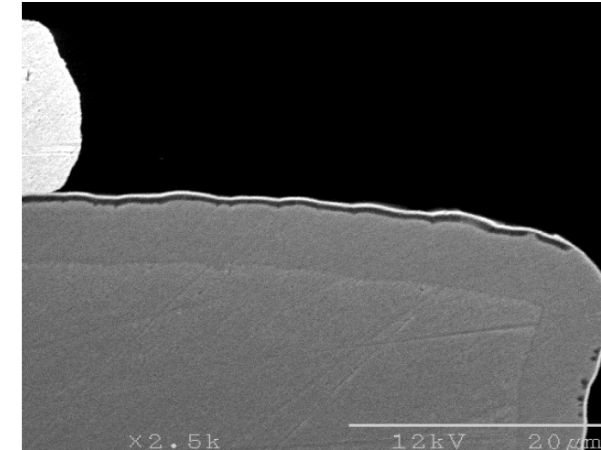
Figure 26 – SEM Image at 2500X Showing Extensive Hyper Corrosion

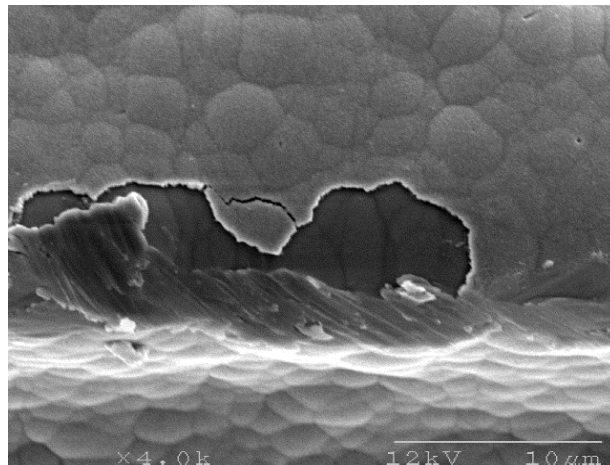
Figure 27 – SEM Image at 4000X Showing the Lifting Pd Layer

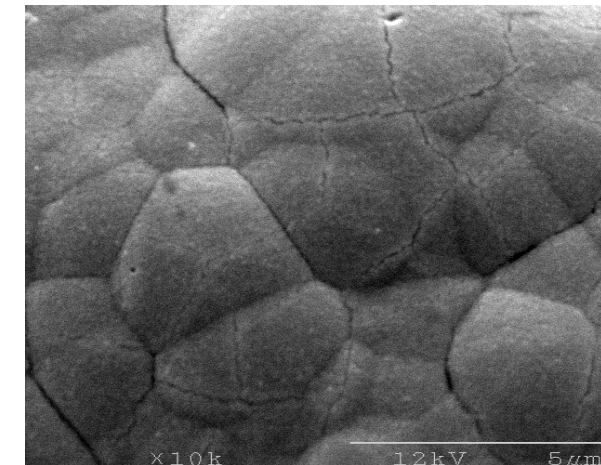
Figure 28 – SEM Image of the Pd Surface Showing the Trans-granular Cracking of the Pd

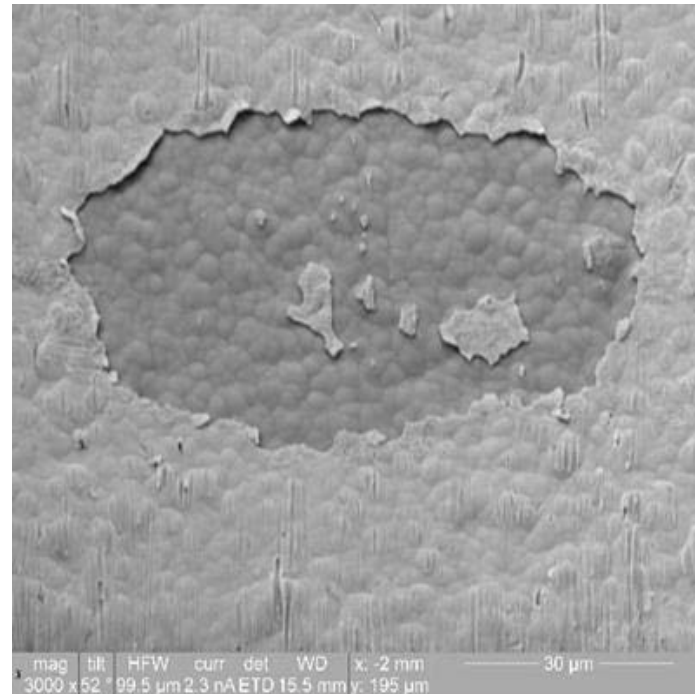
**Figure 29 - SEM Image of the Lifted bond at 3000x**

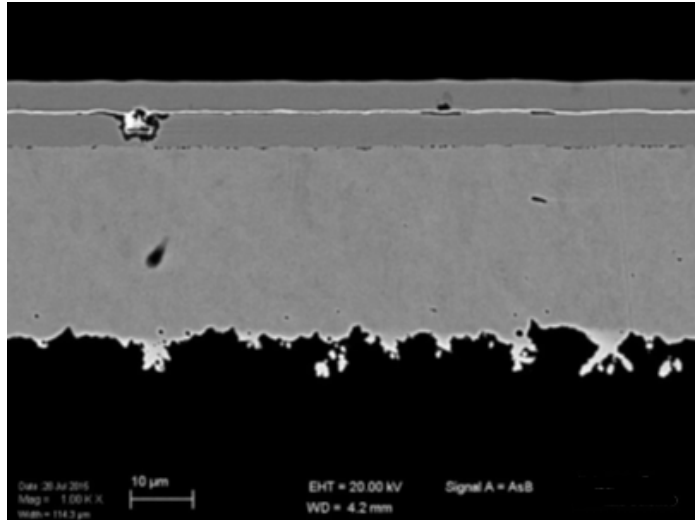
**Figure 31 - Inclusion in Ni layer and Ni Hyper Corrosion**
