# THE LAST WILL AND TESTAMENT OF THE BGA VOID

Dave Hillman, Dave Adams, Tim Pearson, Brad Williams, Brittany Petrick, Ross Wilcoxon  
Rockwell Collins, Cedar Rapids IA  
ddhillma@rockwellcollins.com

## ABSTRACT

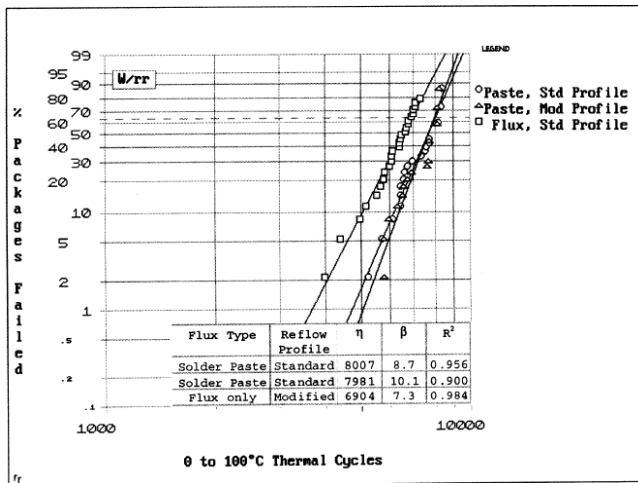
**Figure 2.** Failure Data Weibull Plot from Banks [5]

Figure 2 illustrates Weibull plots that show that BGAs with voids (i.e. Mod Profile) and BGAs without voids (i.e. Standard Profile) did not have distinguishable solder joint failure populations. Banks' work was one of the earliest published tin/lead solder alloy investigations to demonstrate that macro voids did not interact with the solder joint failure cracks and their presence did not cause solder joint failure.

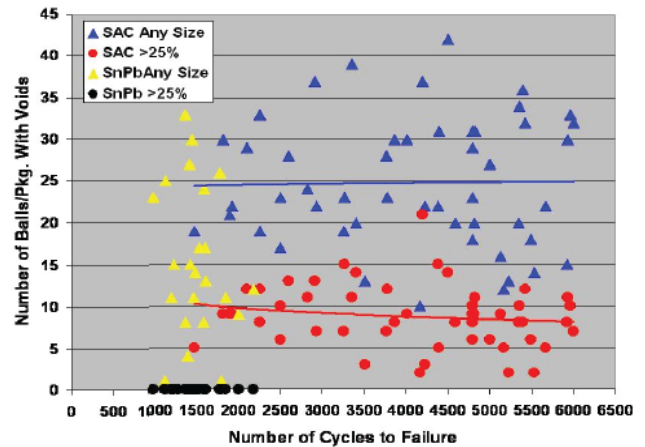
**Figure 3.** Solder Joint Voiding Versus Cycles to Failure for CSP84 Component [6]

The SPVC investigation demonstrated that the number of cycles to failure did not correlate with void size. If there was a negative influence of voids the solder joint integrity, Figure 3 would show a cluster of early low cycle failures for larger voids and a cluster of late cycle failures for the small voids. This was not the case; the results show a uniform data spread for the number of cycles to failure for both void size populations, with no distinctly different groups for either the tin/lead or lead-free solder alloys.

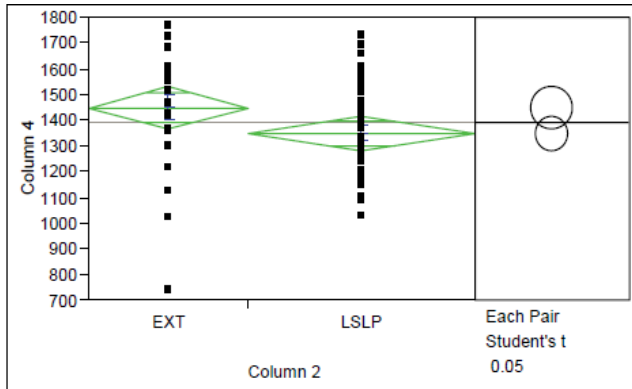
Kim’s investigation utilized two different reflow profiles – typical (aka LSLP) and non-typical (aka Extreme) – to generate voids in the BGA solder joints. The LSLP reflow profile produced minimal voiding whereas the Extreme reflow profile resulted in voiding as large as 60% of the solderball diameter. Preconditioning of the BGAs prior to reflow (10 days of 60°C/60%RH) was included in the test as an additional technique for generating voids. Analysis of the thermal cycle results revealed that there was no statistically significant difference between the void and void-less solder joint populations for the 144 I/O BGA components (Figure 4).

**Figure 4.** Statistical T-Test for Solder Joint Voiding Showing Indistinguishable Failure Populations [7]

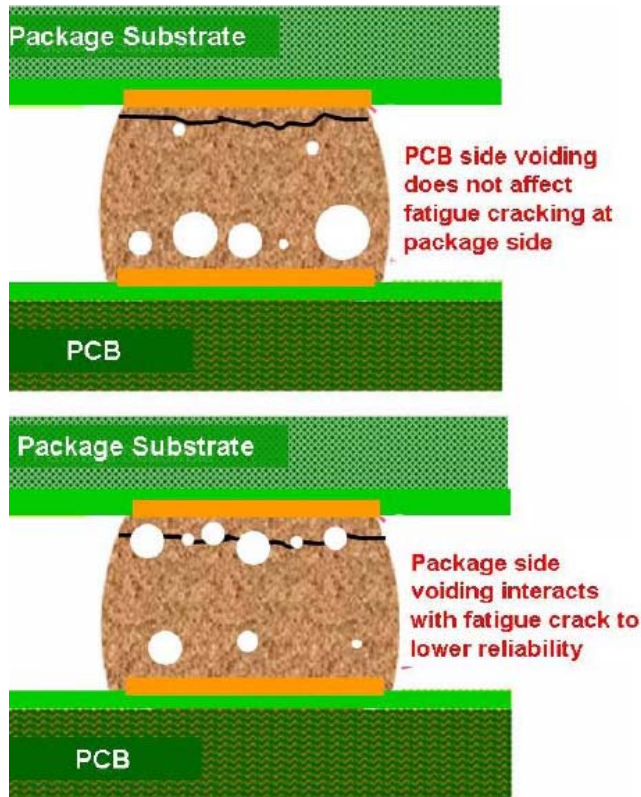
**Figure 6.** Impact of Voids on Solder Joint Integrity, D. Coyle et al [9]

The Coyle investigation found that macro voids reduce solder joint reliability by reducing the effective attachment area and that this geometric effect was independent of solder alloy composition. The study concluded that the dominant factor that impacts solder joint integrity was void location and not the void size or density of voids.

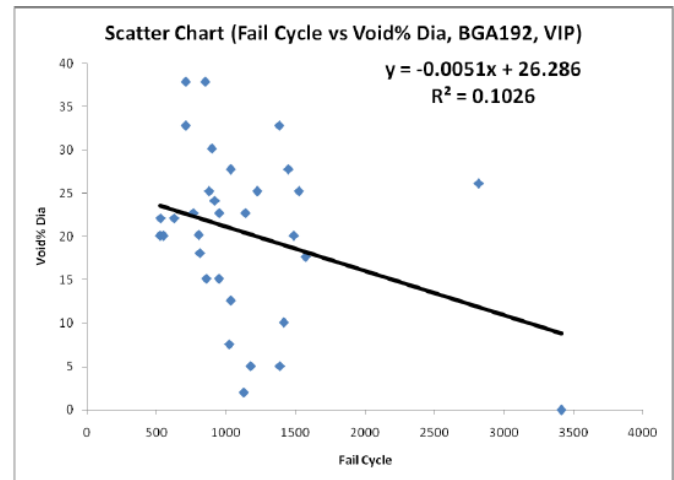
**Figure 7.** Scatter Chart Showing No Correlation between Solder Joint Void and Thermal Cycle Integrity, J. Smetana et al [10]

The Smetana investigation documented that for both a ceramic BGA component and a plastic CSP component, the void diameter or area percentage had no correlation to solder joint thermal cycle integrity. Cross-sectional analysis revealed numerous examples of thermal cycle fatigue cracking having no interaction with the solder joint void.

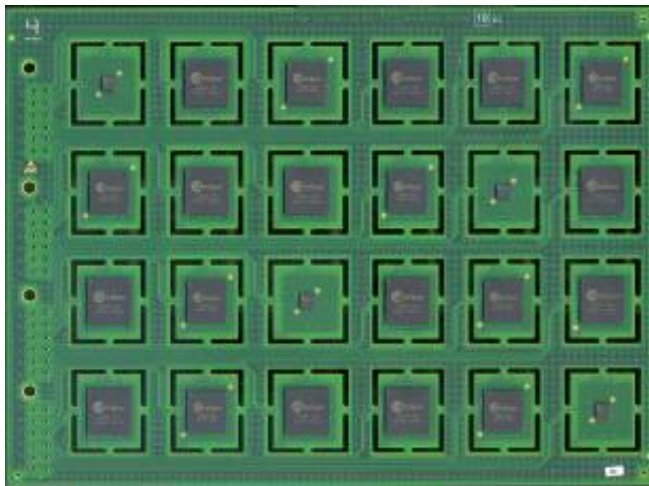
The test board was 2.18mm (86 mil) thick with 14 dummy inner layers. The board was constructed using FR-4 material in accordance with IPC-4101/126 with an electroless nickel/immersion gold (ENIG) surface finish. Figure 8 illustrates a completely assembled test vehicle without the ribbon cable used for monitoring current continuity. Microvias in accordance with IPC-6012 Class 3, Type 4 and IPC 2315 Type II were placed in the component pads to facilitate void generation in the solder joints. Table 3 lists the specific micro-via design data for each component on the test vehicle. Through-holes were arranged along one side of the test vehicle for ease of organizing cabling to the PWB. Instead of using a connector, ribbon cable leads were manually soldered to the through holes corresponding to each component I/O pair.

**Figure 8.** As-Assembled Test Vehicle

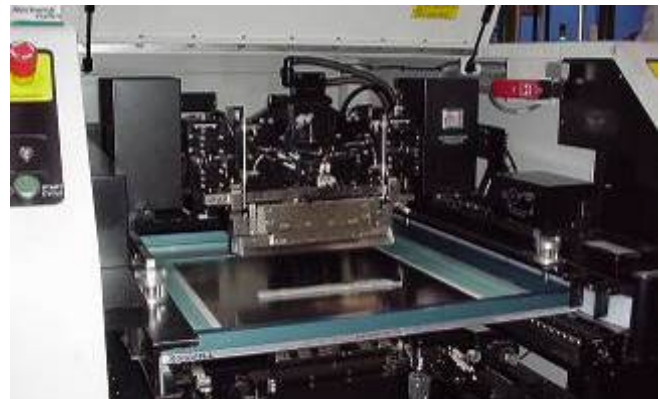
The test vehicles were assembled at the Rockwell Collins Coralville production facility. An MPM Ultra Print 2000 automated stencil printer using a 0.005 inch thick stainless steel stencil applied solder paste to the test vehicles (Figure 9). The solder paste was Alpha tin/lead solder alloy WS-609. The components were placed using the Universal Advantis machine.

**Figure 9.** MPM Stencil Printer

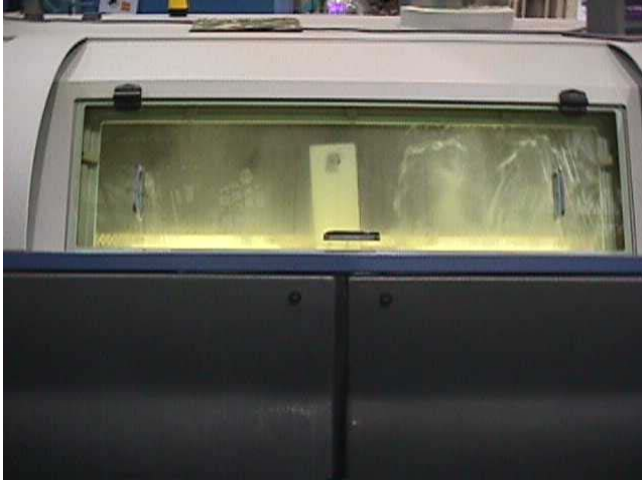
The test vehicles were allowed to air cool after reflow and then placed in the Electrovert Aquastorm 200 in-line cleaning system for removal of solder flux residues and other contaminants from the assembly. The in-line cleaner utilized 13.5% (by volume) Kyzen Aquanox 4625 saponifier in deionized water. The in-line cleaner is shown in Figure 10.

**Figure 10.** Electrovert Aquastorm In-line Cleaning System

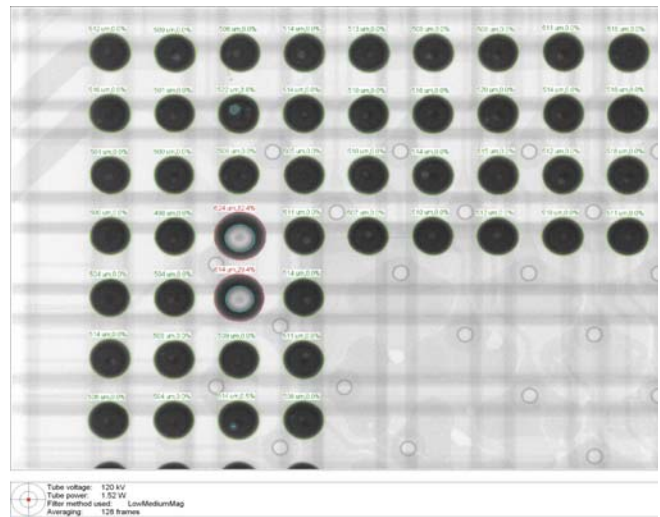
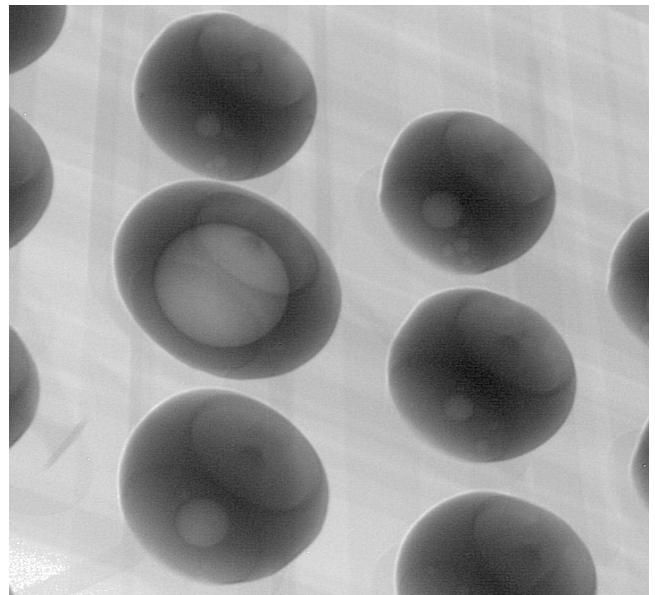
The range of solder voids recorded was from 0% - 35% of X-ray image area, with the majority of the population in the 1% - 10% range. A larger population of solder voids in the 25%-35% range would have been desirable but sufficient solder voids greater than the IPC-JSTD-001 specification of 25% were observed to make the investigation valid. Figure 11 (top) illustrates voids of 32% and 29% area on the inner rows of a test component. Additionally, the low voiding % of the other solder joints is visible. Figure 11 (bottom) shows an oblique view X-ray image of a BGA ball with 30% void. It also shows the interfaces of the solder joint as ellipses above and below the ball.

**Figure 11.** X-ray Examination of Test Vehicle Revealing: Top - Voids of 32% and 29% Area, Bottom - Oblique Angle X-ray View of 30% Void in BGA

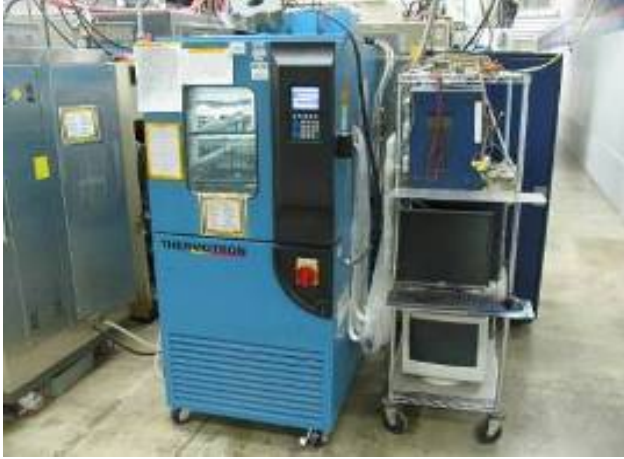
The temperature cycle range used in this study was -55°C to +125°C with a minimum 15 minute dwell at each temperature extreme and a maximum temperature ramp of 10°C/minute. Figure 12 shows the thermal cycling chamber along with the Anatech Event Detection system.

**Figure 12.** Thermal Cycling Chamber and Anatech

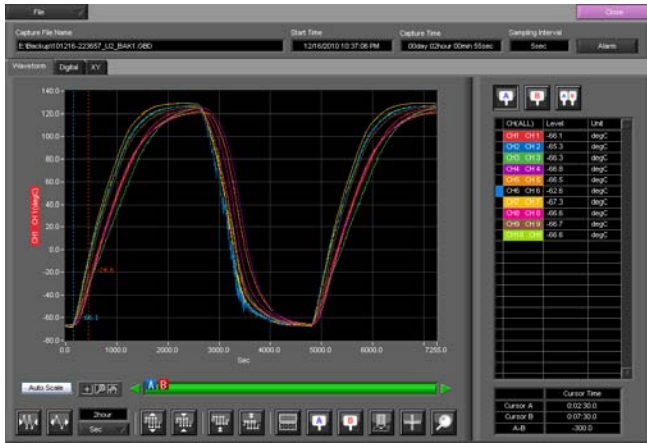
Figure 13 illustrates the thermal profile recorded using the Graphtec Midi Logger GL220 temperature acquisition unit.

**Figure 13.** Thermal Profile

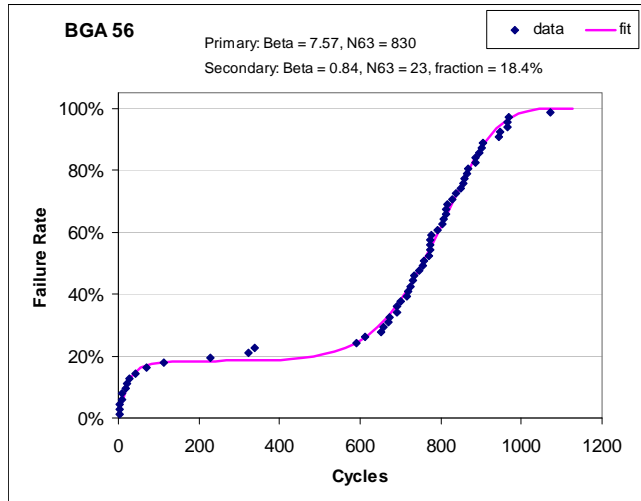
The initial analysis of the data showed that the BGA56 data exhibited characteristics that would be typical of a failure population that contained two distinct failure modes. Figure 14 shows this behavior, in which a number of samples failed prior to 200 cycles, followed by the majority of the population surviving past 600 cycles. A mixed mode

**Figure 14.** Mixed Mode Weibull Fit for BGA56 Data with Voids

Figure 14 showed that the Weibull analysis indicated the existence of two failure modes impacting the BGA56 component solder joint integrity results. Cross-sectional analysis was conducted on the U1 BGA56 component based on the analysis illustrated in Figure 16. The cross-sectional analysis revealed that insufficient solder paste transfer occurred at the U1 component location. The lack of solder paste resulted in the U1 component making an electrical connection with no solder joint structural integrity. The U1 component condition is not a valid solder joint configuration, which justifies its removal from the investigation data set for assignable cause. Figure 29 and Figure 30 illustrate the defective U1 component pad location. The solder joint has a pad impression where it made electrical contact before the thermal cycle induced stresses caused failure.

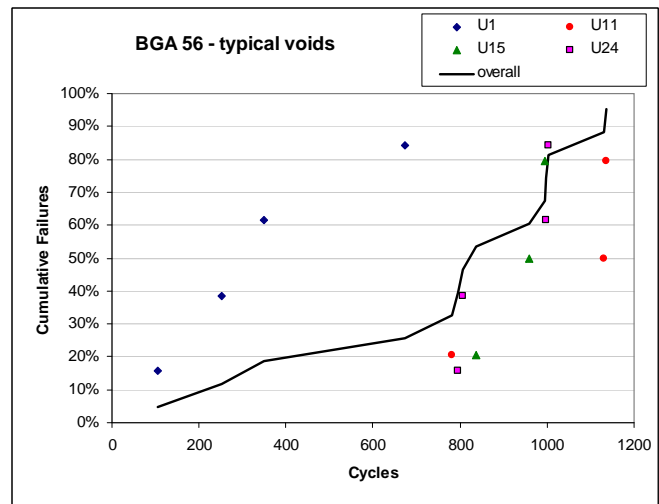
Figure 15 and Figure 16 clearly shows the significant difference in the reliability of the U1 components, which were located in one corner of the test board, compared to the other BGA56 components. This indicated that the secondary failure mechanism was due to an assembly process root cause and not related to the absence or presence of voids in the solder joints. Therefore, subsequent data analysis did not include the data for component reference designator U1.

**Figure 15:** Failure Distributions for BGA56, by Reference Designator, With Typical Voids

For reference, the symbols and colors used in Figure 15 through Figure 18 were defined to help to identify any trends related to the location of a reference designator on the board. Symbols indicate which of the four horizontal rows on the test board that a particular reference designator occupied while the colors correspond to a column. The color/symbol combinations for the reference designator locations are shown Figure 19. There does not appear to be any distinct correlation between the reliability of the components and their location on the test board.

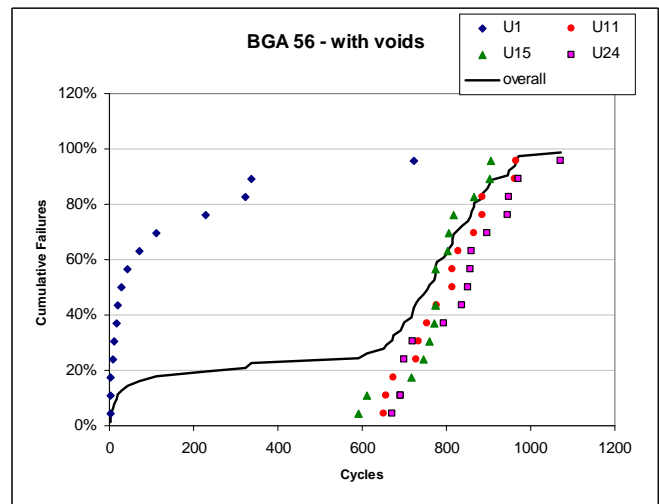
**Figure 16.** Failure Distributions for BGA56, by Reference Designator, With Voids

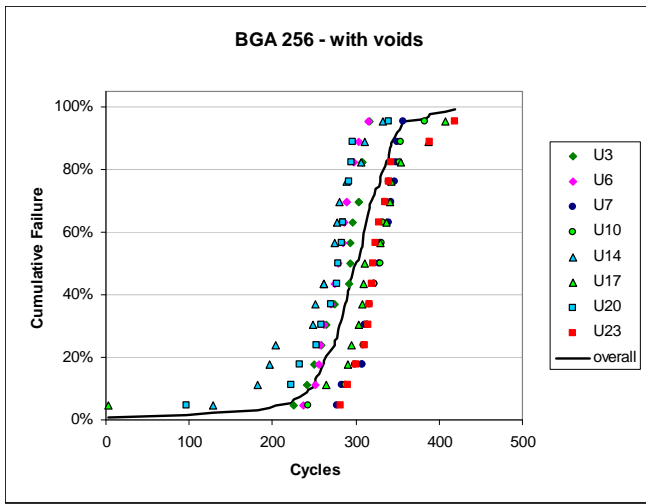
A similar reference designator level analysis was conducted for the BGA256 and BGA288 devices. The results of this analysis, for the samples with voids, are shown in Figure 17 and Figure 18. While these results do show that there was some variation among the individual reliability characteristics depending on the particular reference designator, other than U1 in the BGA56 data set, these differences do not appear to be statistically significant.

Figure 17. Failure Distributions by Reference Designator

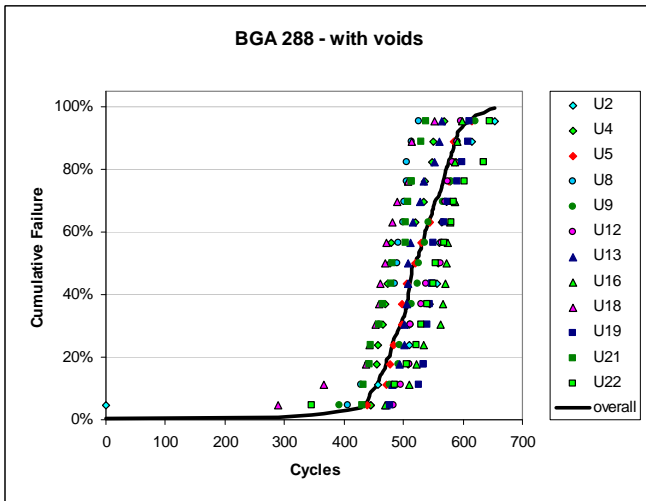
Figure 18. Failure Distributions by Reference Designator

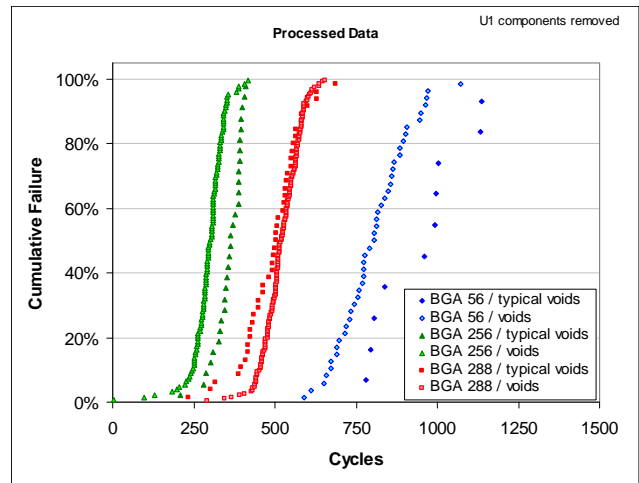
The overall reliability data for the study, not including the data for U1, is shown in Figure 20. This clearly shows that the additional voids have relatively little impact to the

Figure 20. Component Reliability Results

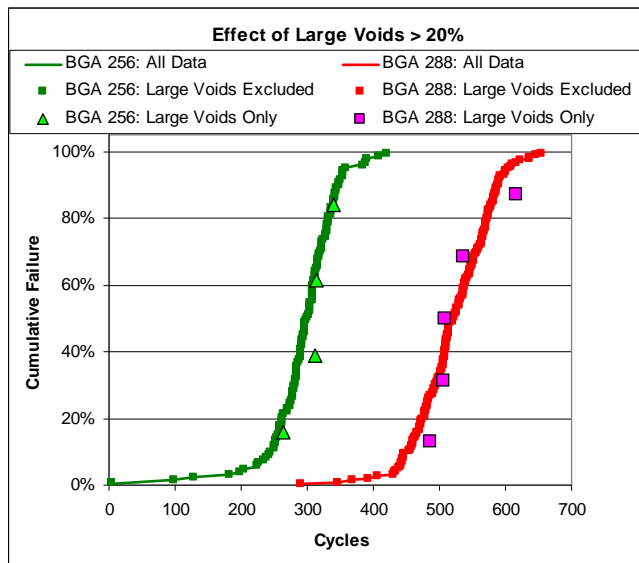
Figure 21 compares the reliability curves for all samples of BGA 256 and BGA 288 components with voids greater than 20% to the rest of the samples tested. The similarity between the trend lines, and the calculated Weibull coefficients shown in Table 5, indicate that the samples with and without voids had the same reliability.

Figure 21. Effect of Large Voids Reliability Results

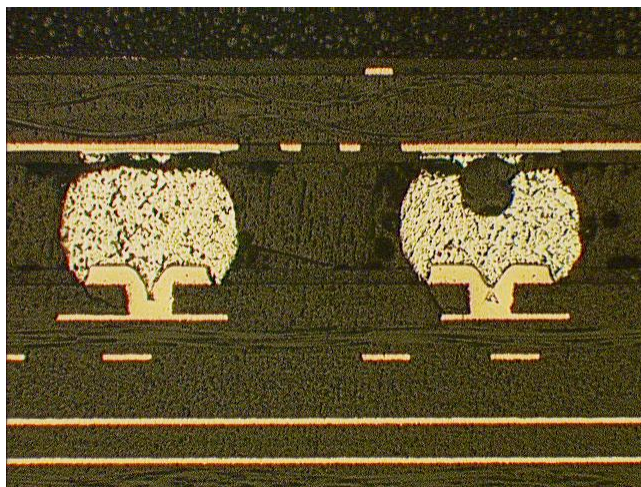
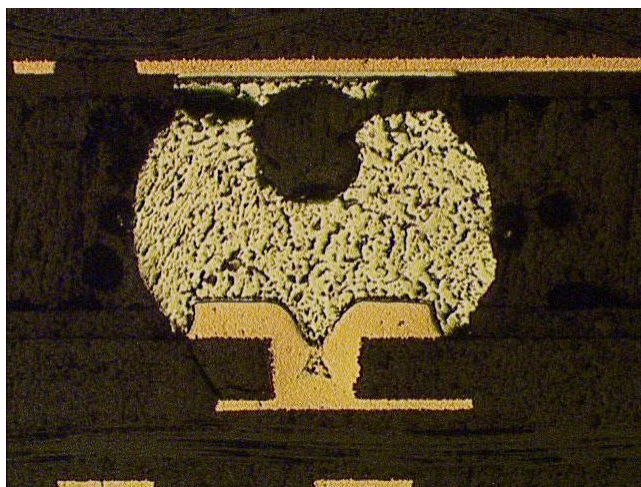
Figure 22 (top image) illustrates two BGA corner/outer row solder joints that failed in the typical location at the component/solder joint interface. One of these solder joints (magnified lower image) has a void less than the 25% maximum requirement but did undergo a loss of solder joint integrity. Figure 23 (top image) illustrates two BGA corner/outer row solder joints that failed in the typical mode but with no voiding present.

**Figure 22.** Macro (Top) and Magnified (Bottom) Views, BGA Void Assessment: 18% Void, Outer Row, 264 Cycles, BGA256

joints with voids less than 25%, it was primarily due to the location of voids in the crack path. This reduced the overall crack path length necessary for joint failure. Figure 22 and Figure 23 illustrate this observation with the void containing solder joint failing slightly earlier (i.e. within 50 cycles) than the non-void containing solder joint. Other examples found during the cross-sectional examination demonstrated that the simple existence of a void was not the controlling factor for the loss of solder joint integrity. The location of void relative to the solder joint failure crack path had a much larger impact than the presence of the void alone. This result is in agreement with both the Sethuraman [8] and Coyle [9] investigations. The results did indicate a more significant effect of large void size on the solder joint thermal cycle integrity than found in the Smetana [10], Sethuraman [8], SPVC [6] and Coyle [9] investigations. It is presumed that the more pronounced effects of large voids observed in this study were the result of the larger temperature excursion (-55°C to +125°C) used for cycling. This wider temperature range imposed larger stress/strain forces on the test components than the forces imposed by the small temperature ranges used in the other investigations and exacerbated the stress concentrations.

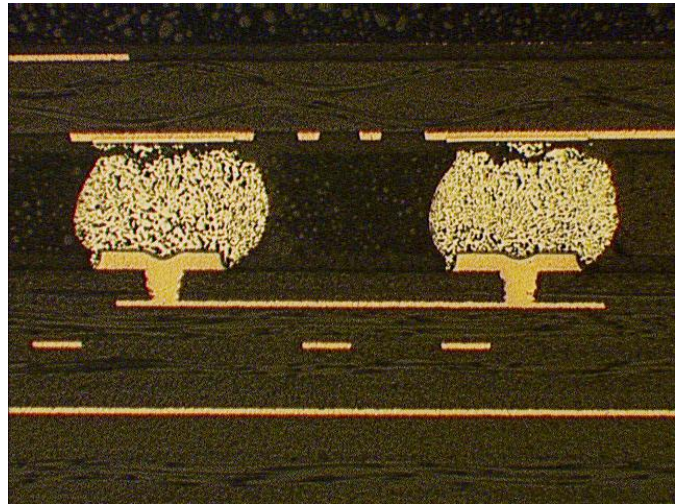
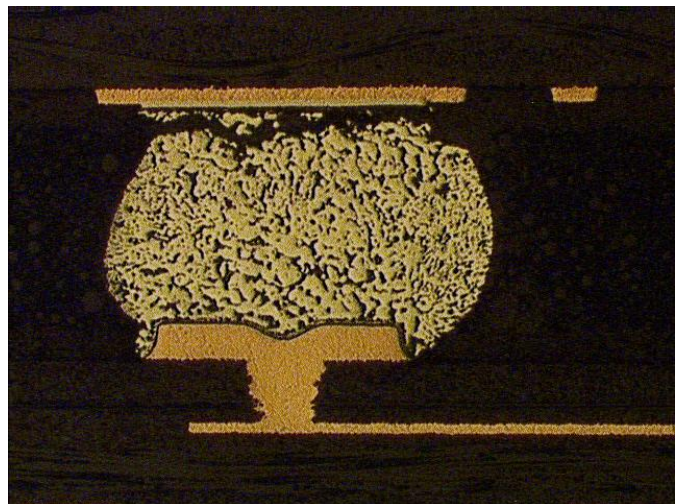
**Figure 23.** Macro (Top) and Magnified (Bottom) Views BGA Void Assessment: No Void, Outer Row, 311 Cycles, BGA256

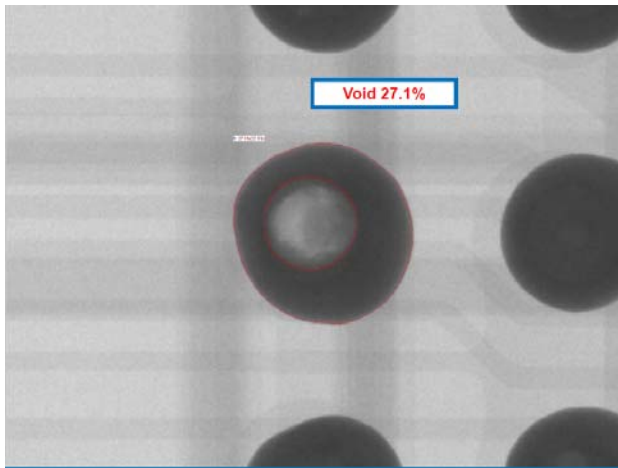
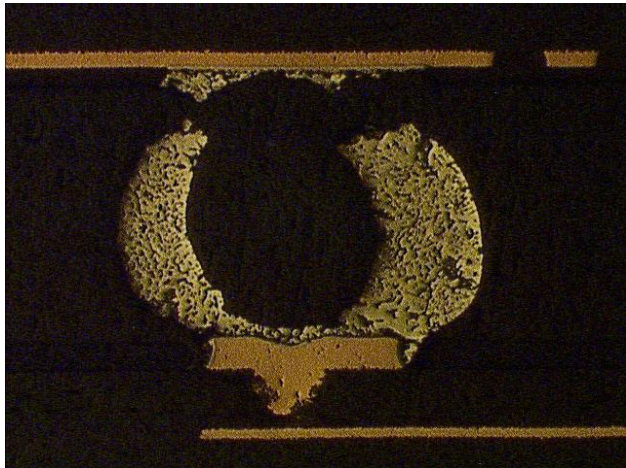
Figure 24 illustrates a solder joint failure due to a 27.1% void that reduced the crack path length and resulted in a loss of solder joint integrity. This BGA solder joint was located on the outer row but not a corner location. Figure 25 and Figure 26 illustrate a solder joint failure due to a 31.3% void reducing the crack path length. This BGA solder joint was located on an inner row/ near package corner location.

**Figure 24.** X-ray (Top) and Cross Sectional (Bottom) Views BGA Void Assessment: 27.1%, Outer Row, 505 Cycles, BGA 288

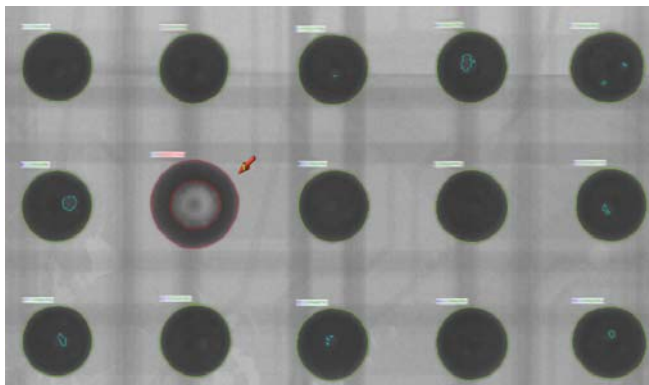
**Figure 25.** X-ray View, BGA Void Assessment: 31.3%, Inner Row/Corner, 311 Cycles, BGA256

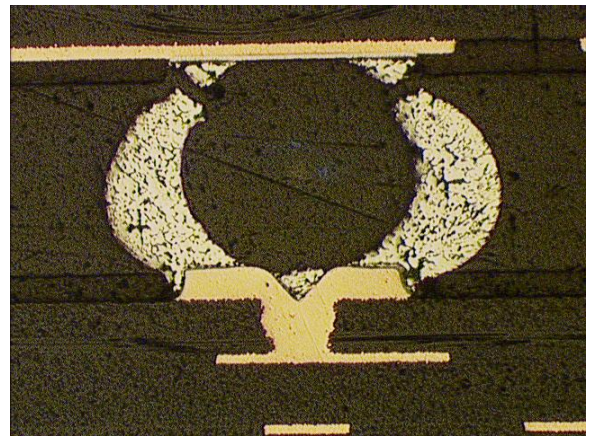
**Figure 26.** Cross Sectional View, BGA Void Assessment: 31.3%, Inner Row/Corner, 311 Cycles, BGA256

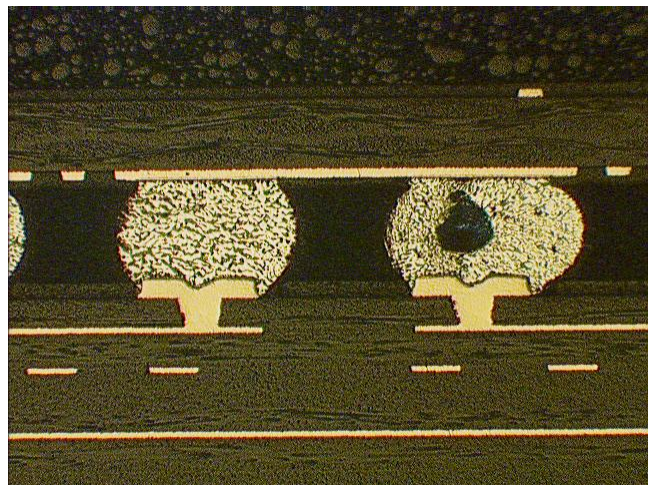
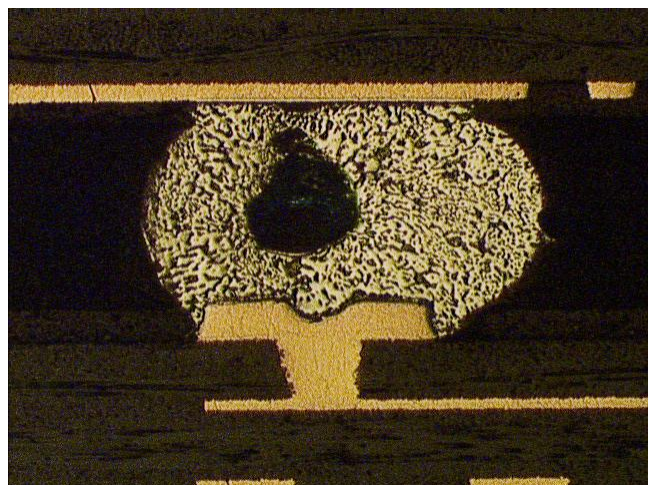
Figure 27 illustrates a typical solder joint containing a 12% void in a BGA solder joint that did not fail the thermal cycling test. This BGA solder joint was located on the outer row but not a corner location. Figure 28 illustrates a typical solder joint containing a 17% void in a BGA inner row that did not fail.

**Figure 27.** Macro (Top) and Magnified (Bottom) Views, BGA Void Assessment: 12%, Outer Row, No fail, BGA288

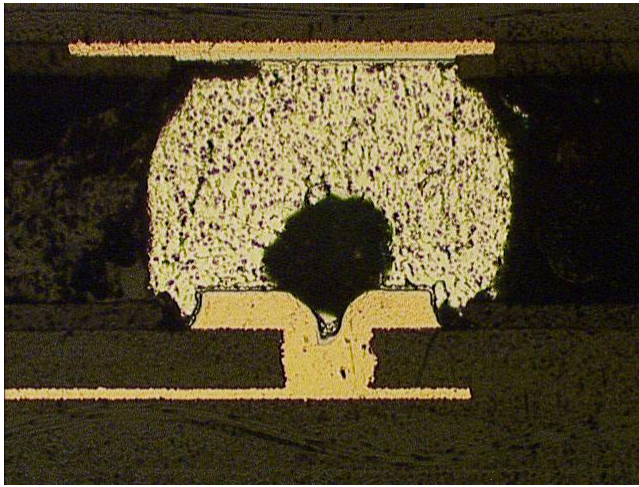
**Figure 28.** BGA Void Assessment: 17%, Inner Row, No fail, BGA256

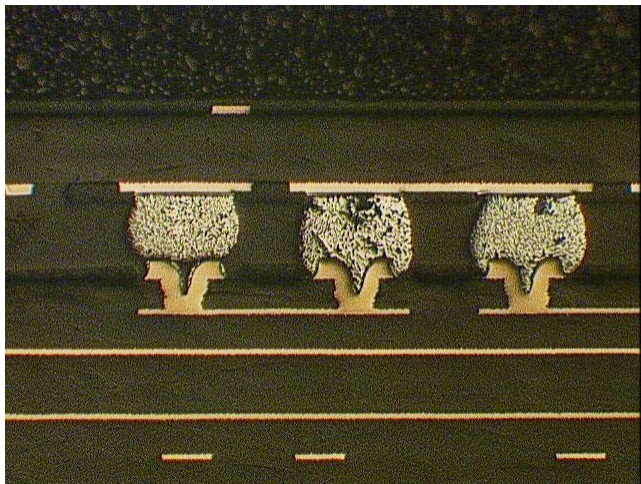
**Figure 29.** Macro View, BGA56 U1 Component Cross-section Showing Assembly Induced Solder Joint Defect, Failed @ 18 Cycles, BGA 56

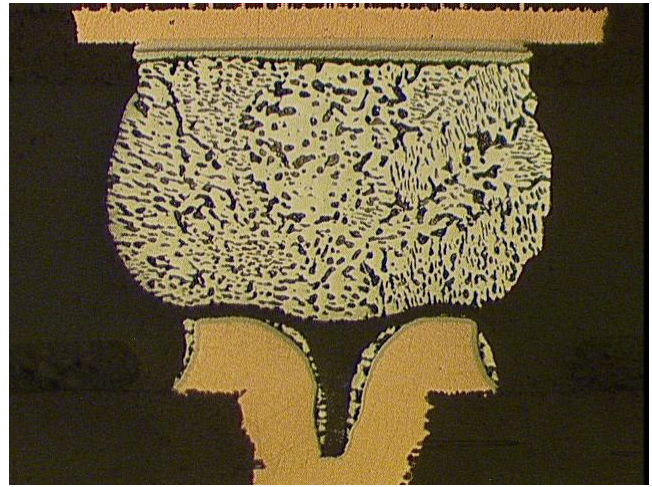
**Figure 30.** Magnified View, BGA56 U1 Component Cross-section Showing Assembly Induced Solder Joint Defect, Failed @ 18 Cycles, Defect Due to Stencil Paste Deposit Issue, BGA56

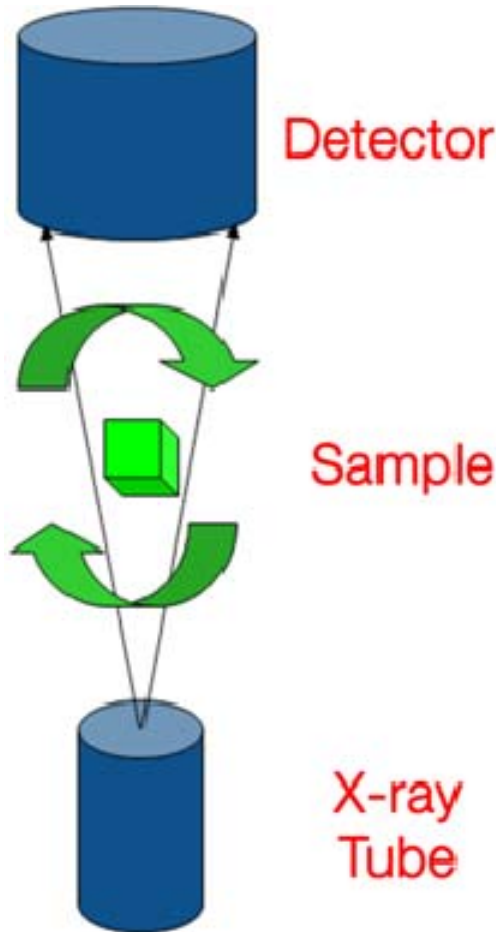
**Figure 31.** Schematic representation of the image acquisition phase of CT inspection

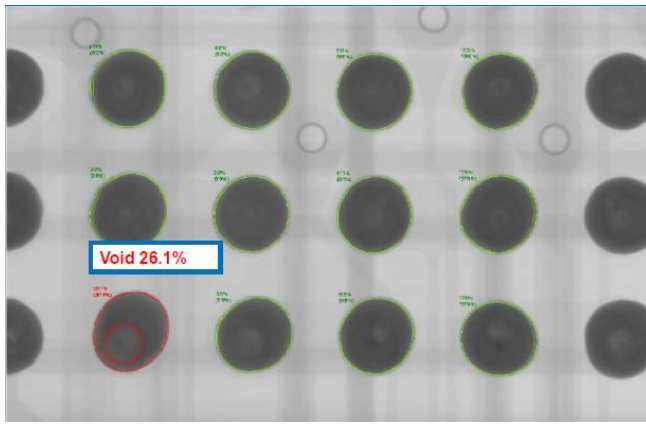
Figure 32 is a 2D X-ray image of the area of interest incorporating void calculations. The location of the voids within the joint is much better assessed using 3D CT virtual cross sectioning. Figure 33 (top) provides a 3D overview of the examined area and Figure 33 (bottom) represents a virtual cross section through the particular BGA row. Black areas represent voids/cracks. The location, size and shape of the voids can be precisely examined. The cracks resulting from the thermal cycling are also clearly visible. Once the CT model is compiled the failure analysis engineer uses dedicated software viewer to pan through each ball in slices as a continuous 'virtual cross-section' through the whole sample in order to evaluate the void size and location. The advantages here compared to mechanical cross-sectioning is that there are no limitations in the position of the virtual section plane, virtual sectioning is fully reversible (as it is done on a software model), and no additional mechanical defects are introduced.

**Figure 32.** 26.1% BGA Voids Selected for CT Assessment

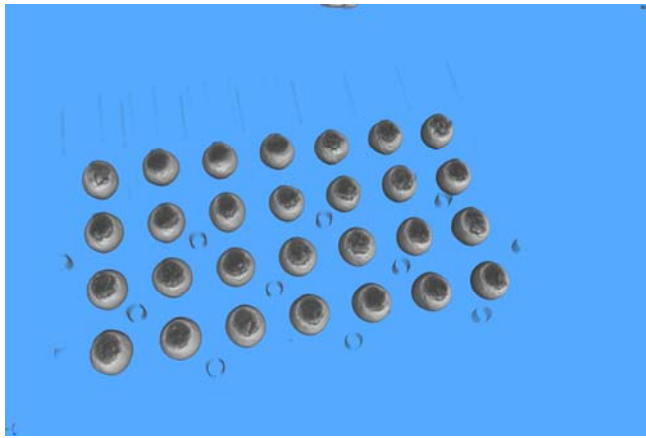
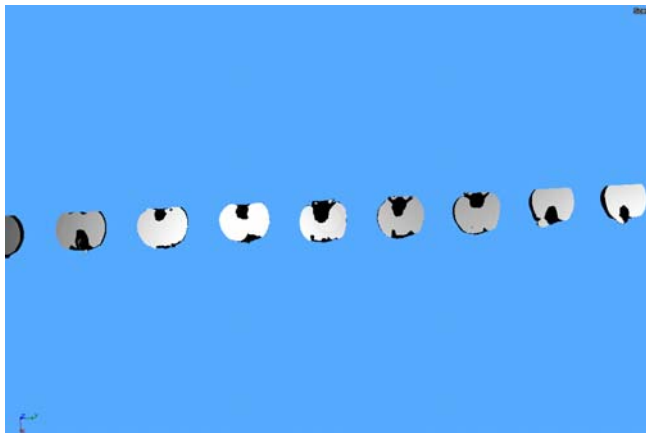
Dr. Evstatin Krastev conducted 3D CT assessment of the BGA voids using the Nordson Dage XD7600NT100 X-ray inspection system after the completion of the thermal cycle testing. The CT assessment allowed for a better understanding of the void location within the solder joints and the interaction of the failure crack path/void interface. The CT assessment results were in agreement with the cross-sectional analysis results indicating that the outer row of the BGA/CSP was most influenced by the void size and location. Figure 32 and Figure 33 illustrate a typical example of the CT assessment of a 26.1% BGA Void on an outer row that failed at 616 thermal cycles.

**Figure 33.** CT Assessment Image of 26.1% BGA Void. Top - CT overview of examined area, Bottom - CT Virtual cross section revealing voids and cracks represented by black areas.
