Equipment Impacts of Lead Free Wave Soldering

** This paper was presented at APEX 2003 and received the Best U.S. Paper Award from IPC*

Abstract

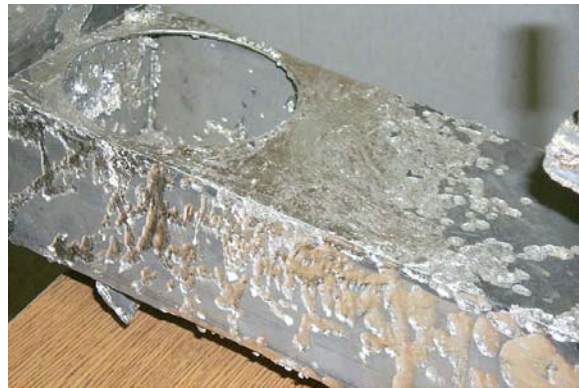
Figure 1 shows a typical failure of an unprotected stainless steel solder flowduct used in a lead free application. Severe erosion and pitting of the metal has occurred and some areas have lost all structural integrity. The most vulnerable stainless steel components are those in contact with flowing solder (i.e. pump impeller, ducts, and nozzles).

Figure 1 – Failed Stainless Steel Solder Flow Duct

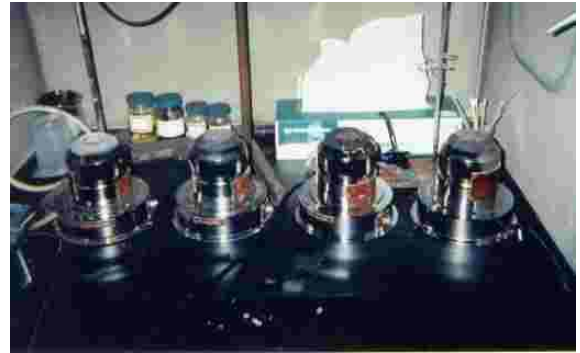
Laboratory testing was conducted on representative samples exposed to 97%Sn solder at different temperatures and various exposure times. Material samples were fabricated into strips approximately 1 in. wide by 3 in. long. These strips were then immersed into a static bath of 97%Sn solder and examined at 2-week, 4-week, and 8-week intervals

for signs of wetting (Figure 3). Baseline pictures were taken prior to running tests.[2]

Figure 3 – Solder Exposure Baths

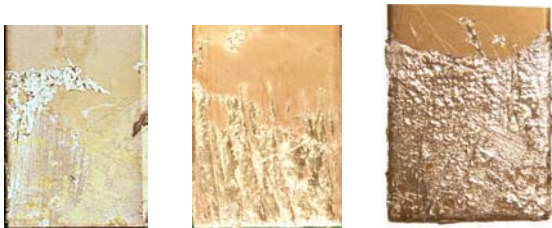
**Figure 7
Uncoated 304 Stainless Steel Samples
Wetting Present on all samples.**

Figures 6, 7, 8, 9, and 10 show the ability of the Melonite® QPQ Nitriding process to protect the underlying substrate of the stainless steel and carbon steel materials. Macroscopically, all coated samples showed very little wetting except in the area that was scratched. The unprotected 304 and 316 stainless steels had significant wetting on all samples. Plain carbon steel samples were tested as a possible “lower cost” material for solder unit internal components. Plain carbon steel exhibited good resistance to corrosion when protected by the Melonite coating. Results indicate that coated plain carbon steel will give equivalent corrosion protection to the stainless steel materials.

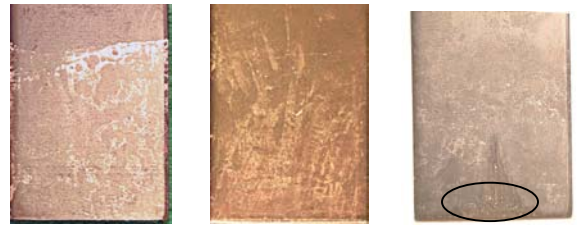
**Figure 8
Melonite Coated 304 SST Samples
Wetting only on 8-week sample at scribe mark.**

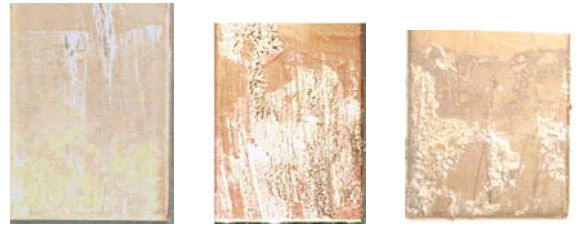
**Figure 9
Uncoated 316 SST Samples
Wetting present on all samples.**
