Investigation of Pad Cratering in Large Flip-Chip BGA using Acoustic Emission

Anurag Bansal, Cherif Guirguis and Kuo-Chuan Liu
Cisco Systems, Inc.,
San Jose, CA
anurbans@cisco.com

Abstract

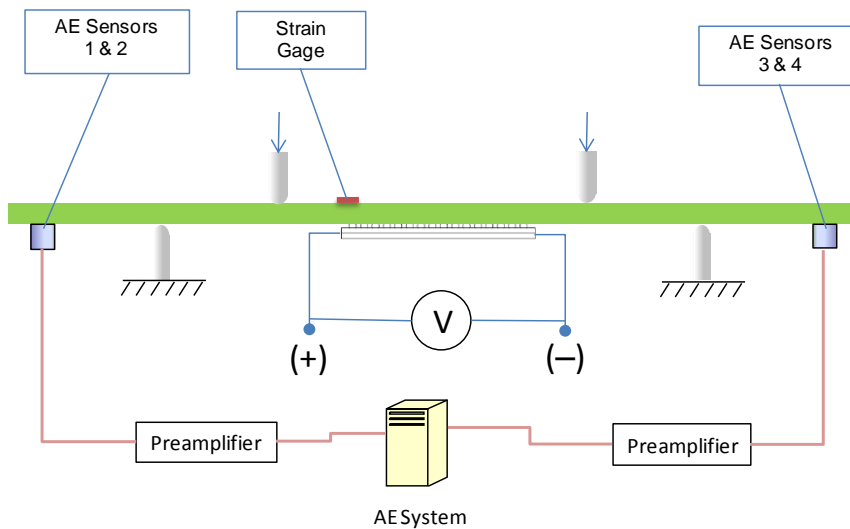
Figure 6 - Schematic of Bend Test Set-up with AE Sensors

Four point bend tests were performed according to IPC-9702 using daisy chain BGA test vehicles. Tests were carried out a strain rate of 5500 microstrain/second, in accordance with requirements of IPC-9702, because brittle intermetallic (IMC) fracture of solder joints is likely to occur only at high strain rate. Note that in our recent studies, it was demonstrated that pad cratering occurs at both slow and fast strain rates, but the strains required to generate pad cratering failure were lower at high strain rate [1, 2]. The bend test set-up is schematically shown in Figure 6. Details of the test matrix, including the variables considered in this study are shown in Table 1.

Four Acoustic Emission (AE) sensors were attached to the test boards to detect the AE events generated from pad cratering or BGA brittle fractures, and also to detect the location of the source of AE activity. In our previous work, two AE sensors were used to determine the linear location of AE events. In this study, with the use of four sensors the methodology was extended to determine the spatial location of AE events in the two-dimensional plane of the test board. These tests were done on assembled 0° and 45° boards, with a small load applied to ensure good contact between the anvils of the bend test fixture and the surface of the board. The algorithm for determining the location of an AE source relies on the velocity of sound in the PCB laminate and the time differential between detection of the same AE event at different sensors [1]. For this study, the orthotropic nature of the laminate was considered and different values were used for the velocity of sound (v_x and v_y), where X is the direction along the length of the board, and Y is along the width. Once the values of v_x and v_y were fine-tuned, a series of “pencil lead break” (PLB) tests were performed to calibrate the accuracy of AE source location. This is a simple procedure wherein the tip of a 0.5 mm mechanical pencil is broken on the board, at a approximately 60° angle from the surface of the board, in order to simulate an AE event. Since the position of the PLB test is known in advance, the location of the event detected by the AE system provides a means to evaluate, and iteratively improve, the accuracy of the source location. Figure 7 shows the AE source location result from a 0° board after pencil lead breaks at the package center, package corners, and near the loading anvils of the fixture.

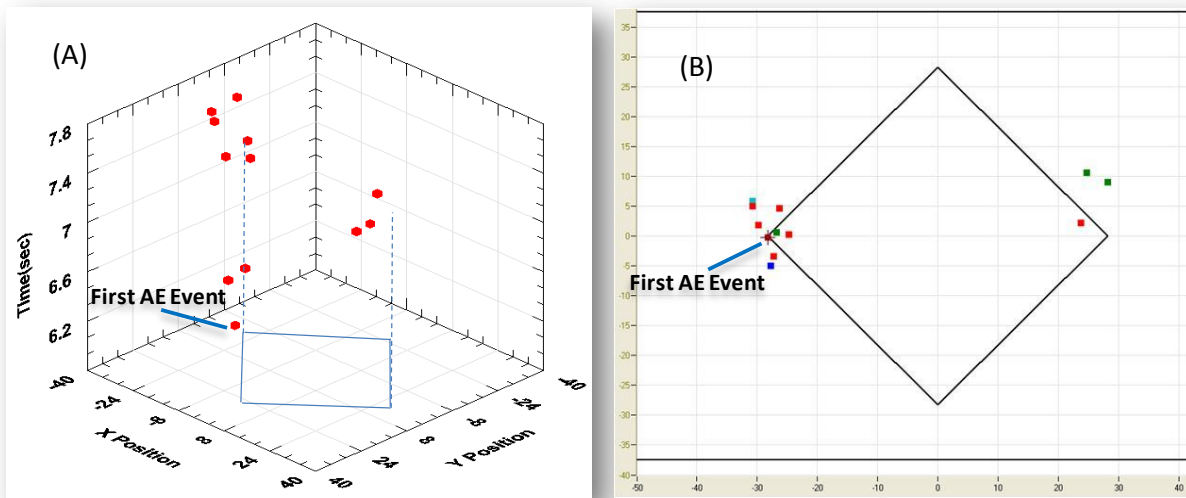
Figure 8 - AE Source Location during Bend Test with 45° BGA Orientation

Figures 8 and 9 show the typical data acquired during the FCBGA bend tests. For a 45° sample, Figure 8 (a) shows the AE events acquired over time as a function of the detected X and Y coordinates of the AE source. The edges of the FCBGA package have been indicated for convenience. Figure 8 (b) shows the same result in a two-dimensional graph of the Y coordinate versus X coordinate of the detected AE event. Note that these detected locations are approximate since the accuracy of AE source location was estimated to be approximately 5 mm from the PLB tests. With this limitation in mind, it is interesting to note that the AE events were clearly concentrated near the left and right corners of the package. These are the locations where the first failures would be expected during four-point bend tests. Similarly, in samples with 0° orientation, the failures were clustered along the left and right edge of the package where the first failures are expected to occur. Figure 9 shows the displacement and daisy chain resistance data acquired for the same sample used as an example in Figure 8. It was found that after the start of the bend test, there was a well defined period of time, annotated as the “Quiet Zone”, during which there was no AE activity. Once the first AE activity began, several consecutive AE events were detected. Most of these early events were clustered at the package corners. Figure 9 shows that the resistance of the daisy chain net was not affected during most of the early AE activity. It was only in a very late stage of the test when the electrical resistance indicated an open circuit. Note that in many cases, the resistance of the daisy chain was not affected even after the bend test was completed. In cases where electrical failure was detected, the onset of AE activity always preceded electrical failure. This result was typical for both 45° and 0° boards.

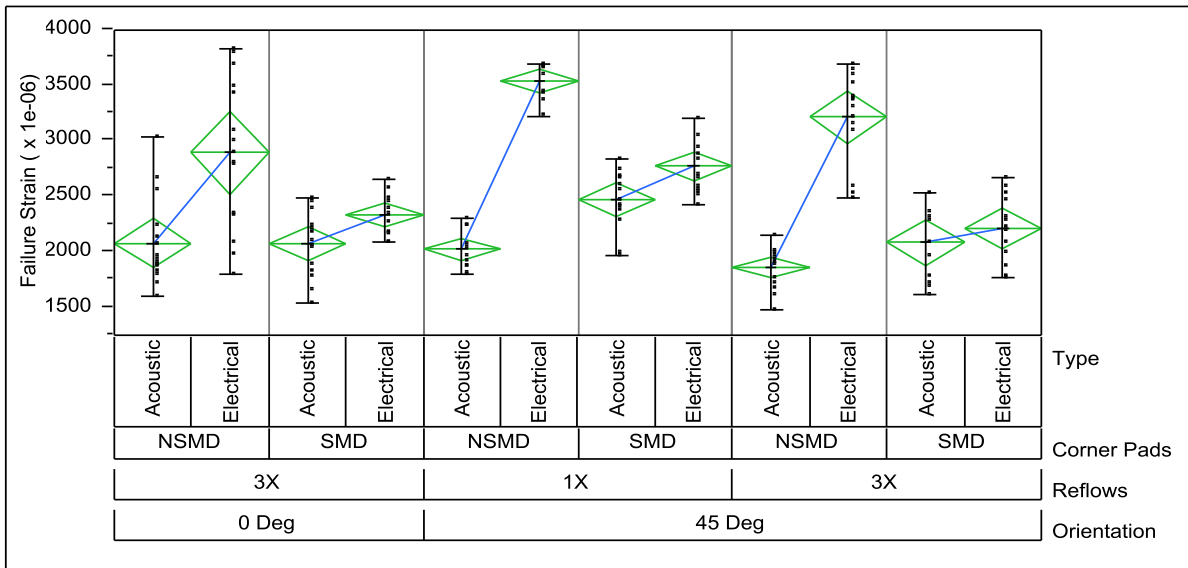
Figure 13 – AE and Electrical Failure Strain from all Test Splits

Having characterized the failure modes, we can now review the effects of design and process variables on the onset of failures in the FCBGA test vehicle. The single axis strain gage mounted on the secondary side of the board, directly beneath a corner-most BGA pad, was used to determine the PCB strain. Figure 13 shows the failure strains for the full matrix of tests conducted in this study. The failure strains showing the onset of both AE failure and electrical failure can now be used to perform a detailed investigation of the effects of component orientation, number of reflow cycles, and PCB pad design. Note that in several cases, the maximum banding strain applied during the tests was not sufficient to generate electrical failures. In order to account for these “survivors”, the maximum bending strain has been shown as the electrical failure strain in figure 13. In most samples, AE failure was detected before electrical failure and in a few samples the AE failure and electrical failure occurred simultaneously. In comparison with the splits with corner SMD pads, the strain gap between AE failure and electrical failure was significantly larger for the splits with a full array of NSMD pads.

While the results from all splits in the test matrix are shown in figure 13, a detailed examination of the effects of individual variables and their interactions is performed in this section. Note that this analysis will consider only AE failures since AE represents the initiation of failure, while electrical failure of the daisy chain occurs at higher strain under monotonic bending.

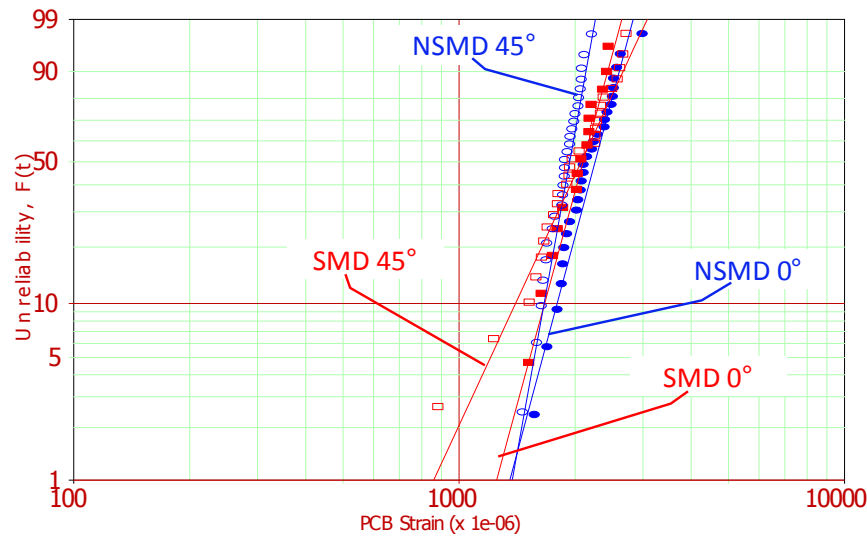
Figure 16 - Weibull Distribution of AE Failures

As noted in the introduction, the lack of a suitable board level test methodology to detect the onset of pad cratering has been a significant barrier for determining the PCB strain limits. The failure strains based on electrical resistance monitoring will significantly overestimate pad cratering resistance, and should therefore not be used to determine strain limits for actual PCB assembly, test, and handling operations. With use of the AE method, we can now see that the failures are initiating at significantly lower strain levels and by fitting an appropriate distribution it should be possible to establish the true strain limits. The AE failure data were fitted with a 2-parameter Weibull distribution for the cases of NSMD and corner SMD pads, with 0° and 45° orientations after 3X reflow preconditioning (Figure 16). Using a failure rate of 1%, the PCB strain limits were found to be in the range of 1250 to 1350 microstrain, i.e. very similar for all cases except the case of corner SMD pads with 45° orientation. In this case the strain limit was approximately 850 microstrain. The significantly different behavior of this case is not apparent in comparison of the mean failure strains due to a lower slope. Since the slope of the Weibull fit is often an indicator of the failure mode in reliability tests, it may be speculated that while mixed failure modes were observed with corner SMD pads, it appears that pad cratering was the dominant failure mode with the 0° orientation and IMC brittle fracture was the dominant failure mode with 45° orientation.

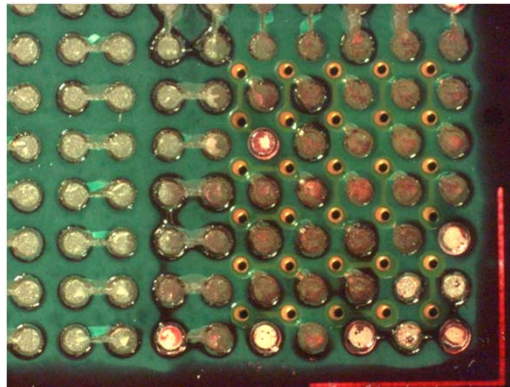
Dye and Pry Result (Corner SMD)

SMD Pads had IMC Fracture

NSMD Pads had Pad Cratering

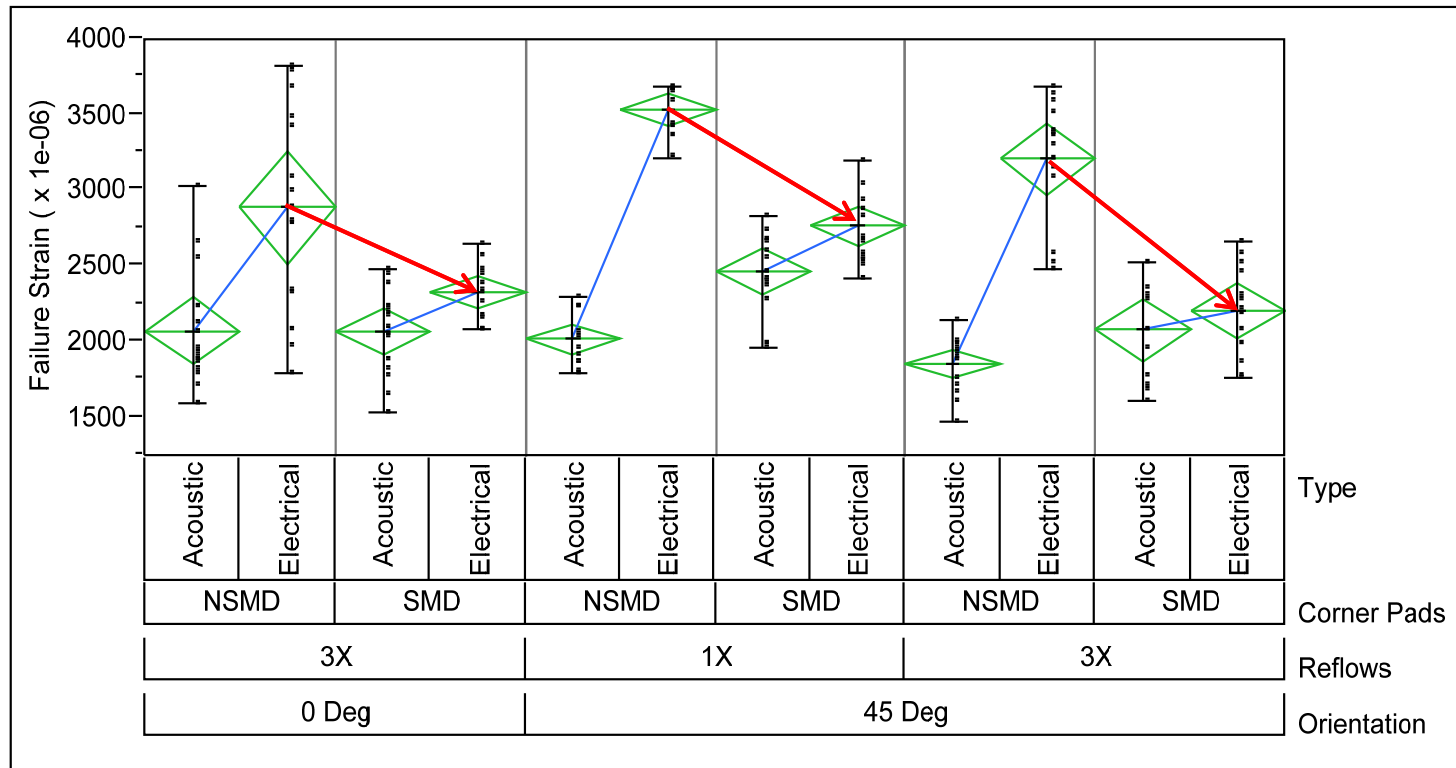
Test Results

- AE failure always precedes electrical failure
- Corner SMD pads had lower electrical failure strain

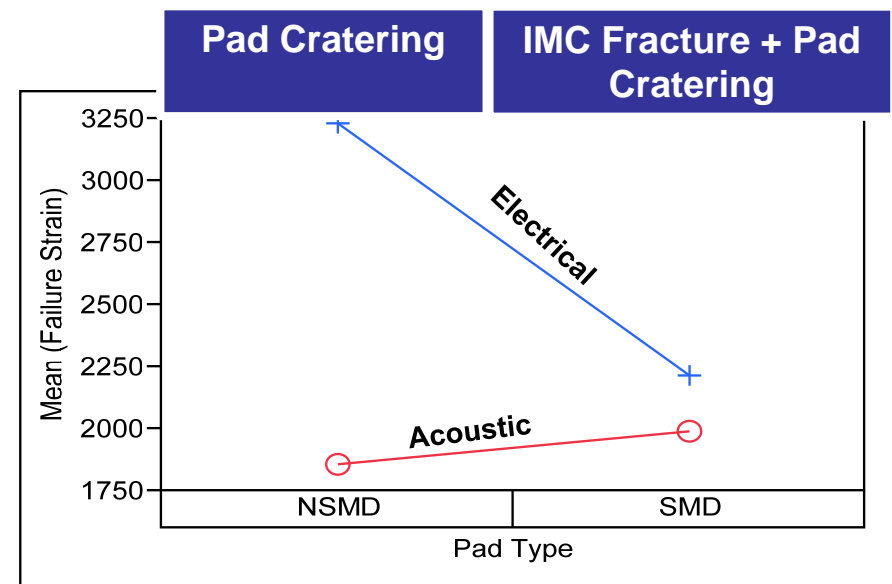
Effect of Corner PCB Pad Design

- Major influence on the failure mode

SMD Pad → IMC Fracture

NSMD Pad → Pad Cratering

- Electrical failure strain significantly lower with corner SMD pads

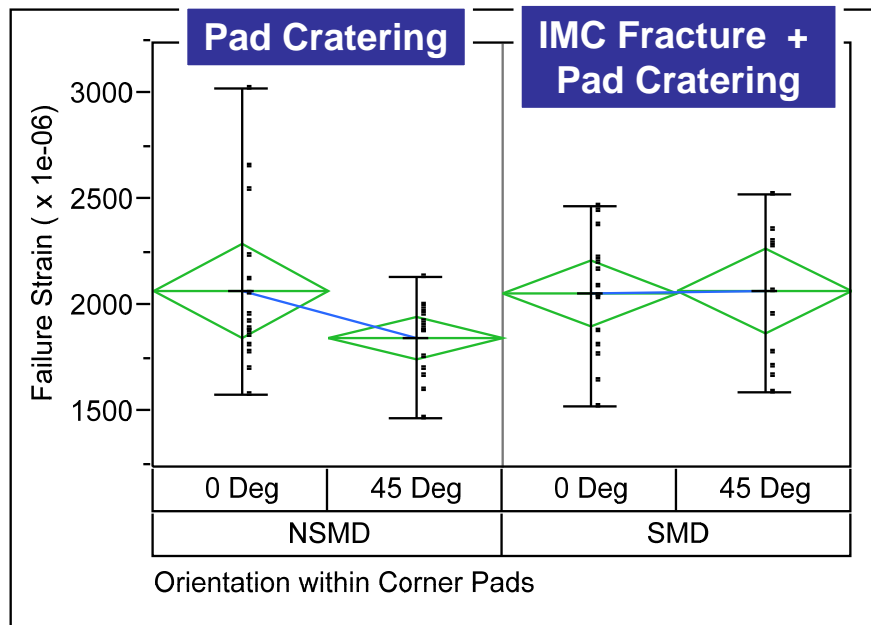
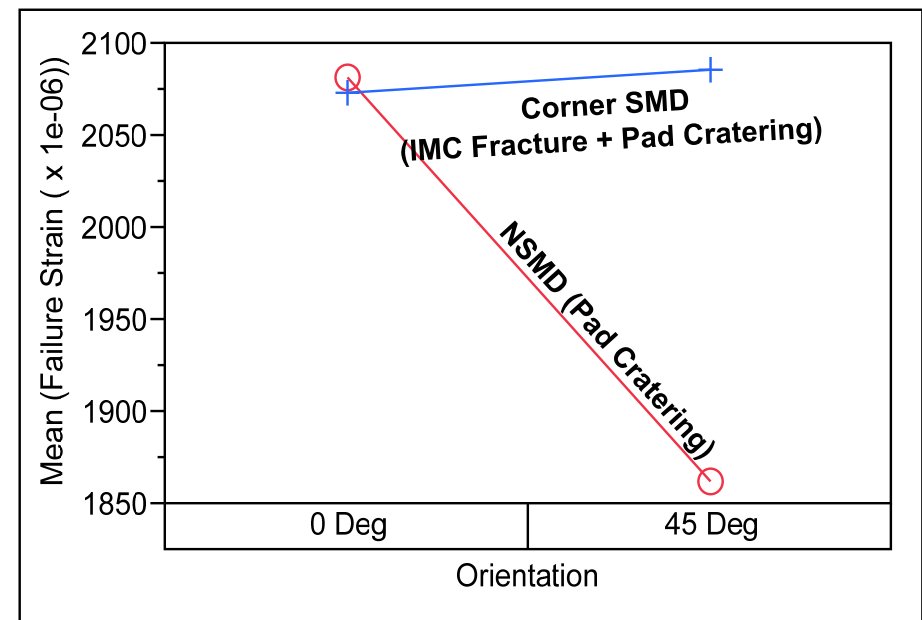
Effect of Orientation

- With NSMD pads, Pad cratering strain limit is lower at 45° Orientation
- No effect of orientation with corner SMD pads

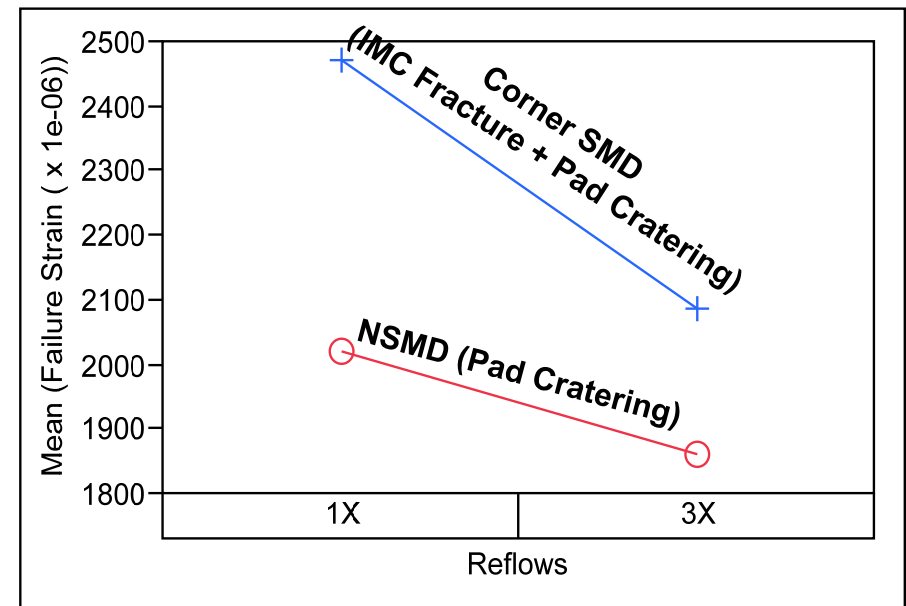
Effect of Multiple Reflows

- Lower failure strain after multiple reflows with both Full NSMD and Corner SMD
- 3X Reflow preconditioning recommended for pad cratering and brittle fracture characterization
