Approaches to Overcome Nodules and Scratches on Wire Bondable Plating on PCBs

Young K. Song and Vanja Bukva, Teledyne DALSA Inc., Waterloo, ON, Canada
Ryan Wong, FTG Circuits, Toronto, ON, Canada

Abstract

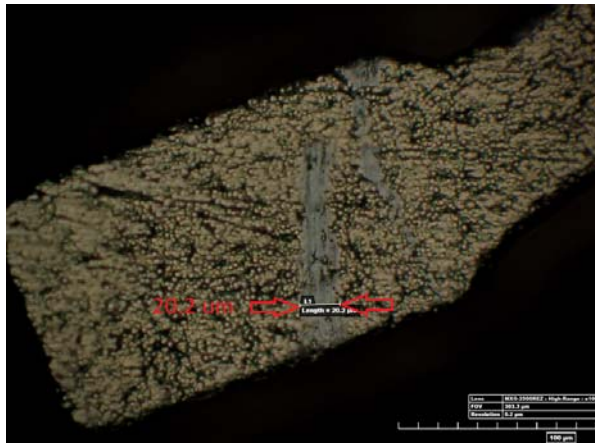
Figure 8 and Figure 9 show examples of scratches on the wire bonding surface on rejected PCBs of Product I from the manufacturer. Those scratches seem to be made after the final surface finish step since the gold layer looks damaged due to the scratch. The widths of the scratches were about 9µm and 20µm as shown in Figures 8 and 9.

Figure 9 – Scratch Observed on Individually Defined Wire Bonding Pad on Rejected PCB

Most artificially created scratches were intentionally made deeper and wider than those on PCBs rejected by the manufacturer, shown in Figures 8 and 9. The integrity and reliability of wire bonds made on artificially created scratches were considered a worst-case condition compared to those made on relatively shallow scratches on PCBs rejected by the manufacturer. Figures 14 and 15 show examples of scanning electron microscope (SEM) images of scratches with elemental analysis using energy dispersive spectroscopy (EDS). Figure 14 shows an example of scratches on a rejected PCB by the manufacturer during the PCB manufacturing process, and Figure 15 shows an example of scratches created intentionally for this study. The amount of gold detected on the surface of the scratched area is significantly reduced compared to that on the surface without scratches, particularly, for Figure 15. On the other hand, the amount of palladium and nickel detected on the scratched area was significantly increased since palladium and nickel were exposed to the surface. Nickel was detected significantly in some isolated areas indicated as Area 3 in Figures 14 and 15.

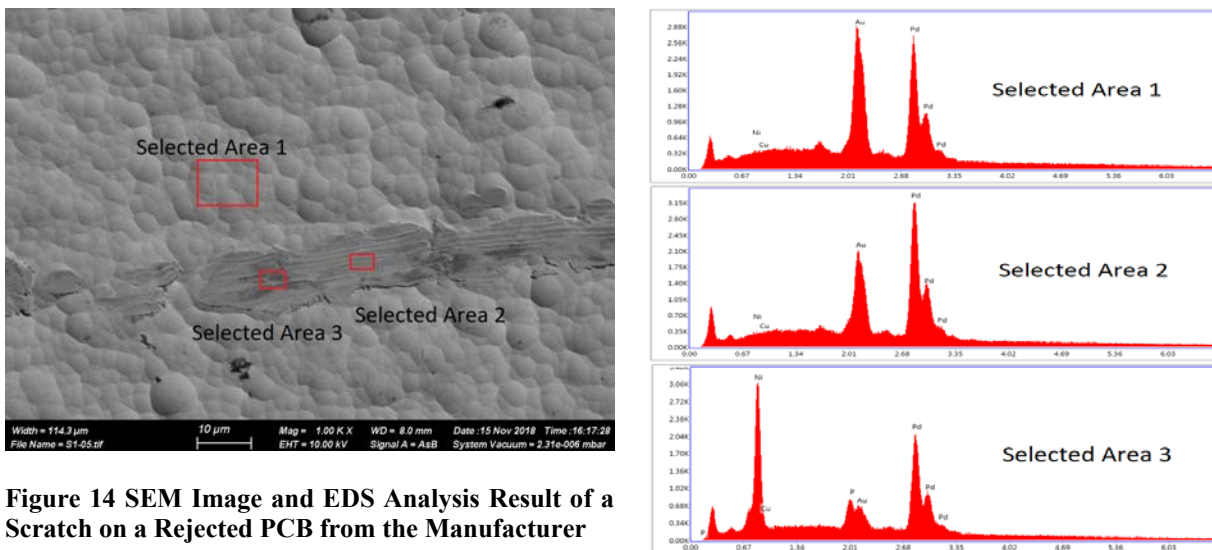
Figure 14 SEM Image and EDS Analysis Result of a Scratch on a Rejected PCB from the Manufacturer

One of the reasons that wide scratches could be tolerable for the wire bonding process in this study could be that scratches did not negatively affect the surface finish wire bonding capability, as shown by the EDS results in Figures 14 and 15. Even though the gold layer was significantly damaged and removed, the palladium layer, considered the wire bondable surface, was not completely removed. In other words, an entire scratched area may not necessarily be a non-bondable surface. This could be considered a benefit of using an ENEPIG finished surface over using an ENIG finished surface for wire bonding.

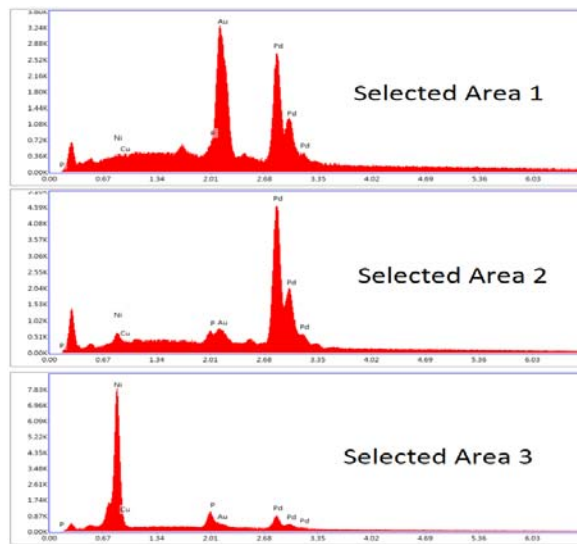
Figure 15 SEM Image and EDS Analysis Result of a Scratch Intentionally Created for This Study
