The Impact of Reflowing A Pbfree Solder Alloy Using A Tin/Lead Solder Alloy Reflow Profile On Solder Joint Integrity

David Hillman, Matt Wells, Kim Cho
Rockwell Collins
Cedar Rapids Iowa USA

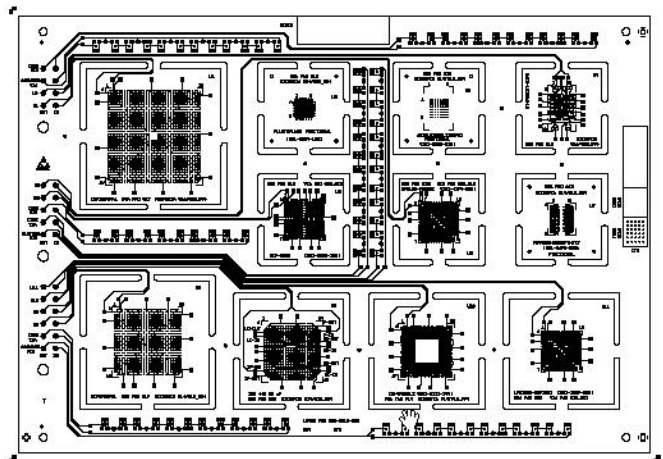
Figure 1: Test Vehicle Design

The test vehicle used in the investigation was 0.082 inches thick, contained 18 layers of 0.5 ounce copper, and used an electroless nickel/immersion gold (ENIG) finish. The test vehicle laminate was FR4 per IPC-4101/26 with a minimum Tg of 170°C. The test vehicle contained 11 component test locations. Figure 1 illustrates the test vehicle design.

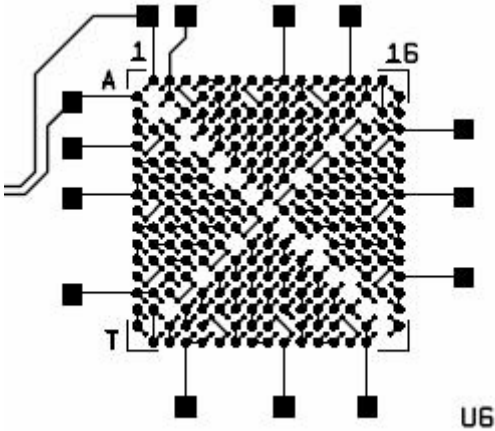
Figure 2: Test Component Pad Pattern

The test component was an 256 Daisy Chained, I/O 256, 17mm x 17mm square, 1.0 mm pitch Field Programmable Gate Array utilizing a Sn/4.0Ag/0.5Cu (SAC 405) soldersphere alloy. The BGA component was originally to

have tin/lead solderballs but was unintentionally supplied with Tin/Silver/Copper (SAC) solderballs. Process time constraints did not allow for the component supplier to replace the BGAs with Sn/Pb solderballs thus allowing the opportunity to investigate the interaction of a SAC solder alloy with a Sn/Pb soldering reflow process. Figure 2 illustrates the test component pwb pad pattern.

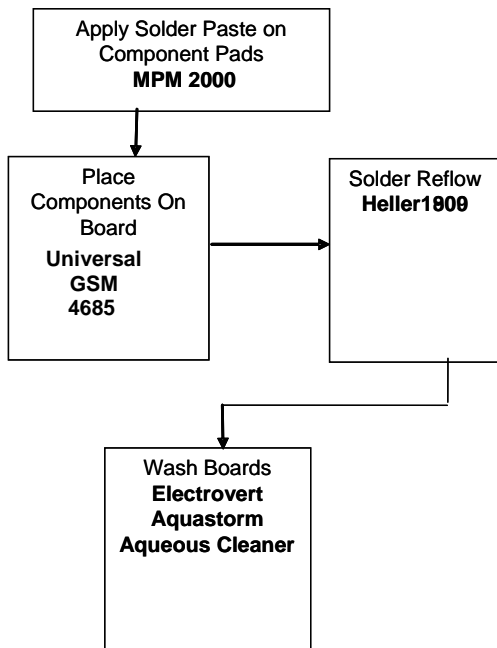
Figure 3: Flow chart of assembly process

The test vehicles were processed as shown in the flow diagram in Figure 3.

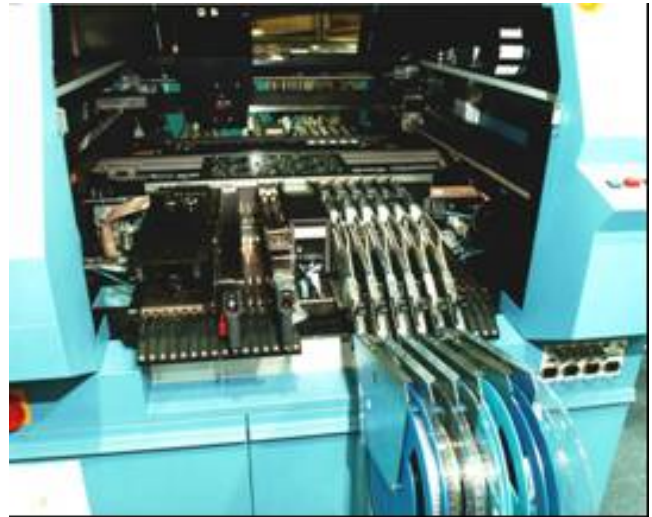
Figure 4: Universal GSM 4685 Machine

The test vehicles were immediately transferred to the Universal GSM 4685 machine shown in Figure 4 upon completion of the application of solder paste. The test vehicles were fully populated.

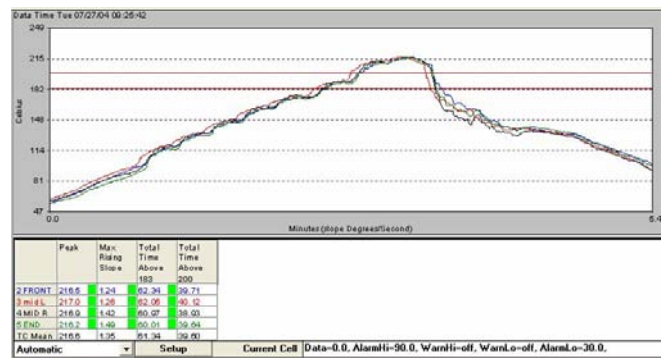
Figure 5: Thermal Profile

The test vehicle was reflowed with a Heller 1809EXL Convection Reflow Oven. This oven had ten temperature zones for solder reflow. The conveyor speed was 34 inches per minute and the nitrogen flow was 1500 cubic feet per hour (approximately 150ppm O₂ concentration). The oven used the high convection setting, and the boards were placed on the rails. The reflow profile as measured on the test vehicle is shown in Figure 5.

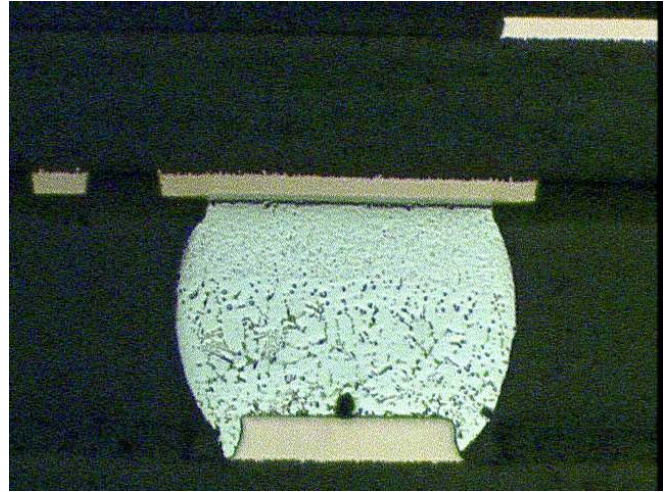
Figure 7: Macro View of BGA Solder Joint Failure

population average being recorded. Typical BGA solder joint failures measured during other area array component investigations [1] has been in the 1000-2000 thermal cycle range. Metallographic analysis was conducted to determine solder joint failure characteristics. Figures 7 and 8 illustrates the BGA solder joint failure observed during the metallographic analysis. The red arrows in Figure 8 point to the solder joint crack.

The BGA solder joint failure is non-typical in a number of ways: (1) a solder joint failure at 137 thermal cycles would be considered premature and an indication of either a component fabrication or manufacturing error; (2) the solder joint crack was located at the solderball/pwb pad side of the solder joint – typical BGA solder joint cracks are located at the solderball/component pad side; (3) the solder joint crack was located at the solder matrix/solder joint intermetallic interface – typical solder joint crack location is in the solder matrix. Inspection of the solder joint revealed four distinct regions of differing microstructure. Each region has been designated as a Zone (A-D) for ease of discussion. Figure 9 illustrates the zones and Table 1 lists the microstructure observed in each zone.

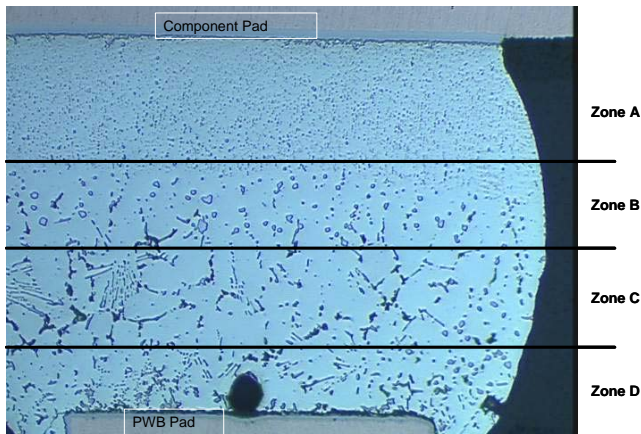
Figure 9: BGA Solder Joint Microstructure Zones

Zone	Microstructure Observed
A	Original SAC solderball - Tin Matrix, Fine Blocky & Platelet Intermetallic Phases
B	Tin Matrix, Large Blocky & Platelet Intermetallic Phases
C	Tin Dendrite Matrix, Interdendritic Phases, Fine Blocky & Platelet Intermetallic Phases
D	Tin Dendrite Matrix, Interdendritic Phases, Blocky & Platelet Intermetallic Phases, Solder Joint Crack

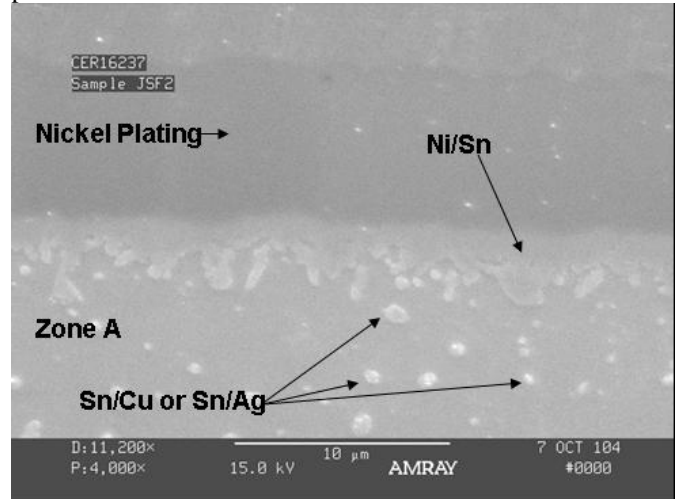
Figure 10: Zone A Microstructure Phases

The BGA solder joint zone A region was the farthest zone from the Sn63/Pb37 solder paste deposit and retained its original SAC solder microstructure. The component pad was a gold/nickel finish prior to SAC solderball attachment by the component fabricator. A tin matrix was present as expected for a SAC solder alloy. SEM EDX scanning found the fine blocky intermetallic phases to be composed of either tin/copper (Sn/Cu) or tin/silver (Sn/Ag). A nickel/tin (Ni/Sn) intermetallic phase was also identified at the solder/component pad interface as expected. The intermetallic phases were identified as Cu_6Sn_5 , Ag_3Sn , and Ni_3Sn_4 in agreement with other industry studies [2, 3]. Some joints showed large platelets of Ag_3Sn intermetallic phase. Figures 10-13 illustrate the microstructure phases identified

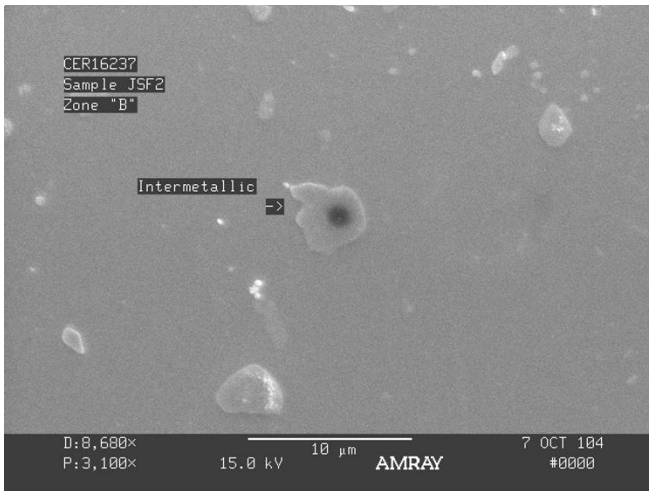
Figure 14: Zone B Large Blocky Phases

A tin matrix is still present in Zone B of the BGA solder joint. Zone B shows the following changes: the fine blocky intermetallic phases were replaced with large blocky intermetallic phases; the intermetallic phases were identified as Cu_6Sn_5 , Ag_3Sn , - no Ni_3Sn_4 was identified. Figures 14-15 illustrates the Ag/Sn microstructure phase identified in zone B and SEM EDX scans of that microstructure phase.

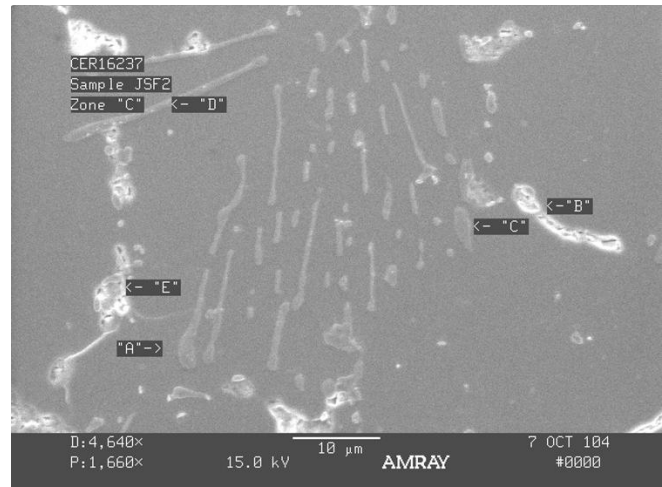
The BGA solder joint zone C region had undergone significant microstructural change. The tin matrix observed in Zones A and B changed to dendritic solidification in Zone C. The large blocky intermetallic phases were identified as Cu_6Sn_5 and Ag_3Sn . A fine platelet intermetallic phase (Ag_3Sn) was observed and a 96.5Sn/3.5Ag eutectic phase was found in the interdendritic regions. Additionally, the first indication of the Pb from the 63Sn/37Pb solder paste deposit was identified in the interdendritic regions. Figures 16-18 illustrate the microstructure phases identified and SEM EDX scans of the zone C microstructure phases.

Figure 16: Zone C Microstructure: "A"- Sn/Ag Platelet, "B" – Pb Interdendritic Region, "C" – Sn/Ag Blocky Phase, "D" - Sn/Ag Platelet, "E" - Pb Interdendritic Region

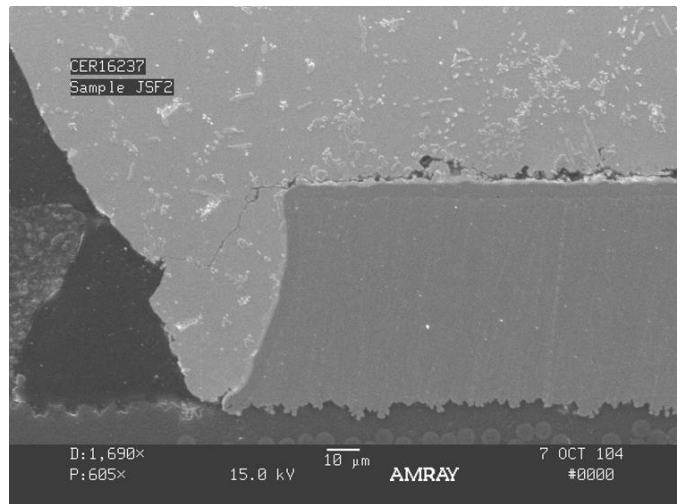
Figure 19: Zone D Solder Joint Crack and Phases

The BGA solder joint zone D region was the zone directly in contact with the 63Sn/37Pb solder paste deposit. Zone D is a region composed of tin matrix, sporadic tin dendrite occurrence, platelet and blocky intermetallics, regions of Pb, and the solder\pwb pad interface. A Ni/Sn intermetallic phase was present due to the use of the ENIG pwb finish. Figures 19 and 20 illustrate the solder joint crack and the microstructure phases in zone D.

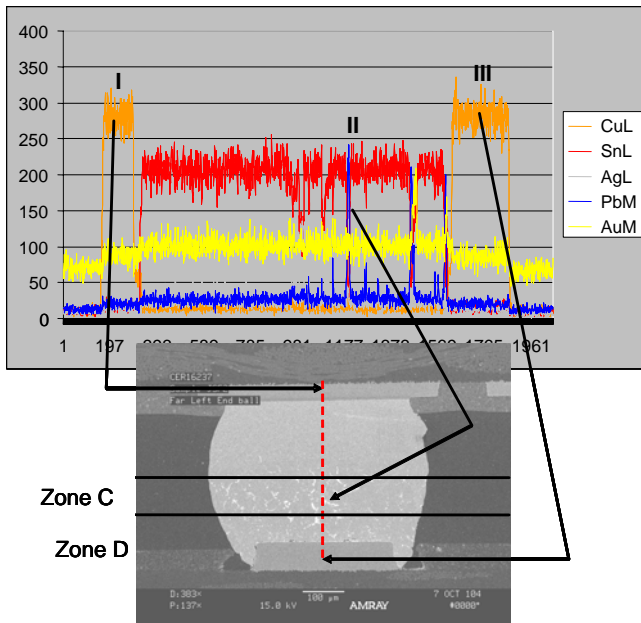
Several SEM EDX line scans were completed to determine the elemental constituent change across a region in contrast to the SEM EDX measurements taken of specific microstructure phases. Figure 21 illustrates a line scan across a BGA solder joint. The component and pwb copper pads are very evident at the beginning and end of the line scan. A large Pb peak was also recorded as the line scan traversed across an interdendritic region in zone C.

Figure 21: SEM EDX Line scan of BGA Solder Joint; (I) Copper of Component Pad; (II) Lead in Interdendritic Region; (III) Copper of PWB Pad. X axis is the scan distance and the Y axis is the elemental count scale.

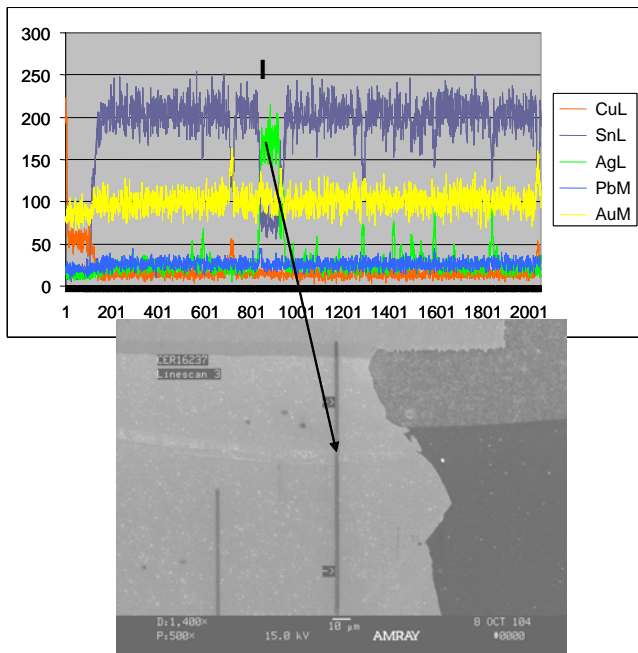
A line scan traversing a large platelet phase produced a large silver peak complementing the SEM EDX specific phase measurements defining the structure as Ag_3Sn intermetallic (see Figure 22).

Figure 22: Ag_3Sn Intermetallic Indication By SEM EDX Line scan; (I) Silver Peak Upon Traversing Large Platelet Microstructure Phase. X axis is the scan distance and the Y axis is the elemental count scale.

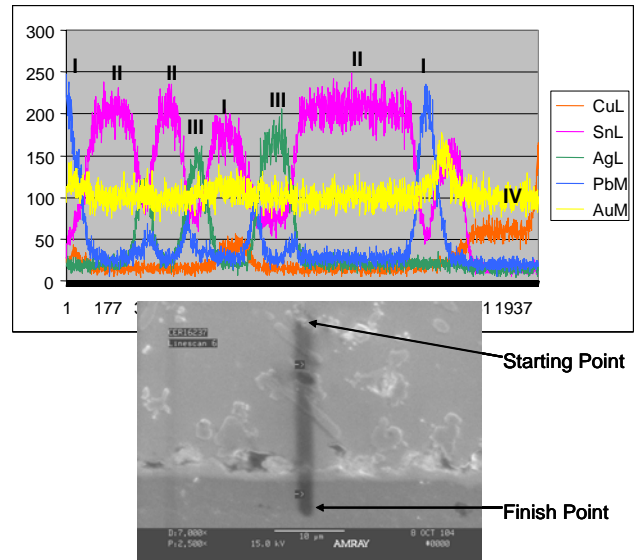
A SEM EDX line scan was completed traversing the solder joint crack in Zone D. The measurements indicated Pb in the interdendritic regions and the solder joint/pwb pad interface, Ag_3Sn intermetallic phase, and the tin microstructure matrix. Figure 23 illustrates these line scan results.

Figure 23: SEM EDX Line scan; (I) Lead Peak; (II) Tin Peak; (III) Silver Peak; (IV) Copper Peak. X axis is the scan distance and the Y axis is the elemental count scale.

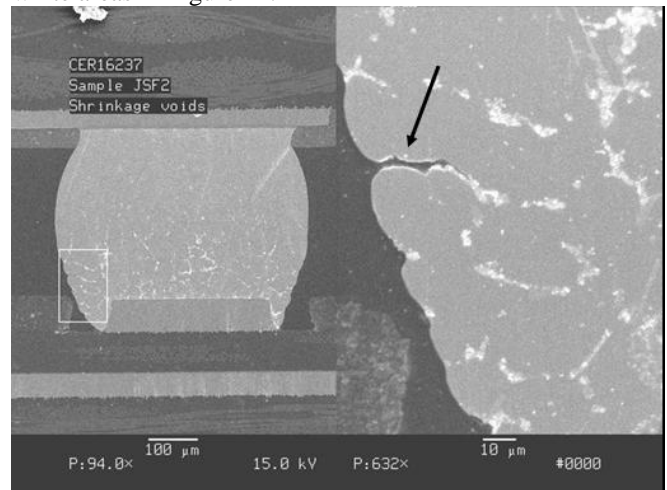
Two other microstructure observations were made during the SEM analysis: the presence of shrinkage voids and large intermetallic platelet phases. The shrinkage voids observed were associated with the formation of the tin dendritic matrix and are the result of solder solidification. The voids are not associated with Kirkendal voiding phenomena. Thermal cycling did not induce or propagate the shrinkage voids into cracks. Other industry investigations [2, 4] have documented similar results for the shrinkage voids. Figure 24 illustrates a typical shrinkage void found in the BGA solder joints. The segregation of Pb from the 63Sn/37Pb solderpaste is clearly visible in the interdendritic regions as white areas in Figure 24.

Figure 24: Shrinkage Void (arrow)

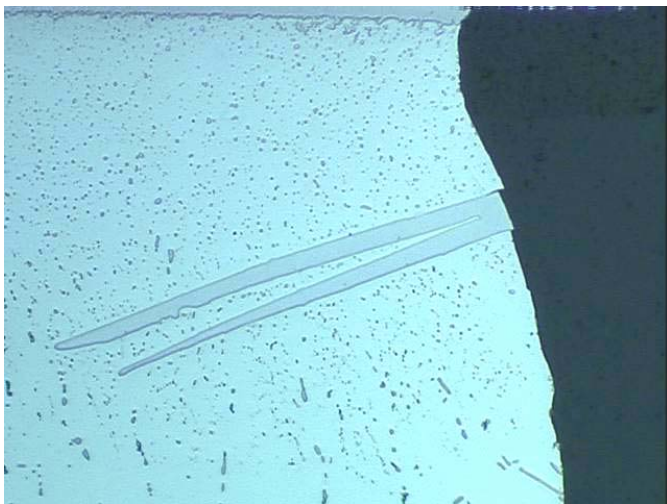
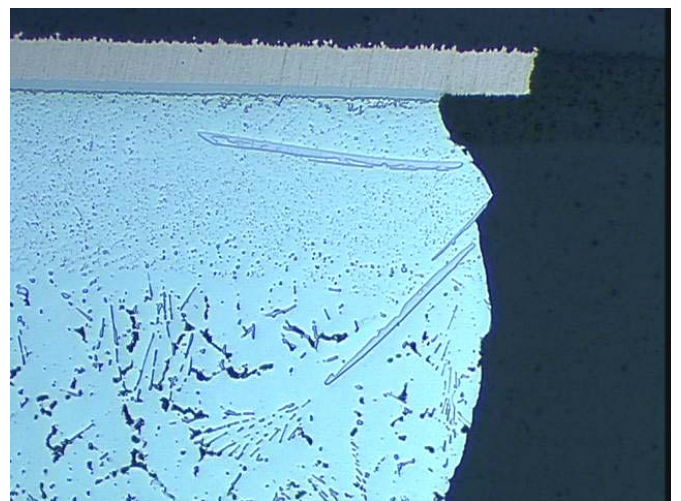
The presence of a large platelet intermetallic phase was observed during the metallographic analysis. Their solder joint location was predominately in zones A and B. SEM EDX analysis revealed these large platelets to be the Ag_3Sn intermetallic phase. A number of occurrences were documented where these platelets intercepted the BGA solder joint surface disrupting the solderball shape. Thermal cycling did not induce or propagate any cracking at/along the length of the large platelets. Other studies have observed similar large platelet intermetallic phases [2, 5, 6]. One industry investigation [7] purposed that the large platelet intermetallic phase could potentially be beneficial by imparting additional structure and strength to the solder joint. Figures 25-28 illustrate the large platelet intermetallic phase observed.

Figure 25: Large Sn/Ag Platelet

Figure 26: Magnified View of Figure 25 Platelet

Figure 27: Large Sn/Ag Platelets in Zone A/B

Figure 28: Solderball Disruption Due to Large Sn/Ag Platelets in Zone A/B

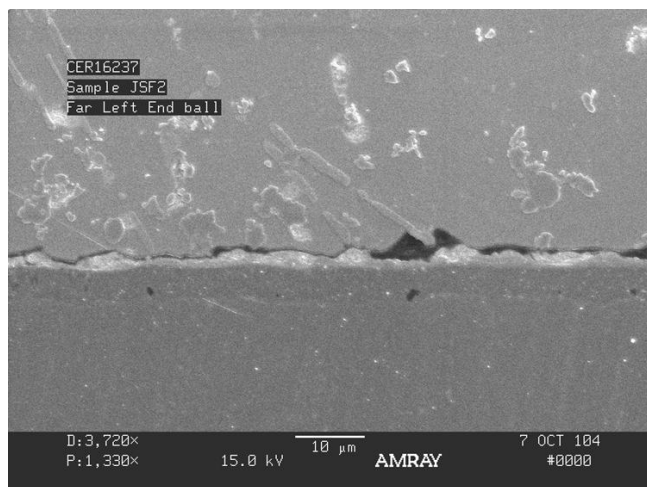
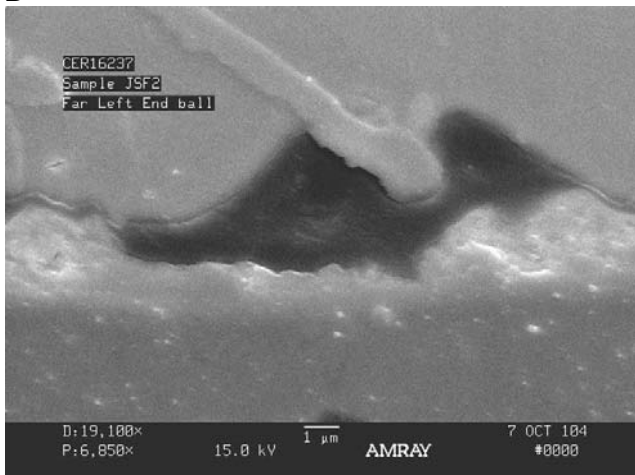
A review of the SEM EDX analysis reveals an interaction of the non-uniform microstructure and the solder joint crack. Figures 29-30 illustrate further evidence of degradation of the BGA solder joint integrity. Figure 30 shows a Sn/Ag intermetallic platelet intercepting a void region along the crack/pwb pad interface. The presence of the Sn/Ag intermetallic platelet intruding into the void space demonstrates the presence of the void during platelet growth or formation of the void upon solder joint solidification – physical evidence of nonwetting/dewetting behavior of the nickel surface during solder joint formation. Soldering nickel surfaces is more complex than soldering copper surfaces due to nickel oxide/flux reactions and the slow diffusion rates of nickel into solder [8]. Secondly, the SEM EDX measurements show that the solder joint microstructure was not uniform. Several industry studies [2, 9, 10, 11] have documented that the formation of a 177°C ternary eutectic alloy (62.5Sn/36.1Pb/1.4Ag) is possible in a mixed surface finish manufacturing scenario. This investigation results show the 177°C ternary eutectic alloy formed in Zones C/D in the interdendritic regions. The

combination of a nickel surface and the non-uniform solder joint microstructure resulted in solder joint degradation leading to solder joint failure. Other industry studies [2, 5, 6, 7, 12] have reported that allowing the formation of a uniform solder joint microstructure with mixed surface finish manufacturing assemblies results in a Pbfree solder joint integrity equal to or better than Sn/Pb solder joint integrity. The non-homogeneous microstructure seen in this study is the result of a Pbfree solderball subjected to a eutectic solder reflow temperatures and lead to solder joint failure.

Figure 29: Solder Joint Crack In Zone

Figure 30: Magnified View of Figure 29

Area array components (ball grid arrays, chip scale packages, flip chip packages) with Pbfree solder sphere alloys should not be reflowed using a tin/lead reflow profile due to the resulting non-uniform solder joint microstructure and potential poor board surface finish wetting interactions.
