The Surface Finish Effect on the Creep Corrosion in PCB

¹IST-Integrated Service Technology, Inc.

²Tripod Technology Corporation

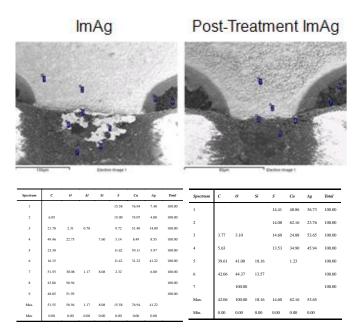
Figure 21: Top view SEM/EDS analysis

The comparison in SEM/EDS analysis between ImAg and Post-Treatment ImAg coating show that the corrosion rate of ImAg is higher than Post-Treatment ImAg. In figure 21, the corrosion of ImAg creeps onto the trace from pad, but the corrosion of Post-Treatment ImAg only occur on the pad and doesn't creep to the trace. The pad of ImAg has been corroded and flaked as shown in figure 22, therefore, it is concluded Post-Treatment ImAg has the better performance than normal ImAg.

The silver layer is getting denser with better coverage of Cu pad preventing corrosion happening. The Post-Treatment ImAg with more organic preservative is designed to have better performance than ImAg under the corrosive gas exposure. [2]

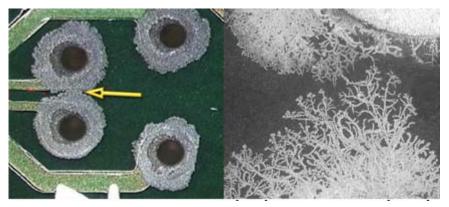
Creep Corrosion on PCB

- Creep corrosion typically occurs when copper is exposed to an environment containing sulfur.
- Cu₂S is the primary creep corrosion product. Cu₂S is produced by the attack of the copper at the edge of the soldermask.
- •Creep appears to begin by growth of dendrites. As the corrosion products increase in thickness, the resistance decreases until functional shorting occurs.

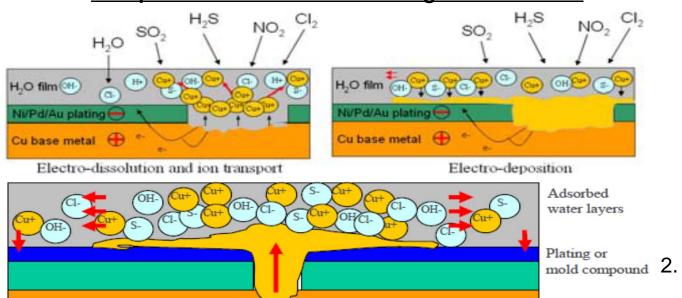
Creep Corrosion on the Gull-Wing Lead of PSOP

The mechanism of creep corrosion in Dr. Ping Zhao's previous published paper described the process of **Dissolution** \rightarrow **Diffusion** \rightarrow **Re-deposition**

1. The multiple monolayers of water are adsorbed on the surface under high relative humidity and then the corrosion products dissolve into these water layers.

The mechanism of creep corrosion in Dr. Ping Zhao's previous published paper described the process of **Dissolution** \rightarrow **Diffusion** \rightarrow **Re-deposition**. The multiple mono-layers of water are adsorbed on the surface under high relative humidity and then the corrosion products dissolve into these water layers. Therefore, they diffuse over the surface in solution down the concentration gradient and re-deposit. The mechanism of creep corrosion is shown in Figure 3. [3]

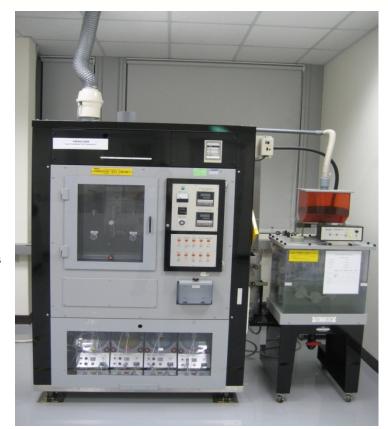
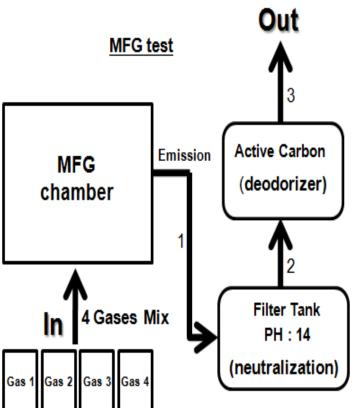
MFG Test System

<u>Humidity Range</u>: 70 ~ 95%(RH)

Inside Dimension:

50 cm (W) x 50 cm (D) x 50 cm (H)

a. Chamber feature is shown in figure 4

Yamasaki GH-180-VL/M(JAPAN)

Temperature: 25°C~+50°C

Humidity range: 70%~95%(RH)

Mode: Single or Mixed flowing gas

Inside dimension: 50(W)*50(D)*50(H)/cm

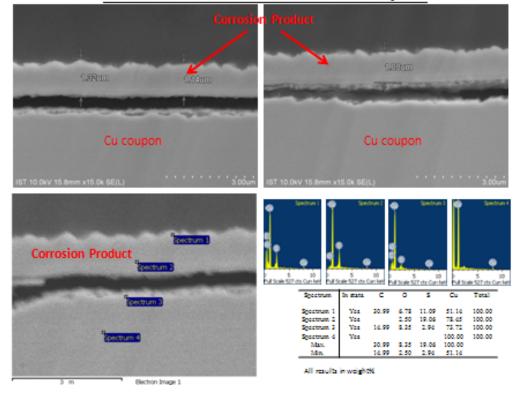
Corrosion Product of Cu Coupon

Weight gain Analysis of Cu/Ag coupons in 3 different concentration of H₂S

- The corrosion rate of Cu coupon rapidly increases while H₂S concentration after reaching at 1000 ppb.
- Ag coupon has more active performance in lower H₂S concentration than higher H₂S concentration.
- Flaking corrosion also happens on the Cu coupon with heavy corrosion product in the high H₂S concentration test condition.

The corrosion rate of Cu coupons rapidly increases with H₂S concentration after reaching at 1000 ppb. Ag coupons have more active corrosion in lower H₂S concentration than higher H₂S concentration. Flaking corrosion also happens on the Cu coupon with heavy corrosion product in the high H₂S concentration test condition. (See Figure 14, Figure 15, Figure 16.)

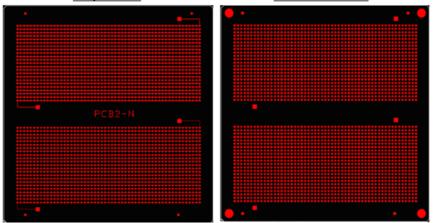
Group A Bottom Side

PCB Design & Surface Finish

Table 5 shows the DOE matrix to investigate material, process and design effect on the creep corrosion. Two groups A and B of sample are investigated in this study. Group A is NSMD. (See Figure 9) Group B is Comb-Pattern design. (See Figure 10)

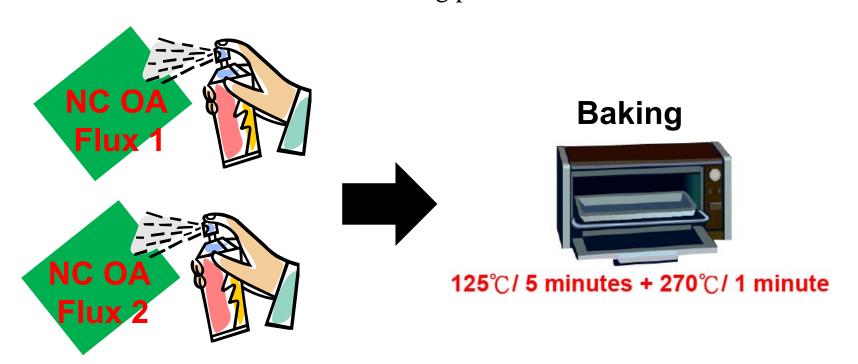
- Group B
- Spray 2 different types of NC OA Flux on the boards
- The boards with flux are baked at 125°C for 5 minutes and then 270°C for 1 minute to simulate the wave soldering process.

In Group B, two types NC(No Clean) and OA(Organic Acid) Flux are sprayed on PCB with the simulation of wave soldering condition by baking the flux residue on the PCB.

PCBs of Group B are put in the oven at 125°C for 5 minutes and then at 270°C for 1 minute after the NC OA Flux are sprayed on it to simulate wave soldering condition and have flux residue remaining on the PCB.

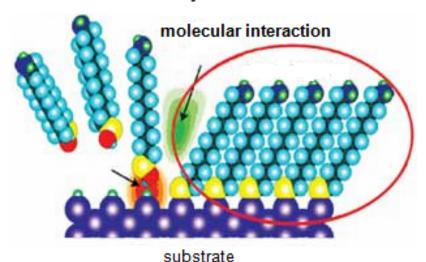
Post-Treatment is molecular self-assembly Monolayer. The molecule will selectively attach itself to available copper. The silver layer is getting denser with better coverage of Cu pad to prevent corrosion happening. The Post-Treatment ImAg with more organic preservative is designed to have better performance than ImAg under the corrosive gas exposure.

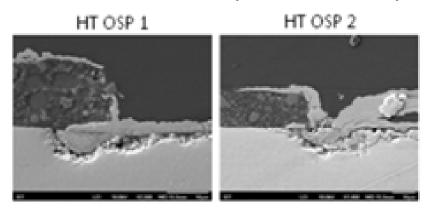
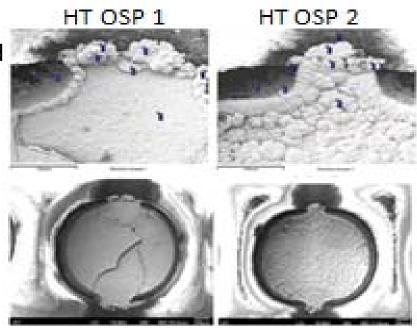
The Comparison of HT OSP1 & HT OSP2

- Both HT OSP 1 and HT OSP 2 have worse performance than ImAg, but there are no enough evidences to judge which one is the worst.
- HT OSP 1 has creep and flaking corrosion. The corrosion product on the pad is thinner and smoother.
- HT OSP 2 has creep corrosion but the pad isn't flaked. The corrosion product on the pad of HT OSP 2 is thicker and rougher.
- Both of them have creep corrosion from pad to the trace and the pad crater. HT OSP 2 has thicker corrosion product on the pad.

Both HT OSP 1 and HT OSP 2 have worse performance than ImAg, but there is not enough evidences to judge which one is the worst. HT OSP 1 has creep and flaking corrosion. The corrosion product on the pad is thinner and smoother. HT OSP 2 has creep corrosion but the pad isn't flaked. The corrosion product on the pad of HT OSP 2 is thicker and rougher as shown in Figure 24. Figure 25 shows the side view of HT OSP 1 and HT OSP 2. Both of them have creep corrosion from pad to the trace and the pad crater. HT OSP 2 has thicker corrosion product on the pad.

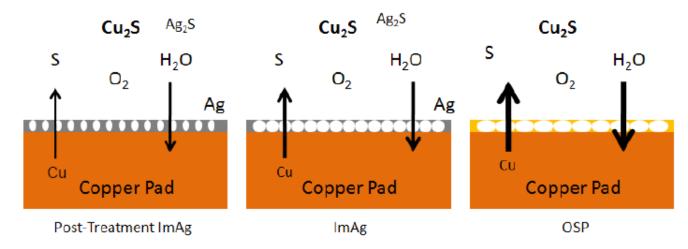
Qualitative Comparison of Porosity Ratio Among Surface Finishes

- ImAg has the higher porosity ratio than Post-Treatment ImAg, it is assumed that OSP might have higher porosity ratio than ImAg.
- In Currently there are three testing methods for surface finish porosity test in the industry, which are Gas Exposure Method, Electrolysis Imaging Method and Salt Spray Test Method.
 But all of them are not the ideal and reliable test methods to identify quantitatively the porosity.

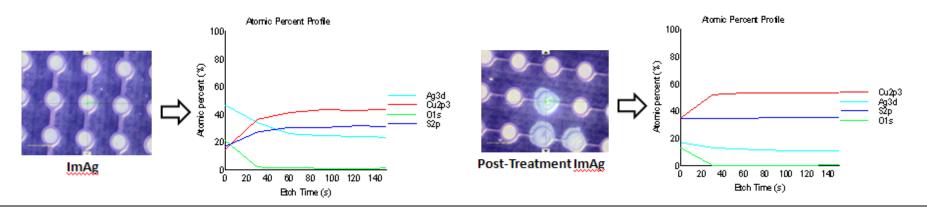
ImAg vs Post-Treatment ImAg

u-XPS Analysis

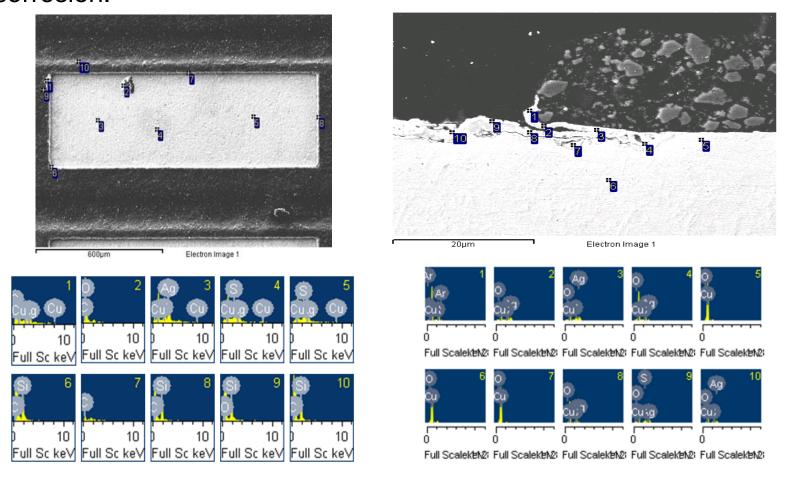
• Flux residue will cause easily moisture absorption and the H+ of ion contamination is helpful to dissociate Cu oxide and accelerate creep corrosion.

Wave-soldering flux residues can promote creep corrosion and this has been published in Dr. C. Xu's paper. [1][10] It is expected we will get a similar result in this study. The SEM/EDS of corroded pad with flux residue is shown in Figure 31. The creep corrosion is found in Figure 32 with SEM/EDS analysis. Flux residue will cause moisture absorption and the H+ ionic contamination will dissociate Cu oxide and accelerate creep corrosion. [2]
