# Improving Thermal Cycle and Mechanical Drop Impact Resistance of a Lead-free Tin-Silver-Bismuth-Indium Solder Alloy with Minor Doping of Copper Additive

Takehiro Wada<sup>1</sup>, Seiji Tsuchiya<sup>1</sup>, Shantanu Joshi<sup>2</sup>, Roberto Garcia<sup>2</sup>, Kimiaki Mori<sup>1</sup>, Takeshi Shirai<sup>1</sup>

<sup>1</sup>Koki Company Ltd., Japan, <sup>2</sup>Koki Solder America Inc., USA

# **Improving Thermal Cycle and Mechanical Drop Impact Resistance of a Lead-free Tin-Silver-Bismuth-Indium Solder Alloy with Minor Doping of Copper Additive**

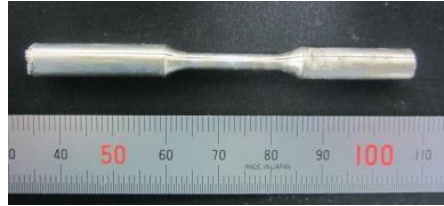
**Figure 1 - Appearance of Micro-Dumbbell**

Tensile testing was conducted on the micro-dumbbells as shown in Figure 1. The micro-dumbbells were manufactured by casting molten solder at around 300°C into a die which is preheated to the same temperature. Then the die was immersed in a coolant which was formulated to set the cooling rate around 5K°/second at the time of reaching the solidus temperature, so

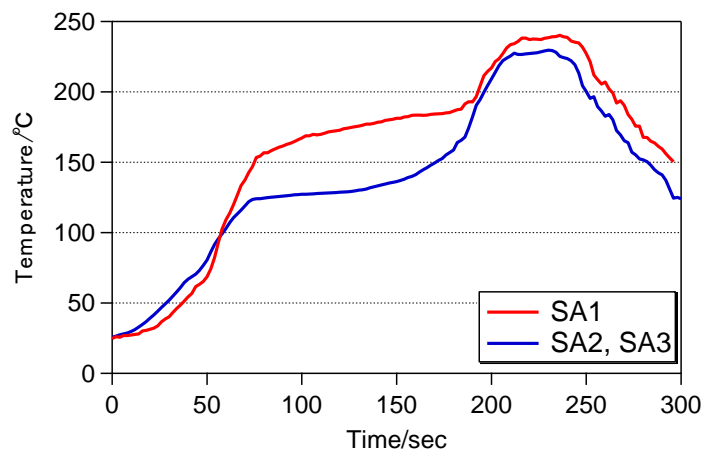
**Figure 2 - Reflow Profile(Air Atmosphere)**

The PCBs for this experiment were assembled using solder paste containing Type 4 solder powder of each alloy and no-clean flux. Solder pastes were printed using a 120 $\mu\text{m}$  thick metal stencil and reflowed using the specific reflow profile indicated in Figure 2 in air atmosphere. The time over liquidous temperature for the SA1 profile was 52 seconds and peak temperature of 245°C. The time over liquidus temperature for the SA2, SA3 profile was 53 seconds and peak temperature of 240°C. Different PCBs and components were used for thermal fatigue and drop tests.

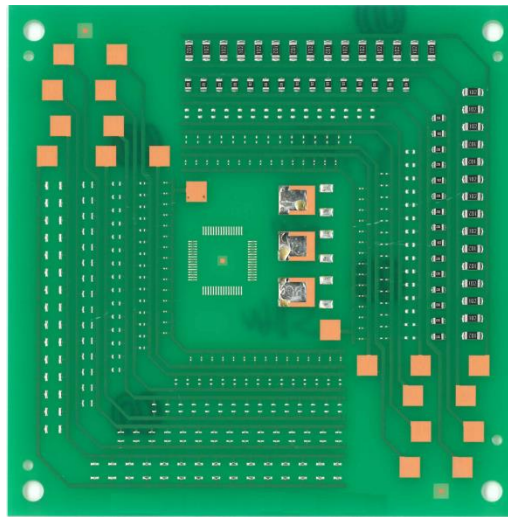
**Figure 3 - Test PCB for Thermal Cycling Test Evaluation (100x100mm)**

The test vehicle for the thermal fatigue test is shown in Figure 3. This test vehicle was intended to measure the electrical resistance of the soldered circuit as well as to measure the shear strength of the 1206 (3216 metric) and 0805 (2012 metric) chip resistors. Two different PCBs with surface finishes Cu-OSP and ENIG with the same 1.6mm thickness and FR-4 grade material were used.

The test PCB for the thermal cycling test is shown in Figure 3. The condition of the thermal cycle is  $-40^{\circ}\text{C}$  to  $+150^{\circ}\text{C}$ . The combined resistance was measured 10 to 20 minutes after the chamber was switched to the dwell time at high temperature, to let the sample temperature stabilize. Measurements were taken at a high temperature because the circuit is likely to be open, as the thermal expansion enlarges the crack. On the contrary, measurement during the dwell time at the low temperature was omitted as at a low temperature, cracks close up. In such a case, even if the solder joint has already been open owing to a penetrating crack, it may appear to be conducting on the measurement data.

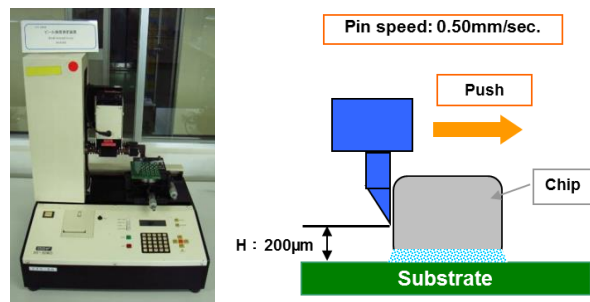
**Figure 4 - Bond Tester Equipment (Left) and Schematic of test method(Right)**

Shear strength tests were performed on the soldered test vehicles after taking some of the boards out every 500 cycles for each of the two profiles. The bond tester for the shear strength test is shown in the left of Figure 4 and the schematic image of the shear strength test is illustrated in the right of Figure 4, respectively. The clearance between the shearing jig and PCB is 0.2mm and the shear strength was calculated at a tool speed of 0.5mm/sec. Shear strength was recorded based on the maximum load that caused solder joint failure.

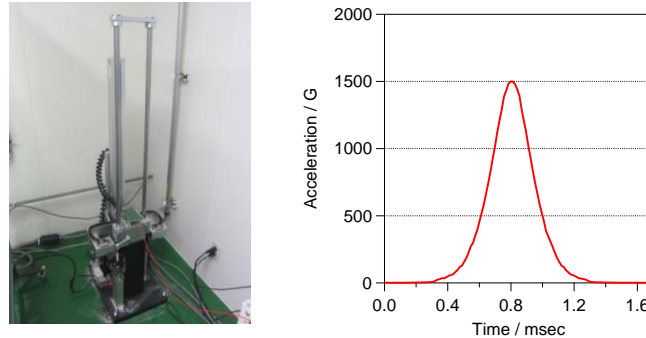
**(a)Test Equipment (b)Shock Wave**  
**Figure 5 - Drop Impact Test Equipment and Shock Wave**

To evaluate the shock resistance property of each solder alloy, board level drop tests were performed. Figure 5(a) shows the drop test machine and Figure 5(b) shows the shockwave. The drop test machine drops the test PCB from a pre-determined height to generate a 1500G, 0.5msec half sine impulse, the image of which is shown in Figure 5(b), until the voltage monitor detects electrical discontinuity.

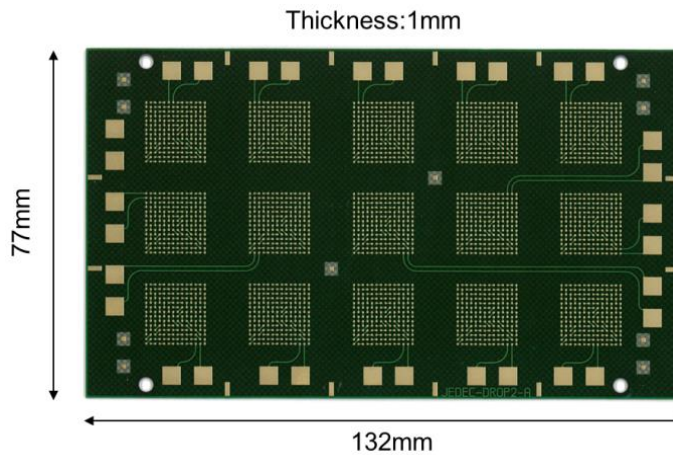
**Figure 6 - Test PCB for Board Level Drop Testing**

The test PCB for the board level drop test is indicated in Figure 6. This PCB has 8 layers and is 1 mm thick. The material is FR-5 grade and the board surface finish is Cu-OSP or ENIG. To detect the circuit failure by electrical discontinuity, the circuit is patterned so that all BGA balls are in one series circuit. One 15mm x 15mm BGA with 196 pins was mounted at the center of the test PCB. Solder balls on the BGA were Sn-3Ag-0.5Cu. The test PCB was then aged in an air atmosphere oven set at  $150^{\circ}\text{C}$  for 500 hours to promote the growth of the intermetallic compound phase at the solder joint interface. Bias voltage was constantly monitored to detect any change derived from the drop shock and to determine whether the circuit had failed [3]. Any change which exceeded bias voltage by more than 20% was regarded as a failure.

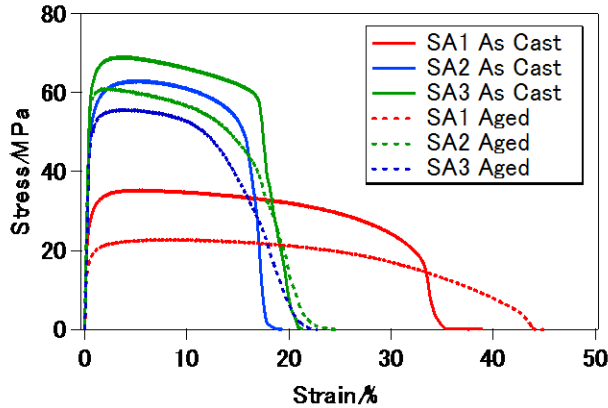
Figure 7 - Stress Strain Curves (SA1, SA2, SA3 alloys: as-cast and aged)

Figure 7 shows stress-strain curves from the tensile test. SA2 (SABI - SnAgBiIn) and SA3 (SABI + Cu - SnAgBiIn + Cu) display almost 3 times higher pull strength than SA1 (SnAgCu), a normal Sn-Ag-Cu type solder alloy. Since the difference between SA2 and SA3 is 0.8% Cu in their compositions, they were not significantly different. SA2 and SA3 had lower

elongation than SA1, which suggests that ductility is reduced by Bi in the solder structure.

All aged samples of tested alloy compositions showed reduced pull strength and increased elongation compared to as-cast samples. However, although SA1's pull strength reduced almost by half, SA2 and SA3, which contained In and Bi, showed rather insignificant loss of pull strength after aging. It can be noted that In and Bi are forming solid solution in the Sn matrix which strengthen the alloys.

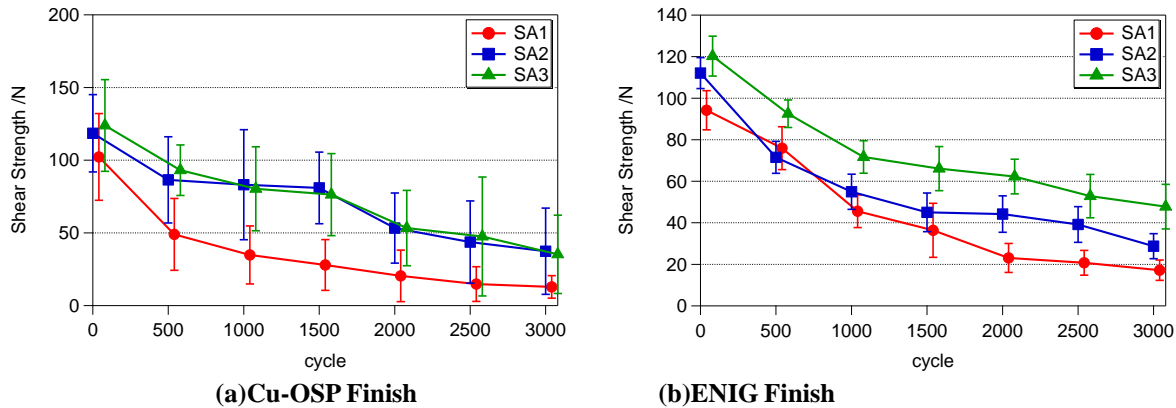
Figure 8 - Shear Strength Transition by Thermal Cycle for SA1, SA2, SA3 Alloys, (a) Cu-OSP Board Finish and (b) ENIG Board Finish

Shear strength test results for 1206 (3216metric) chip resistors after reflow (As Reflow) and after every 500 thermal cycles up to 3000 thermal cycles from -40°C to +125°C, are provided in Figure 8 (a) and Figure 8 (b) for Cu-OSP finish and ENIG board surface finishes, respectively. According to the transition of the shear strength, loss of strength was about the same between SA2 and SA3 on ENIG. In addition, SA2 and SA3 exhibited a smaller degree of strength loss as cycles increased. On the contrary, SA2 on ENIG board finish showed a more significant loss of the strength than on the Cu-OSP board finish, and the difference between SA2 and SA3 was larger on the ENIG board surface finish.

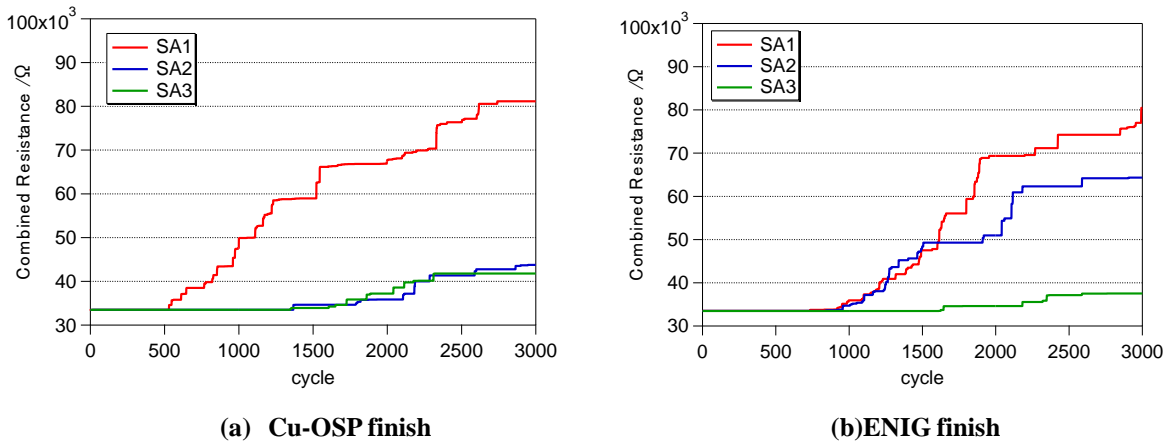
**Figure 9 - Transition of Combined Resistance of the Chip Resistors in Parallel during Thermal Cycling**

The combined resistance of the chip resistors during the thermal cycling test at -40°C to +125°C is shown in Figure 9. In this data, increase in measured resistance indicates decrease in n from Eq.(1), which means more solder joints in the circuit became open. At the beginning of the thermal cycling test, 30 chip resistors were electrically conducting; therefore, the combined resistance was  $3.3 \times 10^4 \Omega$ . Similar to the behavior seen in the shear strength test, increase in resistance is suppressed for SA2 and SA3 compared with SA1. In addition, SA2 and SA3 perform similarly in terms of an increasing trend in combined resistance on Cu-OSP board finish, whereas on ENIG board finish SA2 shows a more significant increasing resistance trend than SA3. According to these observations, it can be stated that SA2 and SA3 solder joints on ENIG board finish show different crack propagation behavior, unlike the solder joints of SA2 or SA3 on Cu-OSP board finish.

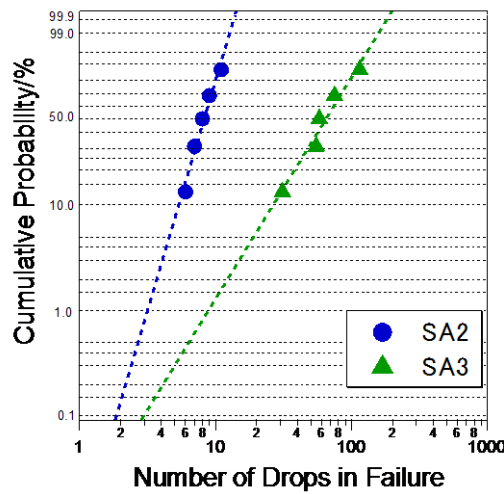
**Figure 10 - The Weibull Plot of the Number of Drops for Failure at the BGA’s Circuit During Mechanical Drop Testing (SA2 and SA3 alloys after ageing on ENIG board finish)**

Board level drop testing was conducted on test samples prepared by soldering SA2 and SA3 solder alloys on ENIG board finish and ageing at high temperature. Five samples were prepared and dropped repeatedly until circuit failure was detected. The number of drops until circuit failure was plotted as Weibull plots as shown in Figure 10. Although the sample size was small for the Weibull plot, SA3 shows significantly better mechanical drop shock resistance as the solder alloy than SA2.

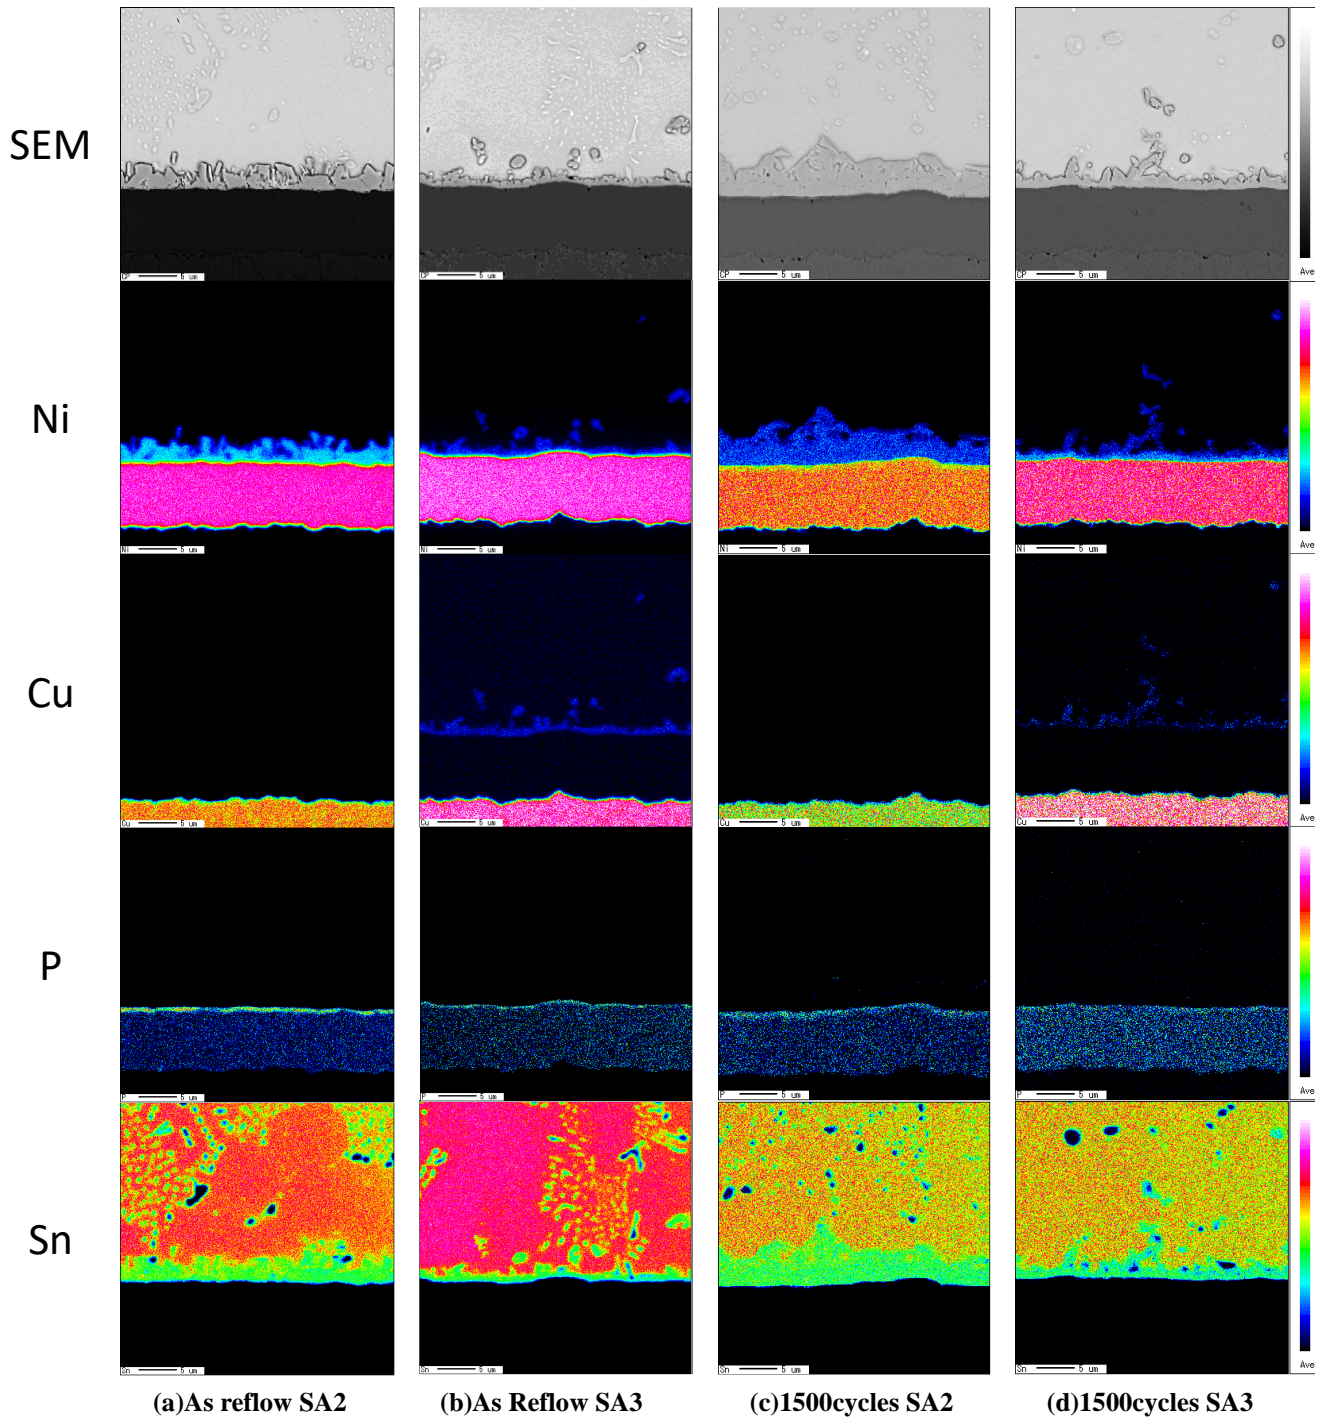
**Figure 11- Solder Joint Interface of ENIG Board Finish: As Reflowed and Thermal Cycled (Ni, Cu, P, Sn Analyzed)**

Two of the tested solder alloys, SA2 and SA3, were reflowed on test PCBs with ENIG board finish and cross-sectioned for the analysis by SEM-EDX. For each solder alloy, as reflowed and thermal cycled (from -40°C to +125°C for 1500 cycles) samples were prepared. SEM and elemental mapping images for different elements are shown in Figures 11 and 12.

As the lands on the PCB have ENIG surface finish, Phosphorus (P) exists in the Ni layer and Au exists on top of the Ni layer. Comparison between SA2 and SA3 for as reflowed samples revealed that the intermetallic compound layer at the joint interface was thicker for SA2. The compound layer for SA2 mainly consisted of Sn-In-Cu, while SA3’s compound layer consisted of Sn-Cu-Ni. By adding a small amount of Cu in the solder alloy, the intermetallic compound layer at the joint interface on ENIG board finish incorporates Cu, and inhibits the growth of the compound layer. This has contributed to improved joint reliability performance during the thermal cycling for SA3 versus SA2 soldered on the ENIG finished PCBs.

P is slightly concentrated at the interface between the intermetallic compound layer and the Ni layer. This suggests that originally, Ni and P were uniformly distributed in the Ni layer, but while Ni moved to the compound layer, the P did not move but rather concentrated around the interface. Thus, when compared to SA3, SA2 exhibits a higher P concentration at the intermetallic/solder interface as its Ni layer at the joint interface has been eroded further.

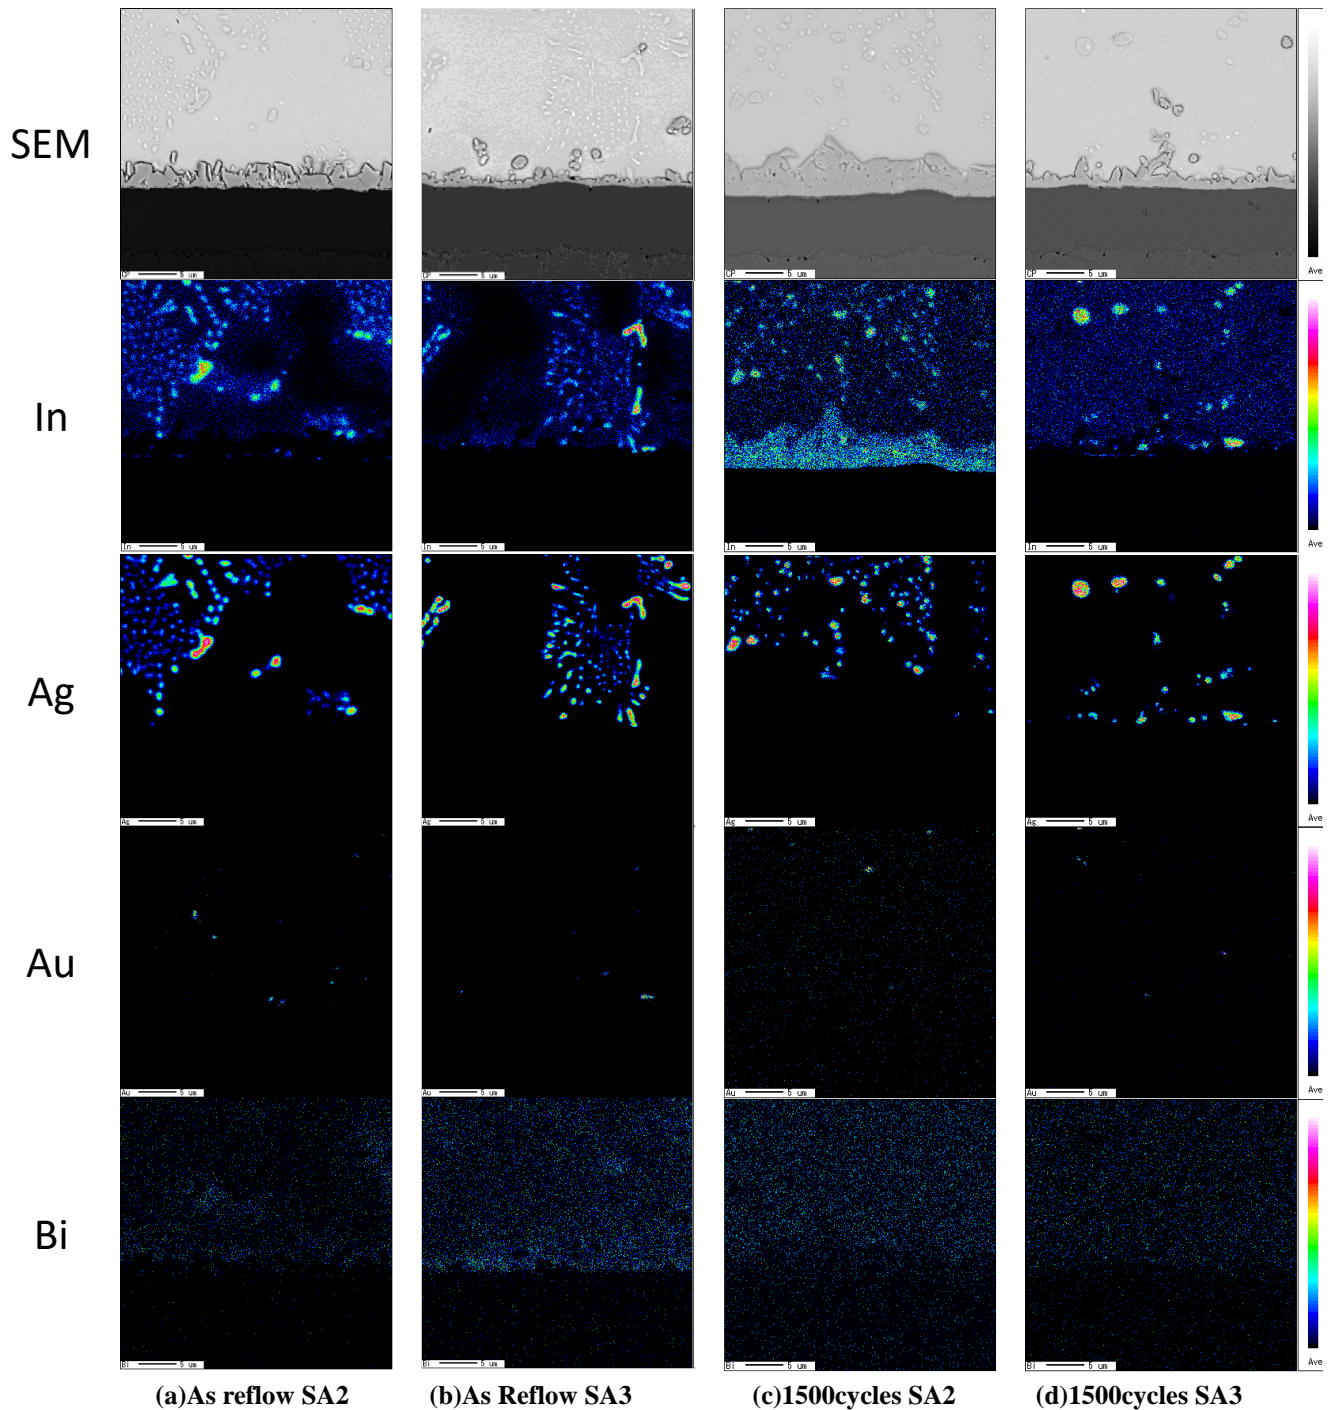
**Figure 12- Solder Joint Interface of ENIG Board Finish: As Reflow and Thermal Cycled (In, Ag, Au, Bi Analyzed)**

As for the Ag, it forms an intermetallic compound with Sn and In in the solder phase; however, it is scarcely detected within the compound layer with Ni content at the joint interface. Au, the plated and outermost layer of the ENIG finish, and Bi, an additive element in the solder alloy, are not detected in the vicinity of the joint interface and are difficult to identify, as they are forming solid solution uniformly in the solder phase.

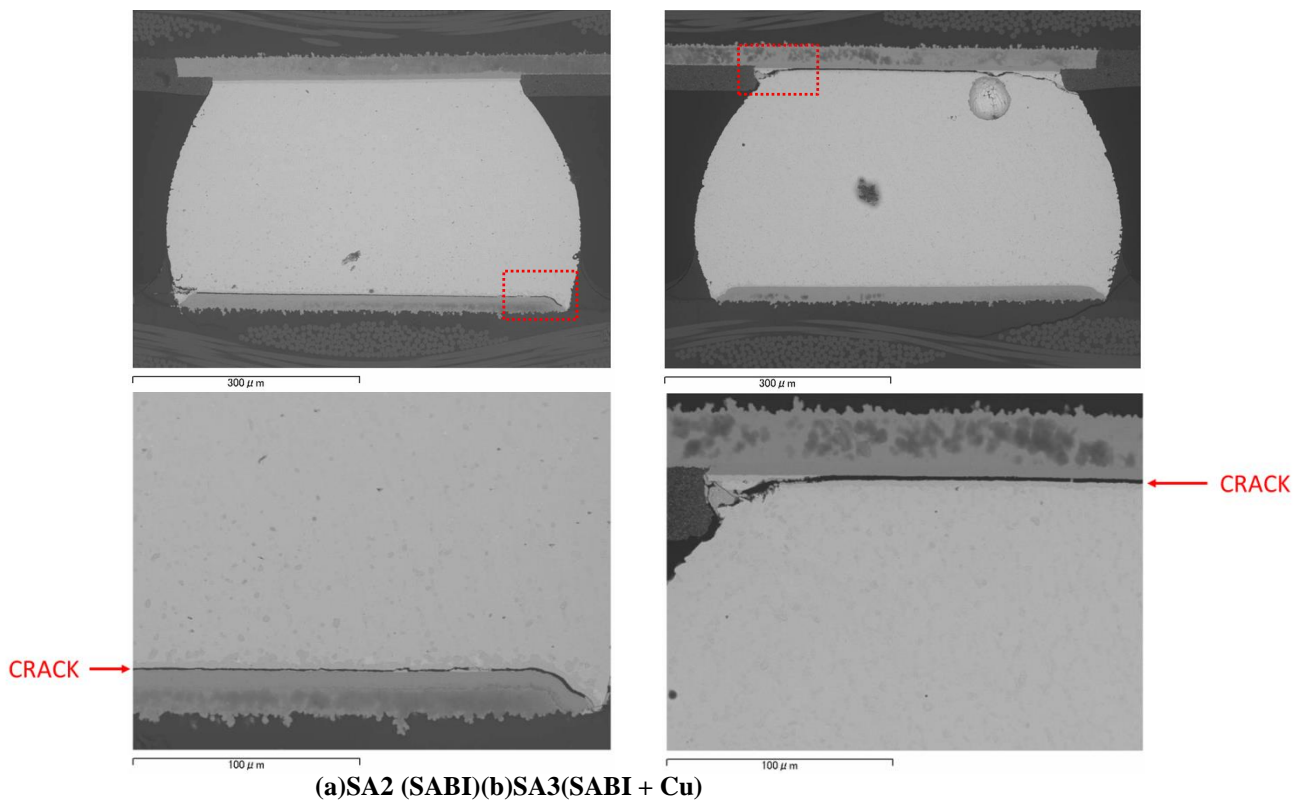
**Figure 13– Solder Joints Fractured in Board Level Drop Testing (Top: Whole Cracked Ball, Bottom: Magnified Crack) (a) SA2 (b) SA3**

Figure 13 shows the cross-sectioned solder joints after they failed in the board drop tests. Each sample suggests that the joint fracture initiated from one of four corners as it is assumed that these four corners are exposed to the most stress, as the joint fracture occurs when the board is warped by the drop impact and the solder joints beneath the BGA are stressed.

Evaluation of the fractured solder joint at the BGA revealed that the location of the fracture is different between SA2 and SA3. For SA2 fracture occurred between the solder ball and PCB, and for SA3, fracture occurred between the solder ball and the component. Since the lands on the PCB are larger than those on the component, it is anticipated to fracture at the component side. However, on all SA2 samples, all fractures occurred between solder ball and PCB.

As for the distinctively short life in the board level drop test and the fracture at solder ball and land interface on the PCB side, phosphorus may have contributed to these phenomena. Phosphorus concentration causes embrittlement of the metal; therefore, once the P concentrates at the interface as seen in the SA2 element mapping in Figure 11, the embrittlement effect can be accelerated which can deteriorate impact resistance. The phosphorus concentration layer of SA2 is thicker than that of SA3.

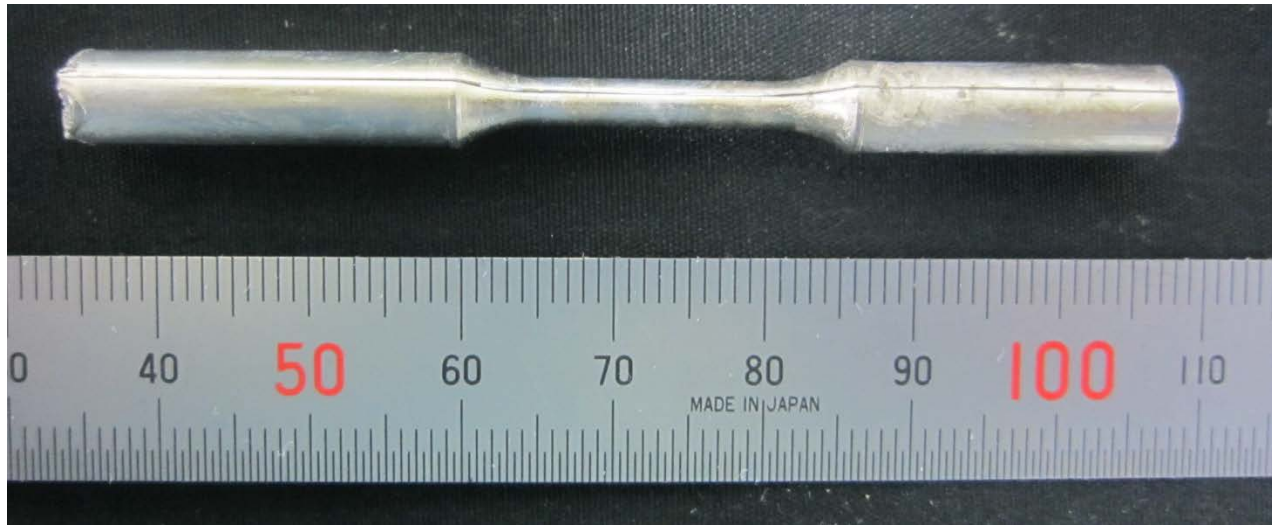
- Pull test on cast micro-dumbbell, of which the diameter at the section is  $\phi$  3mm.
- Since the microstructure of the solder alloys after soldering is the same as the structure of the casted metal, the micro-dumbbell for the evaluation was cast using a die.

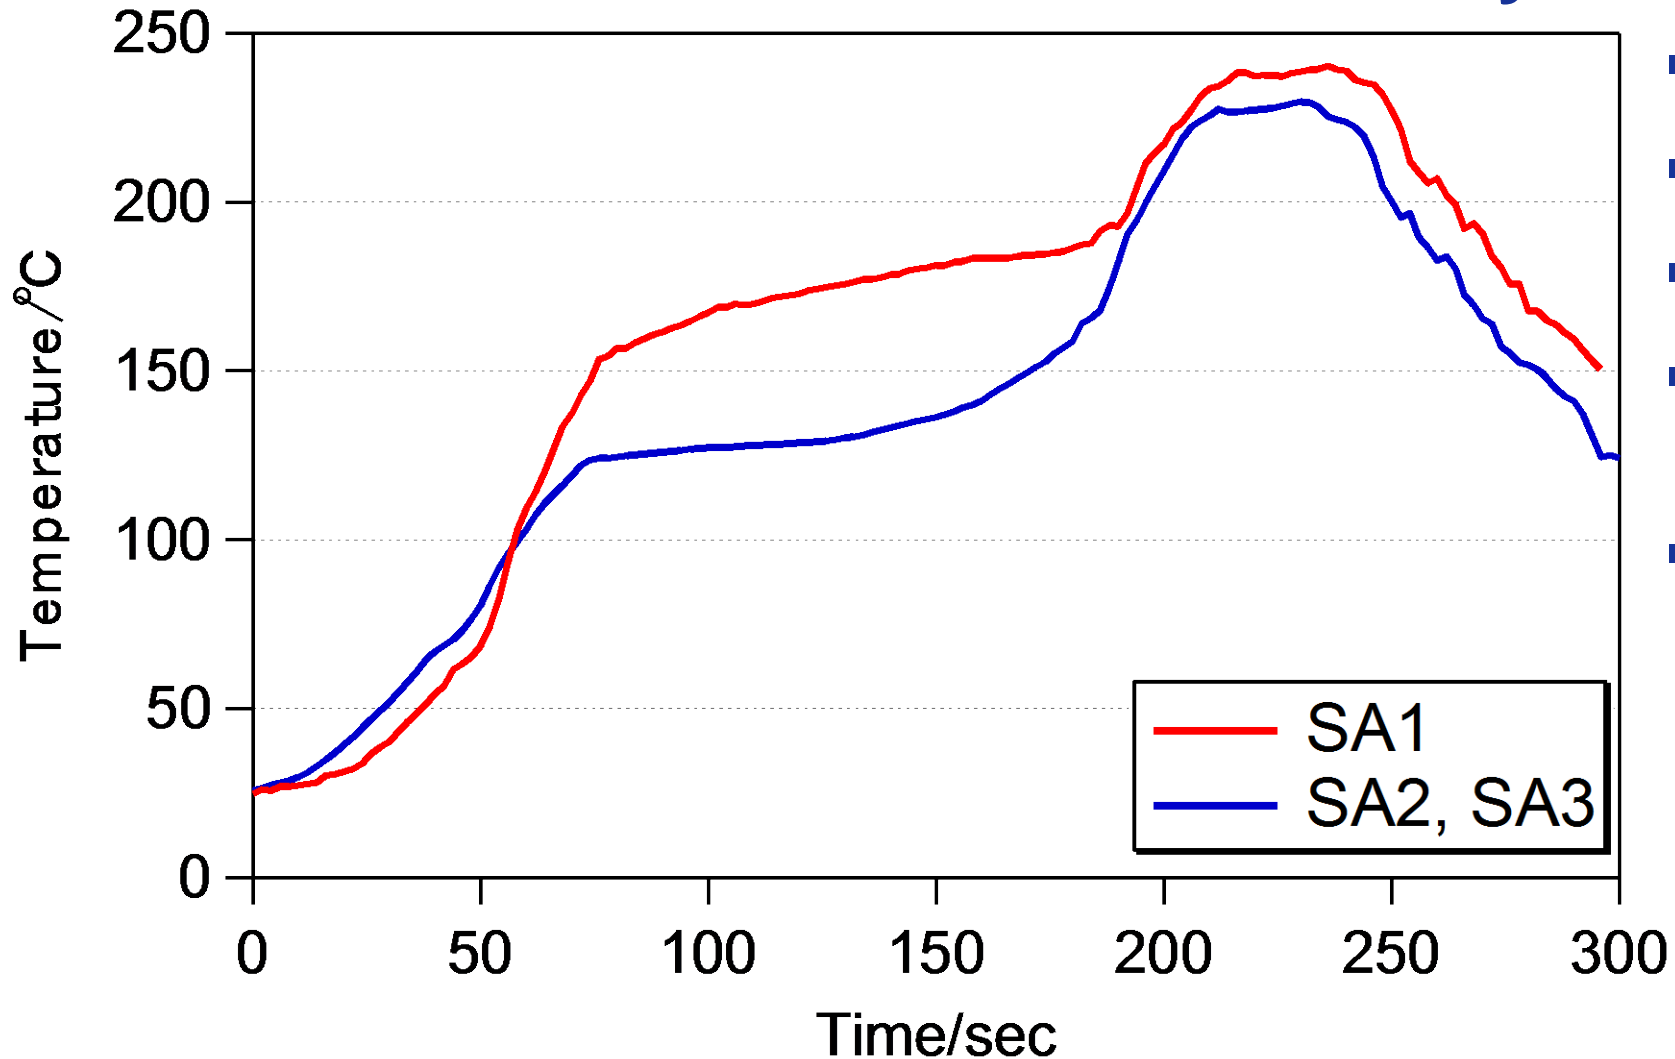
- Type 4 solder pastes
- 5 mil thick metal stencil
- Air reflow
- TAL for SA1: 52 s and Peak Temp: 245°C.
- TAL for SA2 and SA3: 53 s and Peak Temp: 240°C.

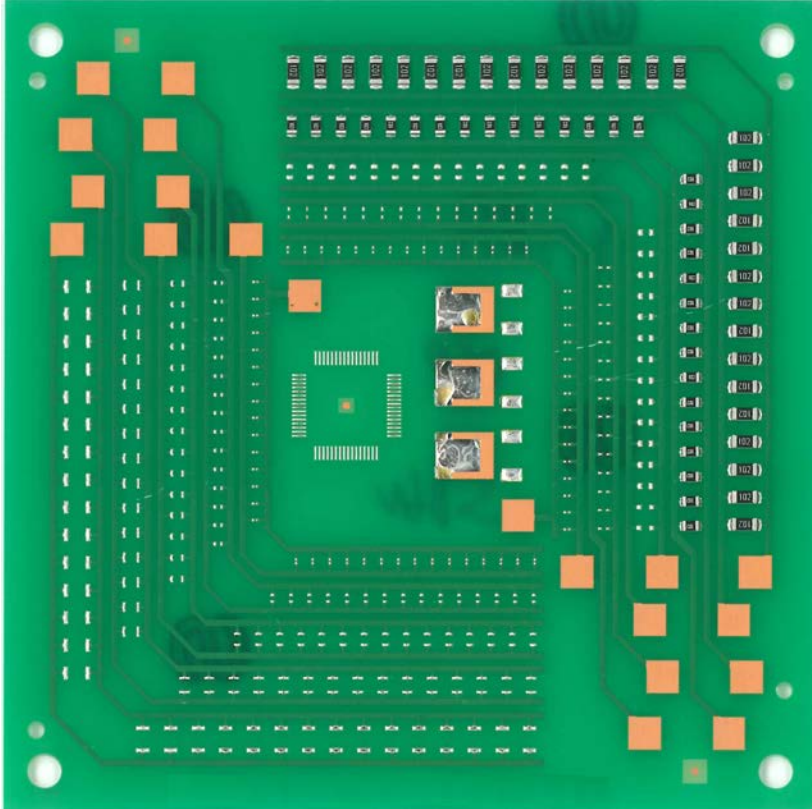
Test PCB for Thermal Cycling Test  
Evaluation(100x100mm)

- 1.6mm thickness and FR-4
- 1206 (3216 metric) and 0805 (2012 metric) chip resistors.
- Two different PCBs:
  - Cu-OSP and
  - ENIG
- Two different thermal cycles:
  - -40C to + 125°C
  - -40C to + 150°C
- 30 min dwell at each extreme.

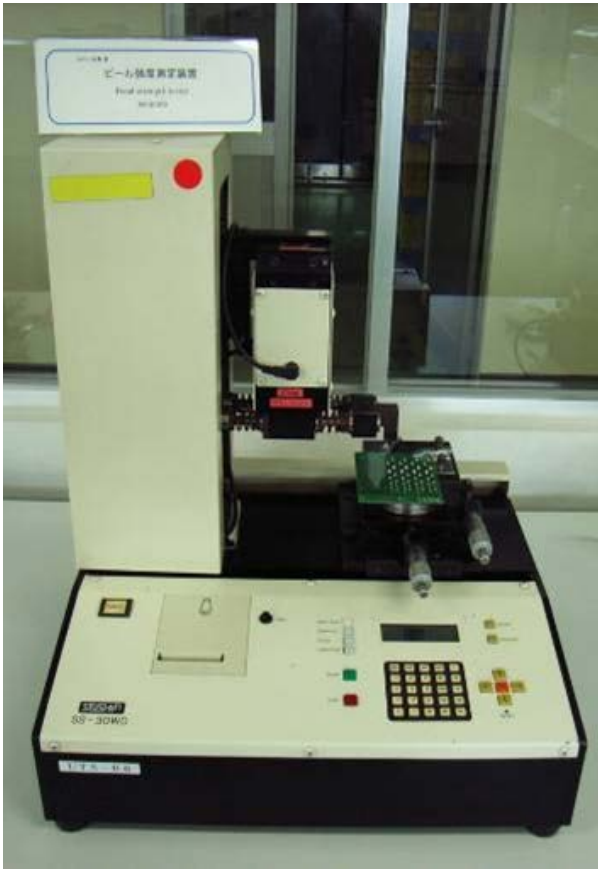
Bond Tester Equipment

- Test performed after:
  - Time 0 (As-Reflowed)
  - Every 500 cycles till 3000 cycles
- Some boards taken out after every 500 cycles
- Shear Speed: 0.5 mm/s
- Stand-off height: 0.2 mm

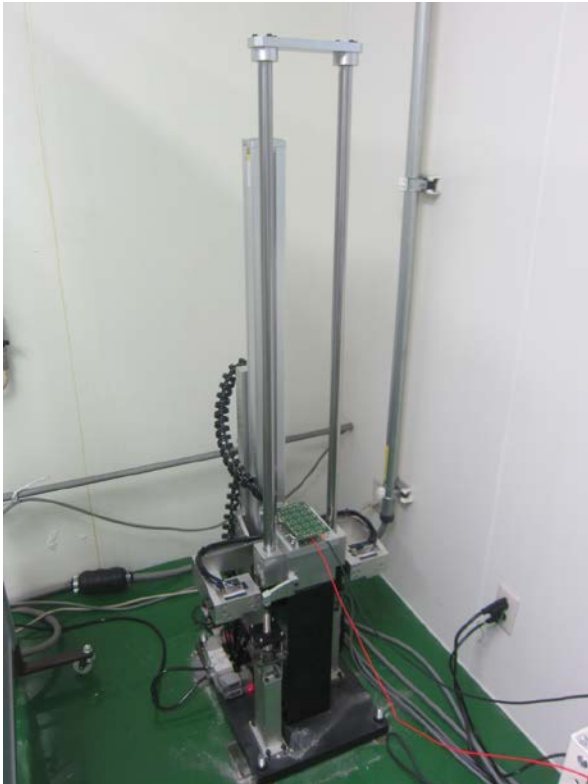
Test Equipment

- Test performed at:
  - 1500G
  - 0.5 msec half sine impulse
- Stopped after detecting discontinuity in voltage monitor

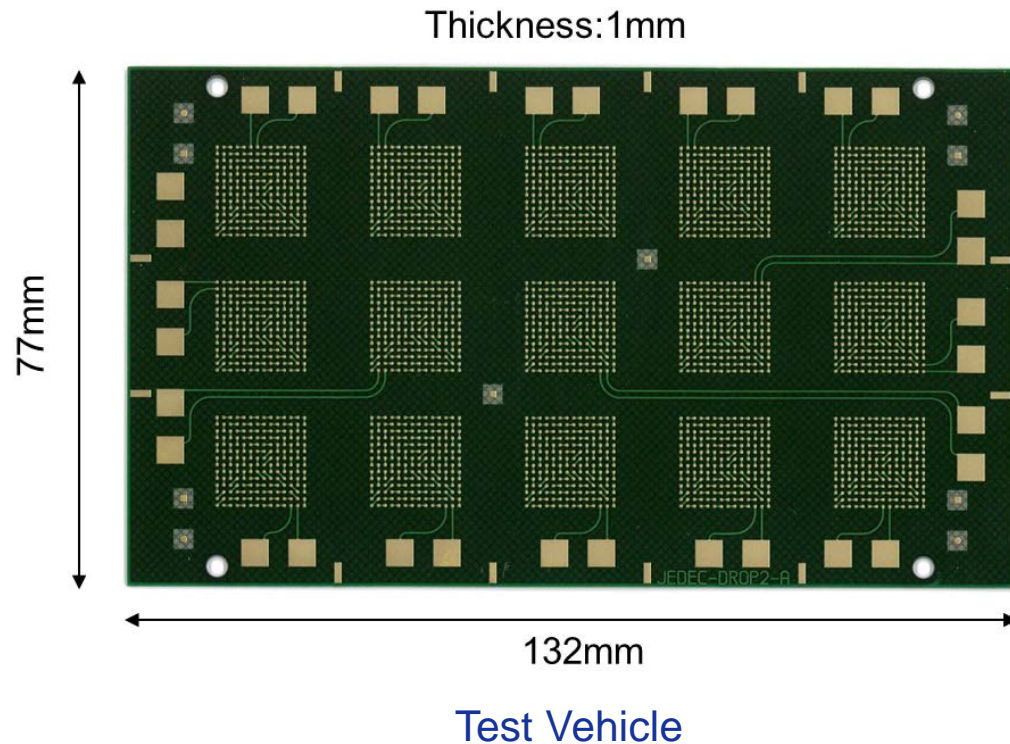
- 8 layers, FR-5 grade
- Two different board finishes :
  - Cu-OSP and
  - ENIG
- Daisy chain circuit
- One 15mm x 15mm BGA with 196 pins per board. (Solder Balls – SAC 305)
- Isothermal Aging at 150 °C for 500 hours before begin the test for IMC growth
- Failure recorded after >20% increase in bias voltage

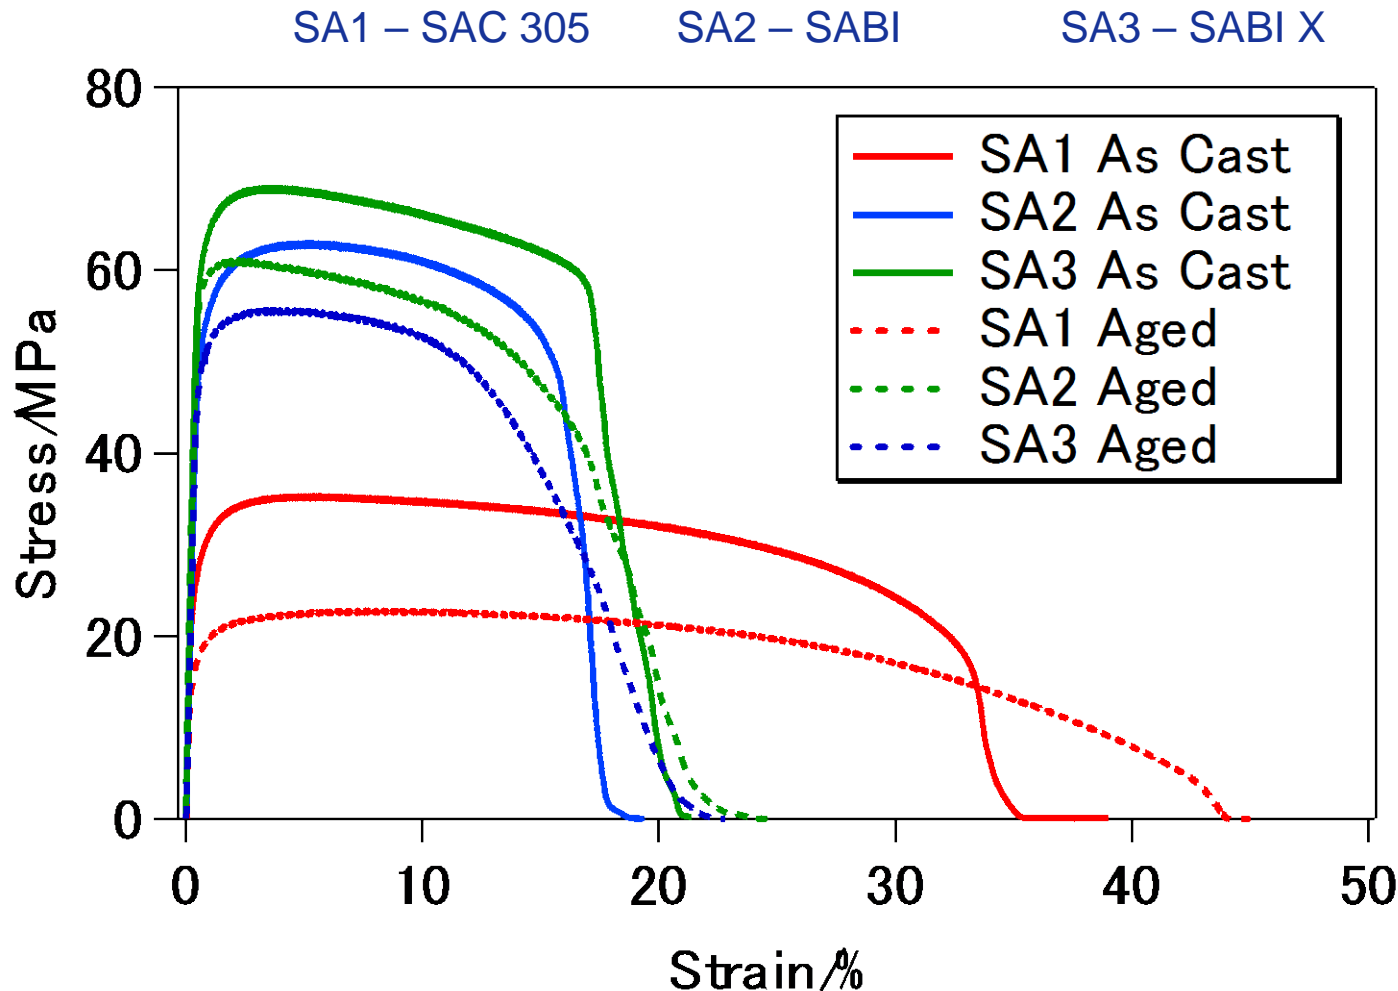
- Both SABI (Sn-Ag-Bi-In) and SABIX (Sn-Ag-Bi-In +Cu) alloys had lower elongation than SAC305. Bi reduces ductility.
- SAC305 pull strength reduced to almost half after aging.
- In both SABI as well as SABIX alloys, the reduction in strength after aging is not as drastic as SAC305.
- This can be due to solid solution strengthening by In and Bi in Sn matrix

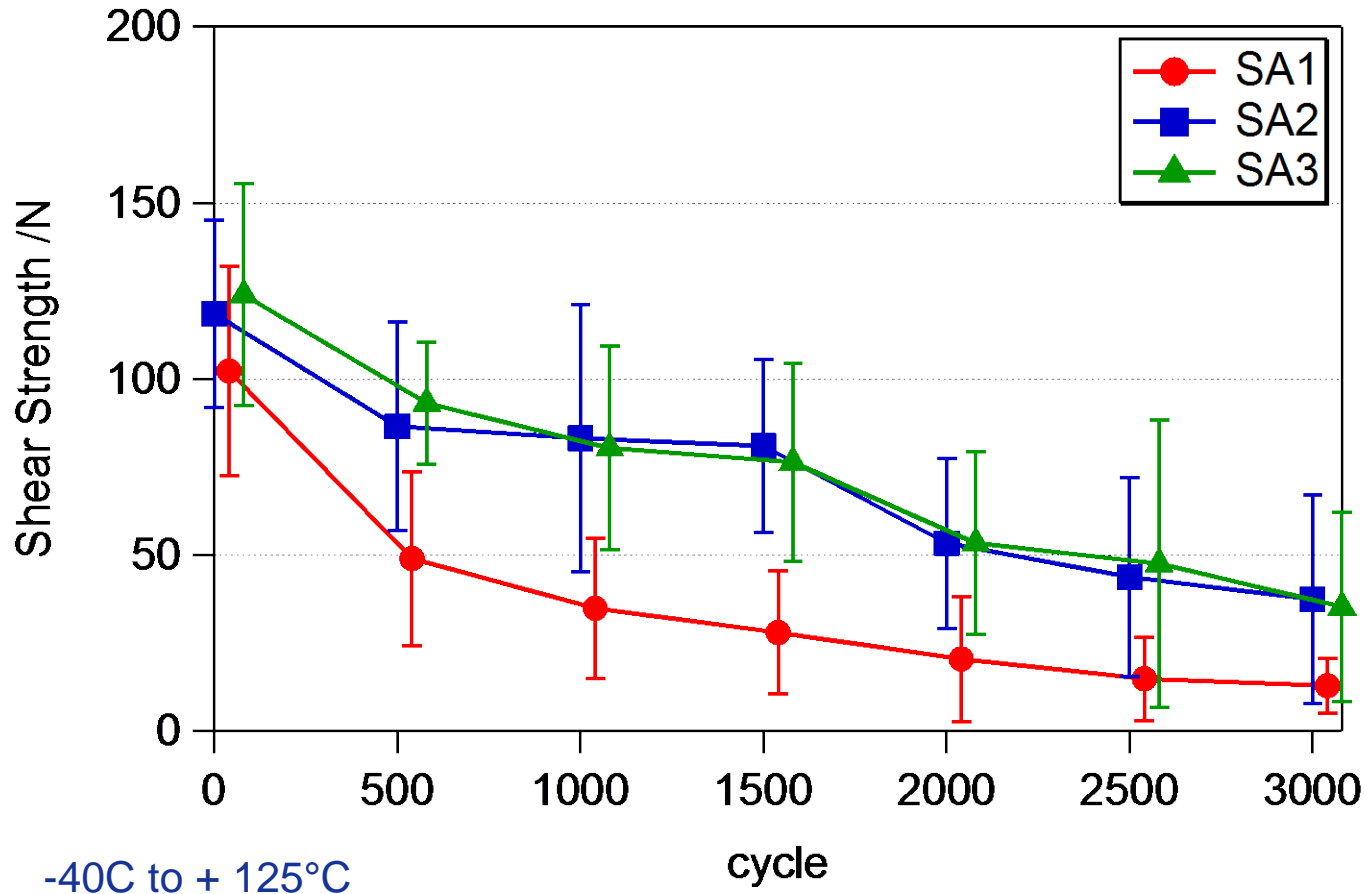
- As expected, both SABI and SABIX performed similarly on Cu-OSP surface finish.
- The loss of shear strength was about the same for either of the alloys
- Both the alloys outperformed SAC305 considerably.

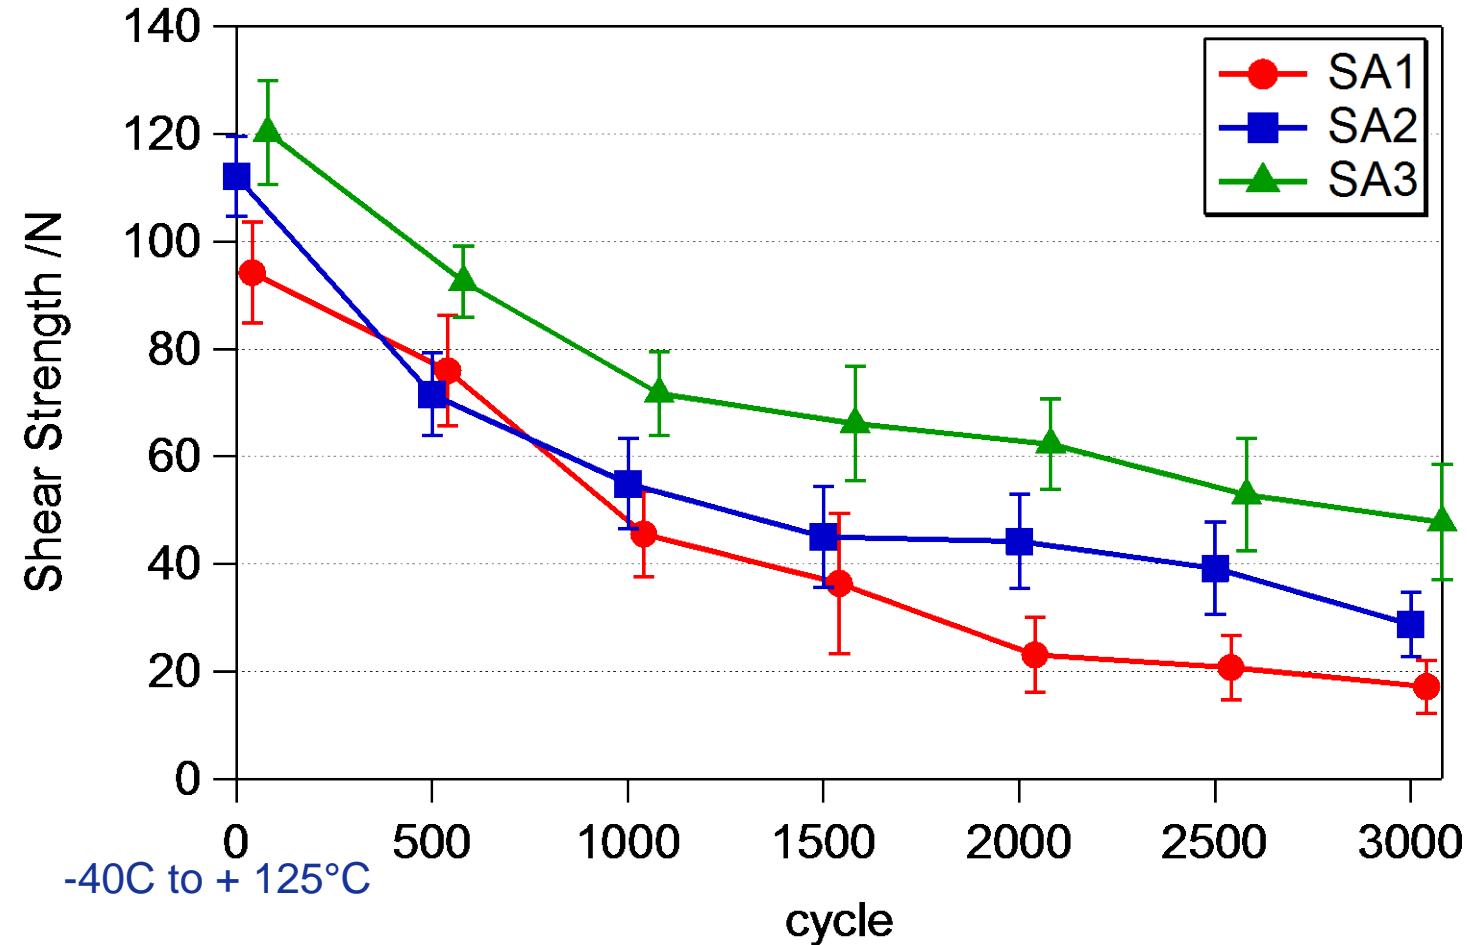
- The minor alloying addition of Cu does seem to help SABIX alloy in retaining the shear strength over the course of thermal fatigue cycling
- SABI alloy however significantly dropped in strength on ENIG as compared to Cu-OSP.
- The difference between strengths of SABI and SABIX seem to be larger on ENIG than that on Cu-OSP.

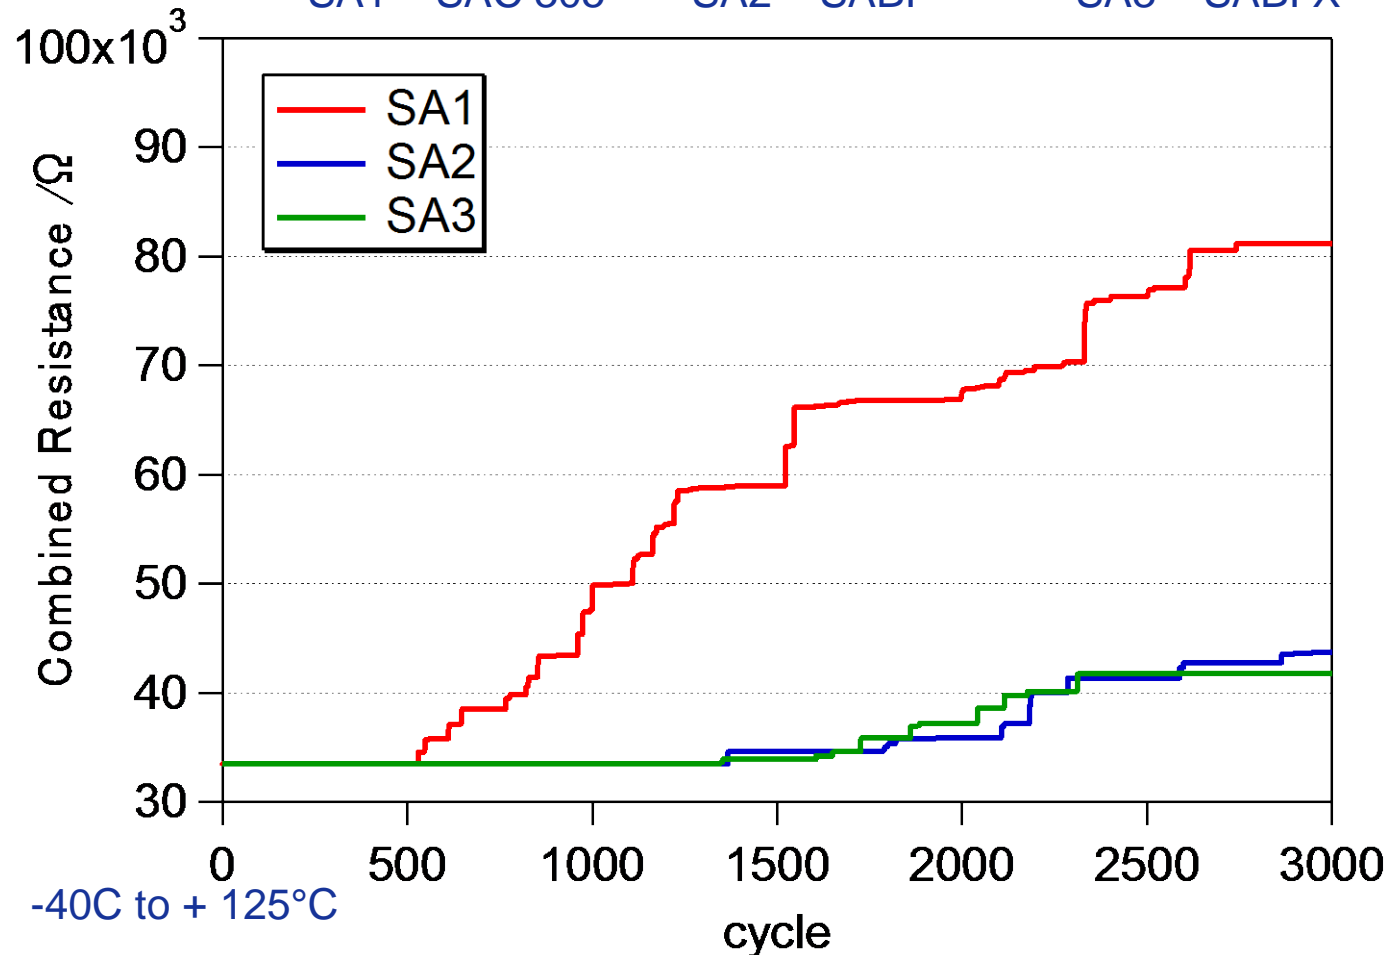
Cu-OSP

- Increase in combined resistance indicates solder joints in the circuit are failing.
- Increase in resistance is rather contained for SABI and SABIX alloys as compared with SAC305.
- In addition, as expected both SABI and SABIX performed similarly in terms of resistance increase on Cu-OSP.
