# Improving Thermal Cycle and Mechanical Drop Impact Resistance of a Lead-free Tin-Silver-Bismuth-Indium Solder Alloy with Minor Doping of Copper Additive

Takehiro Wada<sup>1</sup>, Seiji Tsuchiya<sup>1</sup>, Shantanu Joshi<sup>2</sup>, Roberto Garcia<sup>2</sup>, Kimiaki Mori<sup>1</sup>, Takeshi Shirai<sup>1</sup>

<sup>1</sup>Koki Company Ltd., Japan, <sup>2</sup>Koki Solder America Inc., USA

# **Improving Thermal Cycle and Mechanical Drop Impact Resistance of a Lead-free Tin-Silver-Bismuth-Indium Solder Alloy with Minor Doping of Copper Additive**

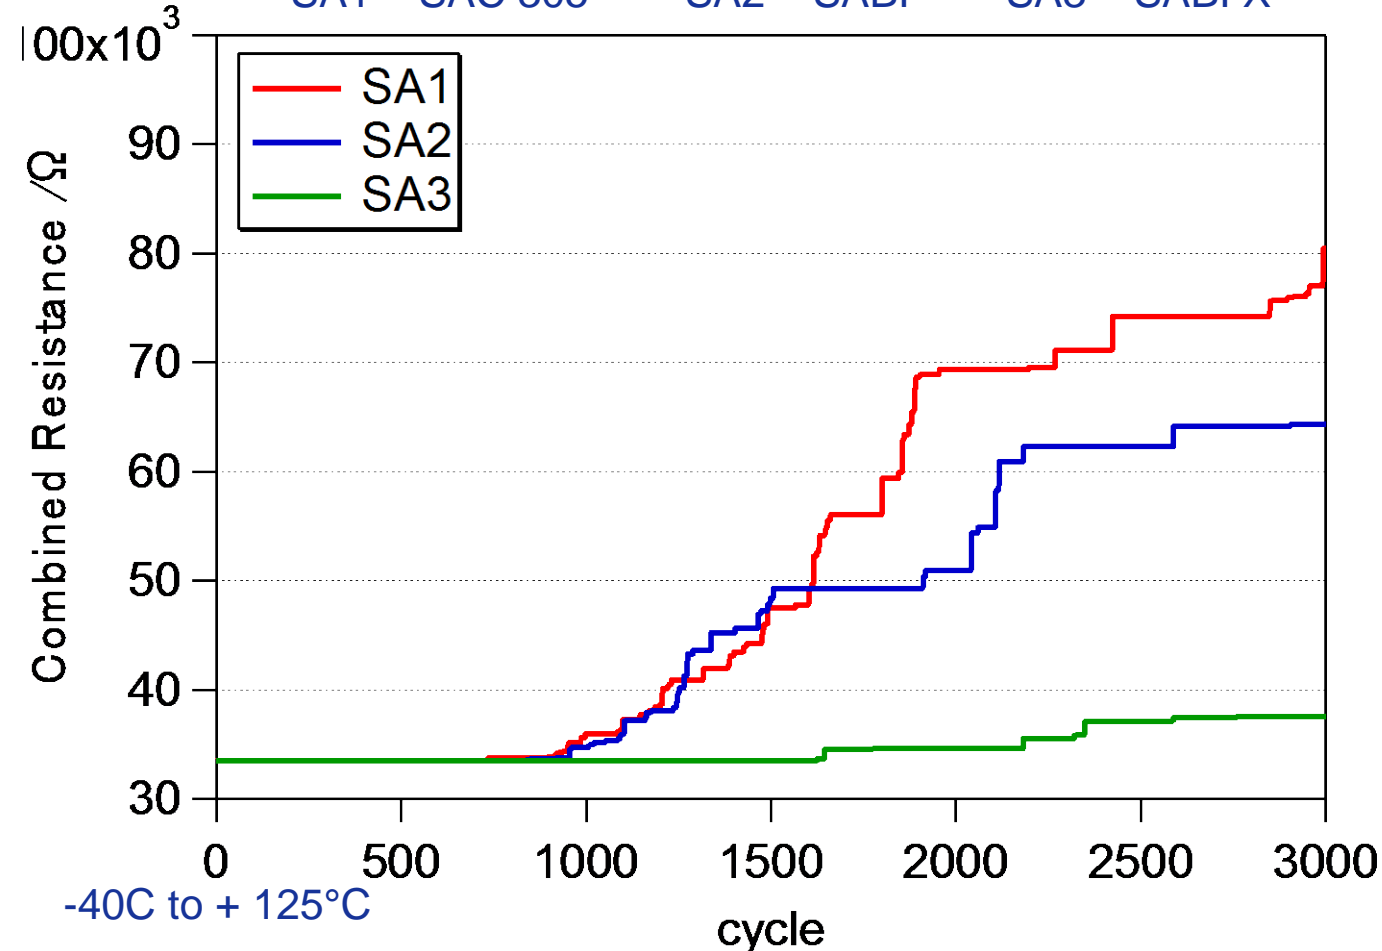
- Increase in combined resistance indicates solder joints in the circuit are failing.
- Increase in resistance is rather contained for SABIX alloys as compared with SAC305 and SABI alloy.
- SABIX alloy outperformed both SAC305 as well as SABI alloy on ENIG surface finish which implies the minor addition of Cu does seem to help strengthen the alloy.

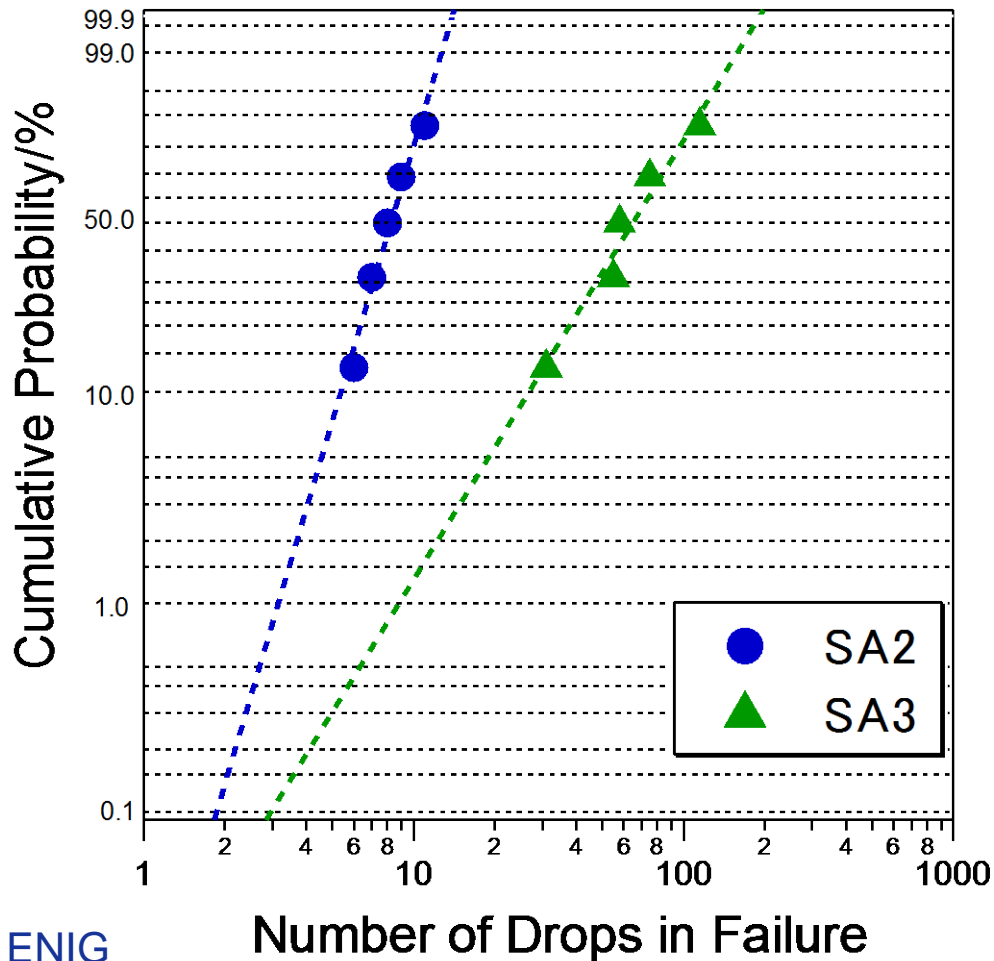
- SAC 305 BGA, daisy chained, isothermally aged at 150°C for 500 hours before starting the test.
- As the sample size is small (5), we are not trying to conclude anything but we can certainly see some positive result trends.
- SABIX alloy lasted at least 10 times more as compared to SABI alloy on ENIG surface finish after aging.
- Comprehensive test is going on and we will report the results in future work.

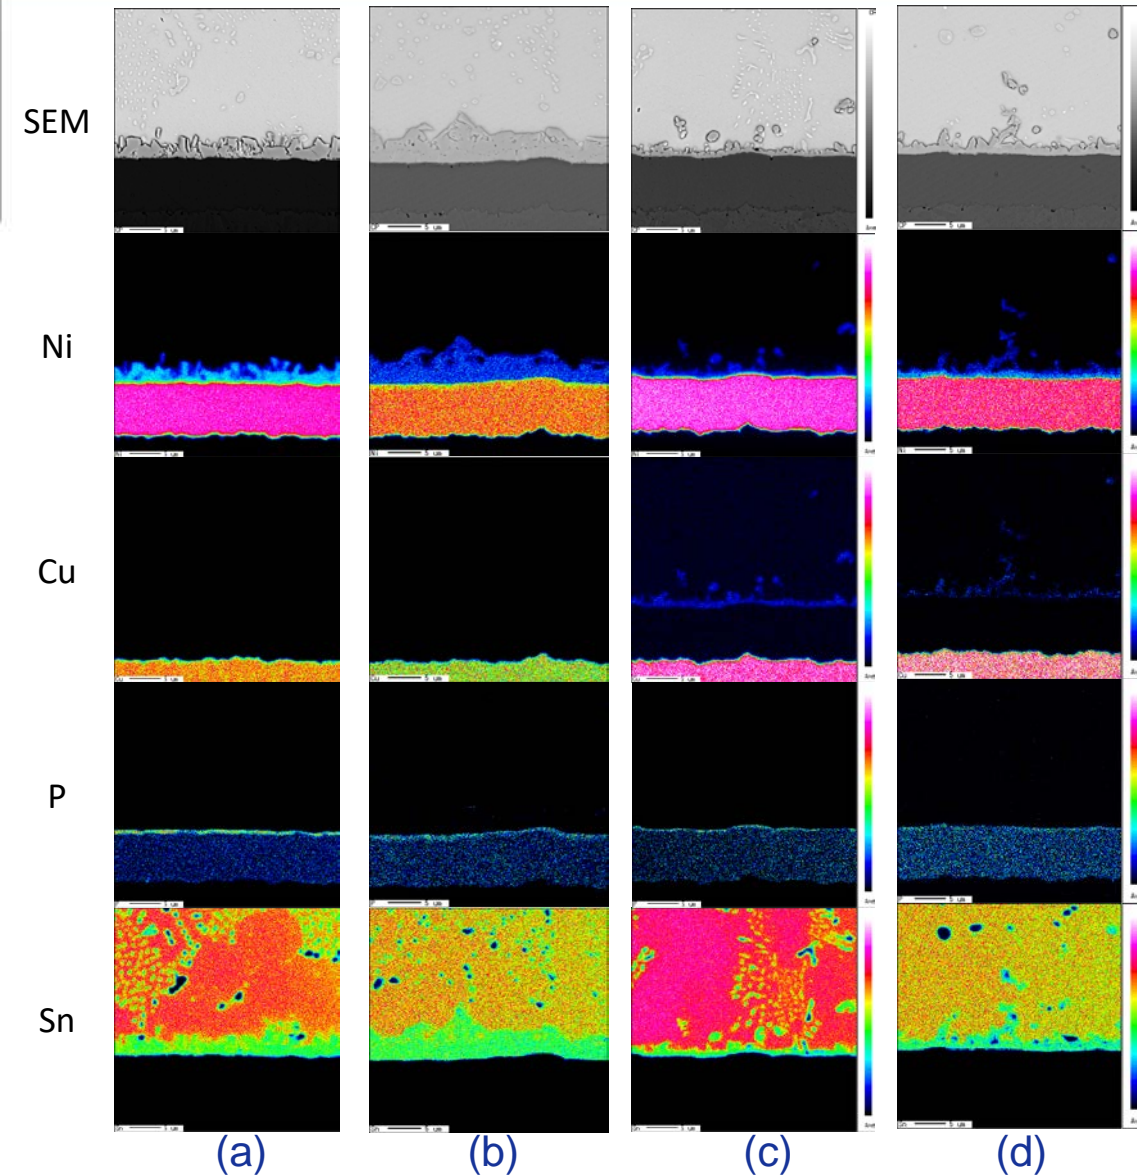
a) SABI-T0      b) SABI- 500TC      c) SABIX-T0      d) SABIX-500TC

- **For as reflowed samples, thicker IMC for SABI as compared to SABIX**
- **SABI IMC consisted of Sn-In-Cu**
- **SABIX IMC consisted of Sn-Cu-Ni**
- **Minor alloying by Cu seems to inhibit IMC growth for SABIX alloy after TC which explains superior drop shock reliability as compared to SABI alloy.**
- **SABI alloy seems to exhibit stronger P concentration at interface as compared to SABIX alloy.**

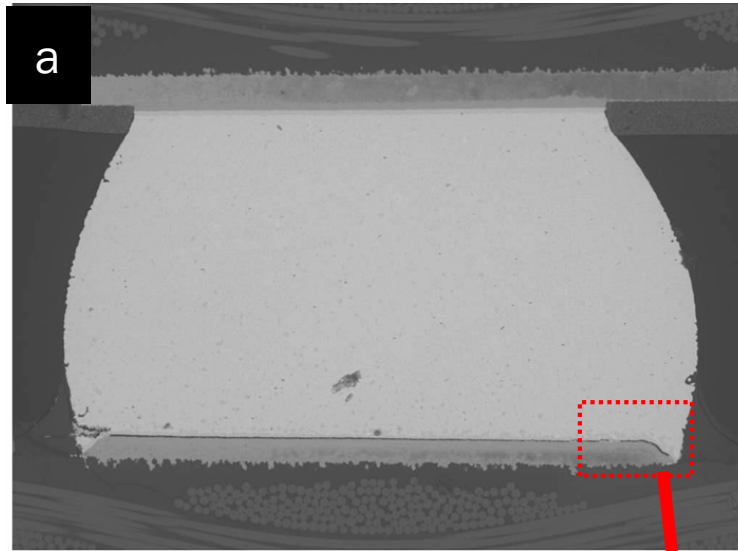
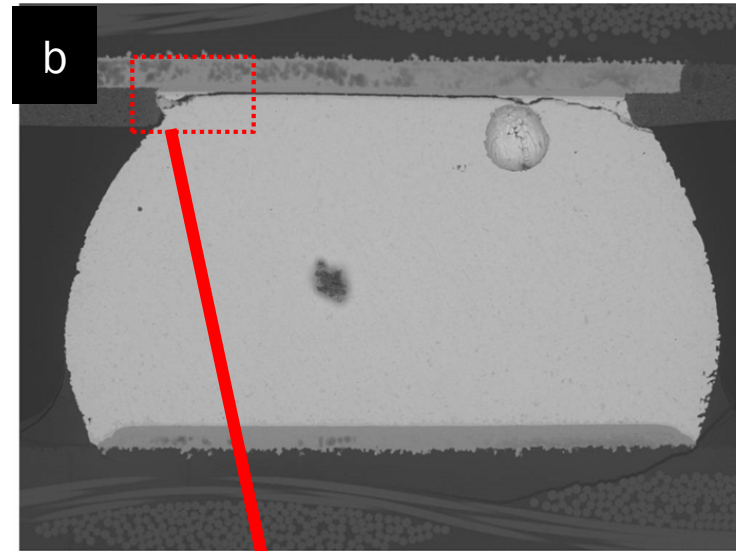
a) Failed SABIX alloy joint in drop test  
b) Failed SABIX alloy joint in drop test

- For SABIX alloy, fracture occurred at board side and for that of SABIX alloy it occurred at component side.
- As we used SAC305 BGAs, component side was predominantly SAC305.
- The failure location difference may be accounted for by the higher P concentration.
