Influence of Salt Residues on BGA Head in Pillow (Hip)

J. Servin, C. Gómez,
M. Domínguez, A. Aragón
CONTINENTAL CUAUTLA
Av. Ignacio Allende Lote 20
Parque Industrial Cautla
Cd. Ayala, Morelos 62749, México
E-mail: jose.servin@continental-corporation.com
cynthia.gomez@continental-corporation.com

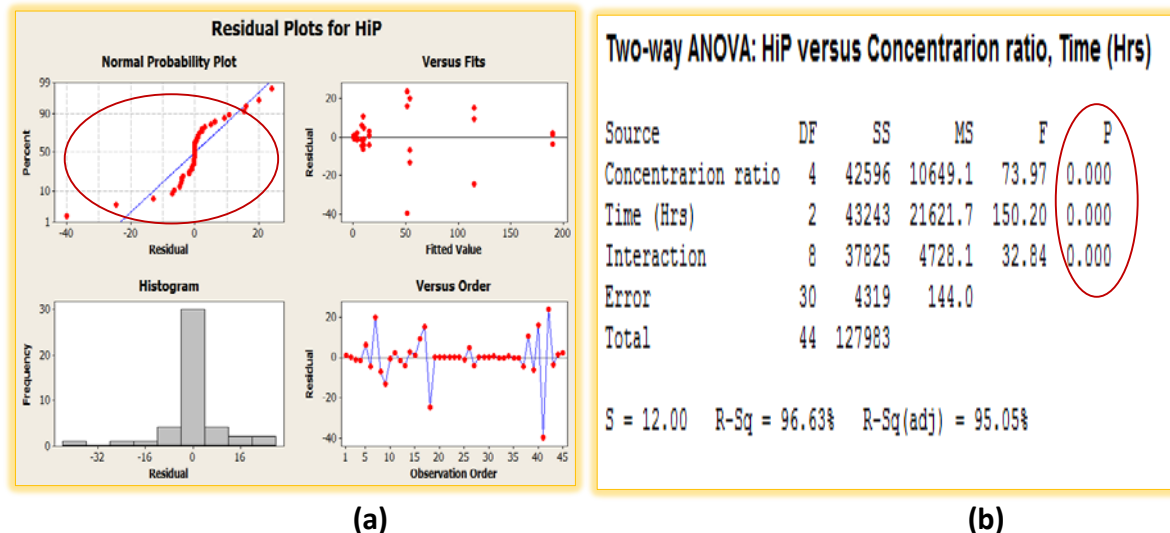
The results are presented in the residual plot analyses, see Figure 9(a), the normal distribution has a small deviation and correlation (see top left graph). The p-values are below 0, see Figure 9(b); therefore, both conditions (Concentration and Exposure Time) and their interaction have statistical influence on BGA HiPs, we accept the errors.

Figure 9. (a) Residual Plot Analysis, (b) ANOVA: HiP versus Concentrations, the p-values are below 0.

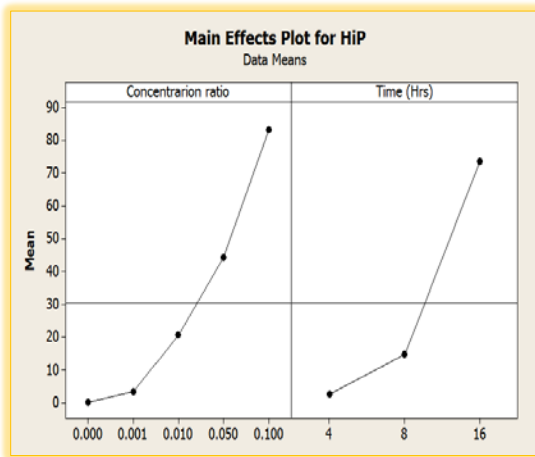
(a)

In the Main Effects plot for HiP, see Figure 10, shows the relationship between the concentration and quantity of HiP defects. On the left side shows the relationship between HiP and time. It is observed that the higher concentration the greater HiP defects, and in a more prolonged time the greater HiP also. This is also seen Figure 11, the plot for HiP Interactions.

Figure 10. Main Effects plot for HiP versus Concentration and Time.

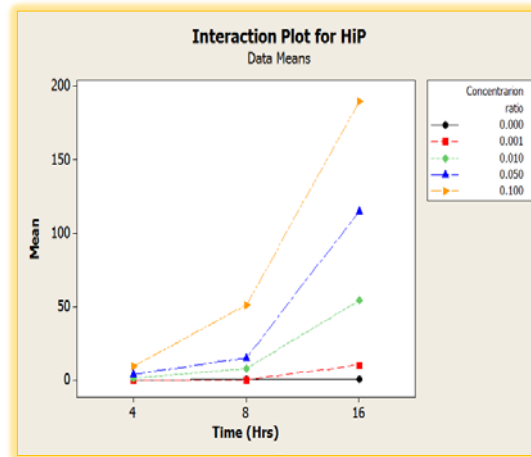
(b)

Figure 11. The Interaction plot for HiP in DOE 3

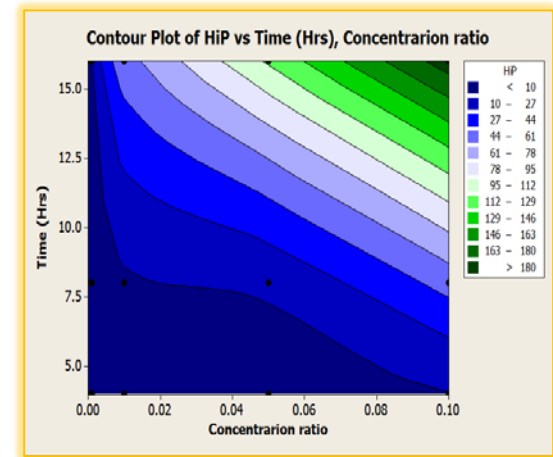
(c)

Figure 12. Contour plot of HiP vs time (Hrs)

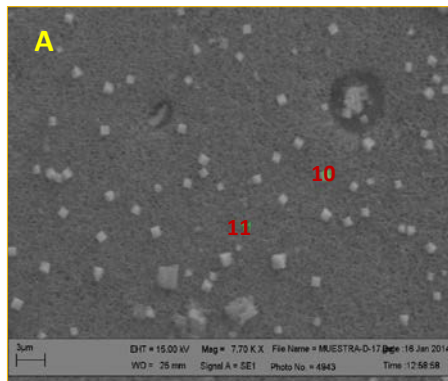
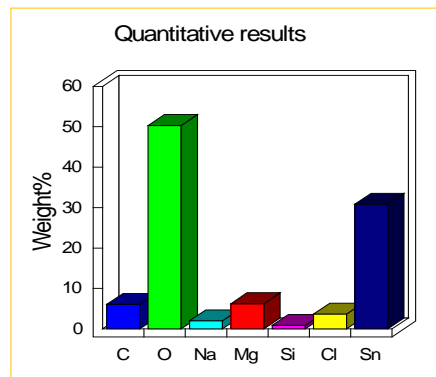
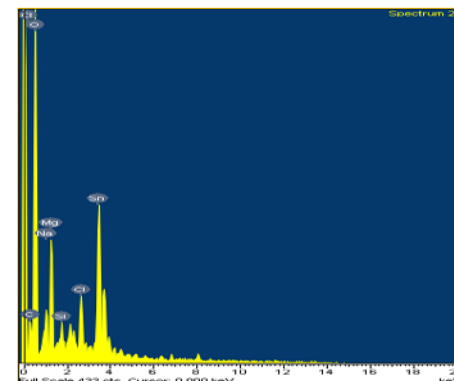
The SEM analysis shows contamination of NaCl in BGA body in this case, see Figure 18. The contamination is in form of small squares.

Figure 18. (A) General analysis body component (b) corresponds at point 10, and (c) is the point 11.
