Improving PCBA Yield

Title: Improve the Yield of P	CBA from 82% to	92% at PCBA functiona	al Test Stage.
Current situation: Presen Sigma	•		
Scope of Project: Vendor	PCB Assembly to F	unctional Testing of PCBA	
Characteristics	Measure	Defect Definition	
Yield at PCBA functional testing	Percentage	Yield < 92%	
Project Black Belt: Subrat Praja	apati

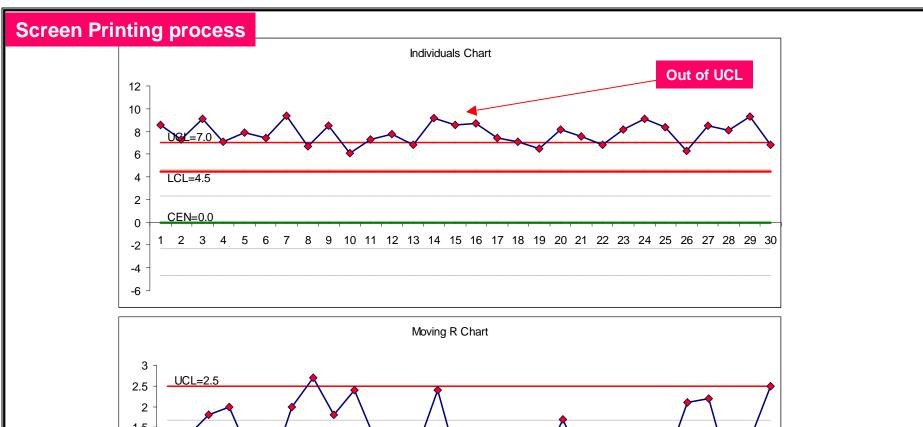
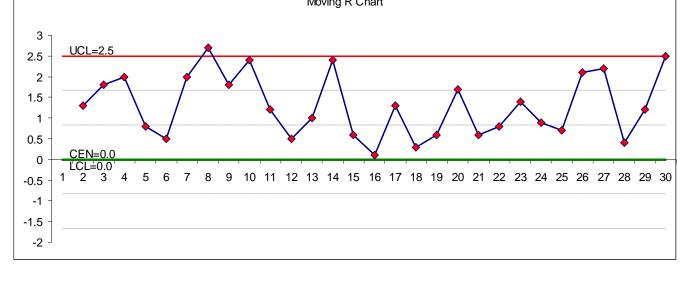
I-mR/ Paste Thickness

Observation : From Normal Distribution Summary shows Mean of Paste thickness observed is 7.8 mil (198 micron).

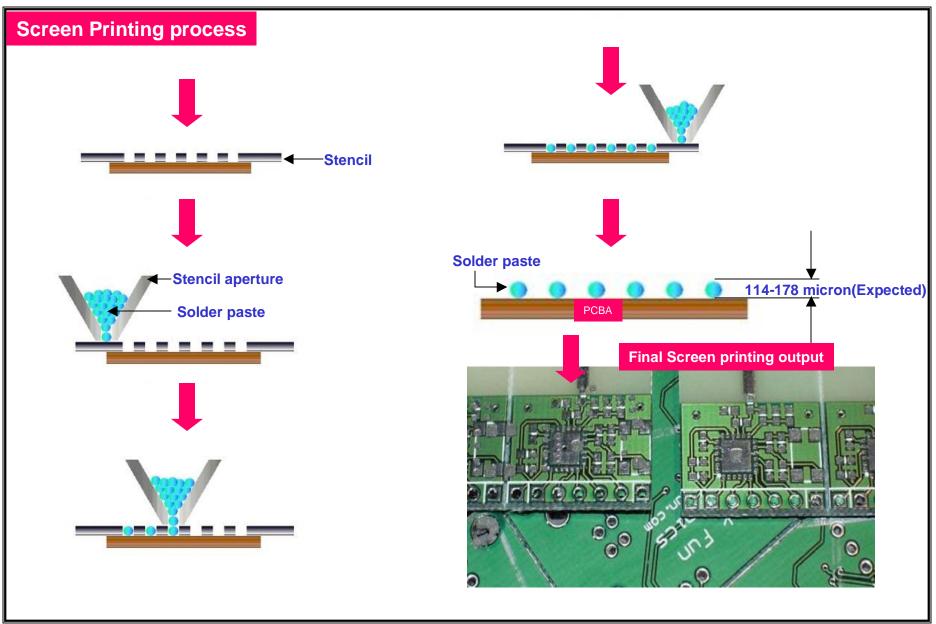
Paste Thickness running out of Specification

Concludes 80% of process is running outside USL, with Cpk= - 0.24 Mean Paste thickness = 7.8

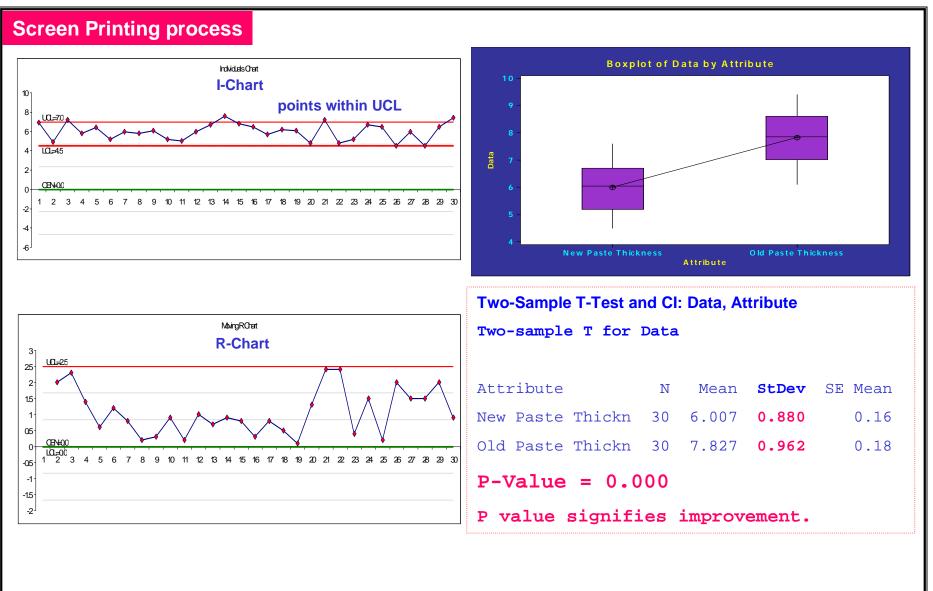
Concludes paste thickness lying outside USL reduces to 13% from 80%, with Cpk= 0.35 from -0.24 Mean Paste thickness = 6.0 from 7.8 mil

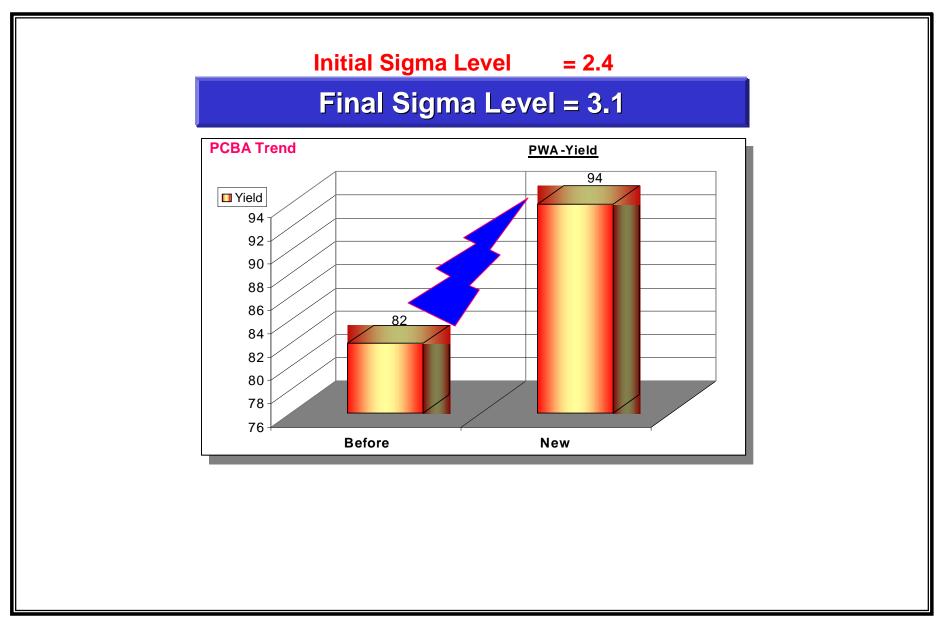
Results

FTP 80% We will guide for DPMO calculation for initial lot. Reflow DPMO 5000 Vendor to maintain record & log. Programming / Yield 96% Vendor to maintain records & log.	Quality	Index Matrix			
Screen Printing Control Chart 4.5 to 7 mils. display at measurement area. Reflow FTP 80% We will guide for DPMO calculation for initial lot. Reflow DPMO 5000 We not to maintain record & log. Programming / Yield 96% Vendor to maintain records &	Process		Benchmark	Actions / Responsibility	
Reflow Programming / Yield 96% calculation for initial lot. Vendor to maintain record & Image: Constraint of the second sec	Screen Printing	Control Chart	4.5 to 7 mils.		
Programming / Yield 96% Vendor to maintain records &		FTP	80%	3	
	Reflow	DPMO	5000	DPMO.xis	
lesting display.	Programming / Testing	Yield	96%	Vendor to maintain records & display.	
Main Unit AssemblyYield98%Vendor to maintain records & display.		Yield	98%
