Profiling for successful BGA/CSP Rework

This paper discusses how to successfully profile a printed circuit board when reworking Ball Grid Array and Chip Scale Packages.

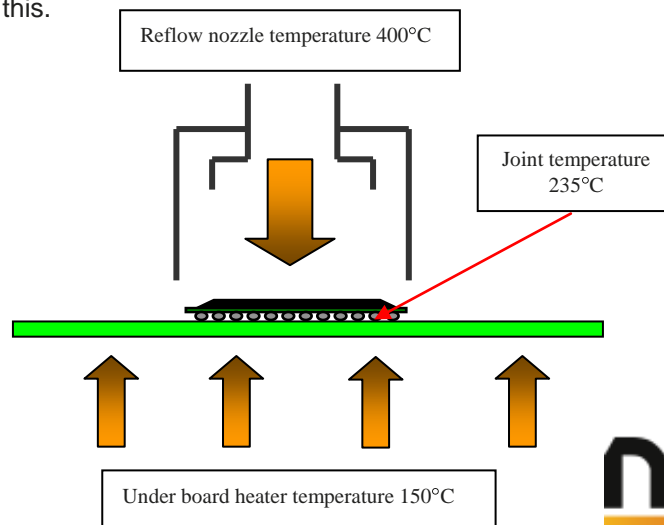
Example 1

On any reflow soldering system that heats both sides of the PCB assembly, the required solder joint temperature is a function of how much heat is applied to both the top and bottom side. It is quite possible to achieve the same solder joint temperature with a number of heat settings. The following 2 examples illustrate this.

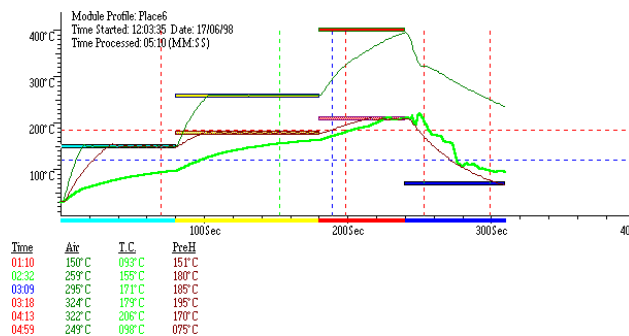
The graph below shows a trace of a profile taken from under a 492 PBGA on a PC motherboard where the thermocouple trace appears to be normal – hitting the desired pre-heat, soak and reflow temperatures.

In this case with either solder paste or flux, a very low pass rate was achieved.

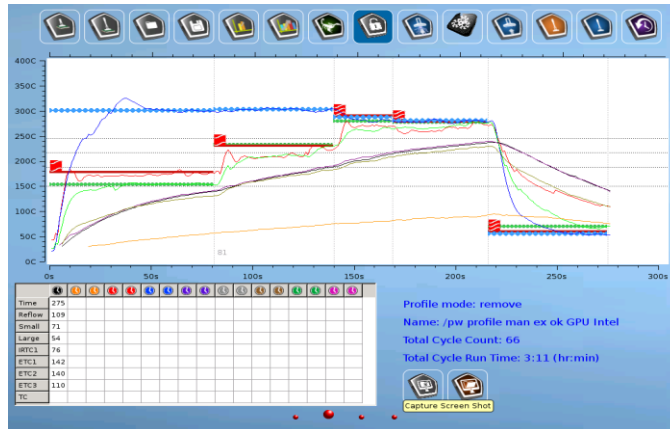
The second graph shown is the final profile that was used, and as you can see, the 2 traces are very similar but the heating has been done in a totally different way. In this case, we have increased the number of zones to 4, reduced the top air temperature significantly while increasing the underboard heat to the whole board and utilizing an underboard centralized heating zone.

The route of the yield problems was due to the plastic BGA warping during reflow. An excessive source temperature on the topside of the PCB caused this.

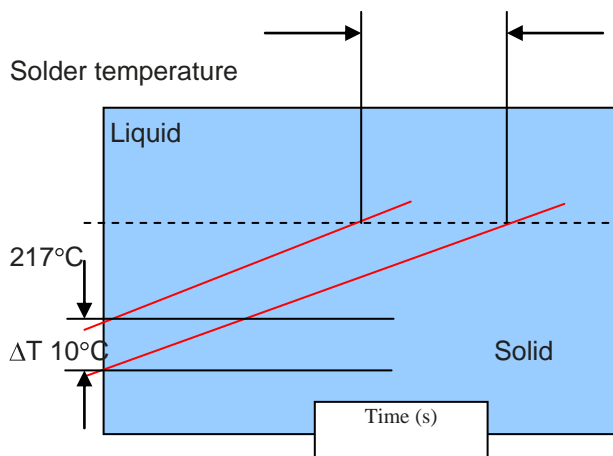
Graph of ramp rate at $0.5^\circ\text{C}/\text{Sec}$

The following diagram shows a graph section of a components’ solder joints going from solid to liquid at a melting temperature of 217°C . We are assuming that the achieved ΔT across the component is 10°C .

Total time to achieve reflow 20 seconds

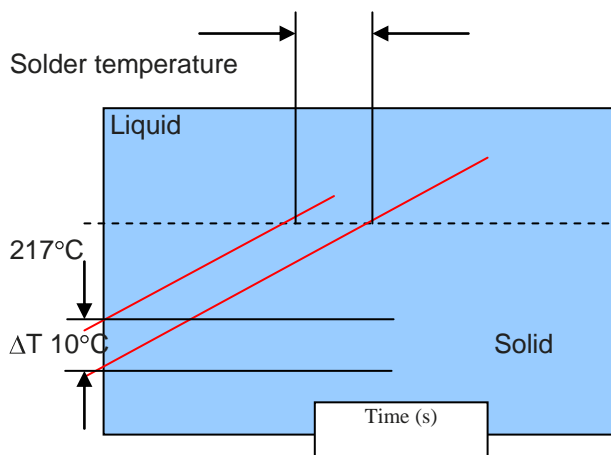
Graph of ramp rate at 2.5°C/Sec

The solution would involve changing the profile input- temperatures to achieve a higher ramp rate. This would in turn produce a more simultaneous reflow as illustrated in the graph below.

Total time to achieve reflow 4 seconds
