MODERN 2D / 3D X-RAY INSPECTION -- EMPHASIS ON BGA, QFN, 3D PACKAGES, AND COUNTERFEIT COMPONENTS

Evstatin Krastev and David Bernard

Nordson DAGE

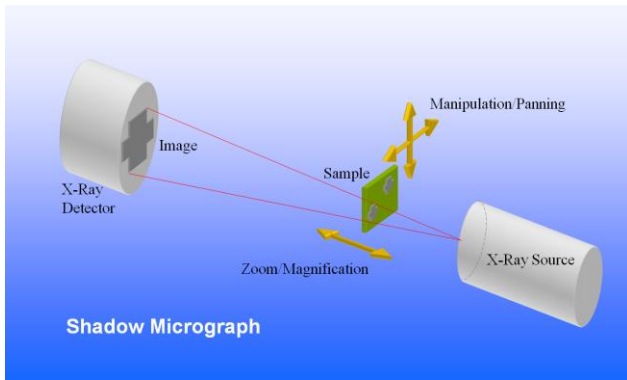
Figure 1. Basic operation principle of X-Ray inspection system

The 2D X-Ray inspection systems are essentially X-Ray microscopes (Figure 1 and Figure 2). A wide cone of X-rays is emitted by the source (X-Ray tube). The inspection is accomplished by moving the sample inside the X-Ray emission cone. All materials absorb the X-Ray radiation differently depending on their density, atomic number and thickness.

Thicker and/or denser material will absorb more of the X-Rays. The resulting image, composed of shades of grey with darker areas corresponding to higher X-Ray absorption, is registered by the X-Ray imaging device, usually a very high quality digital image intensifier or a flat panel. The closer the sample is to the X-Ray source the higher the magnification level (Figure 1). The ability to inspect at an oblique angle view is crucial for finding defects like cracks and open joints. Generally two ways are used to accomplish oblique, or angled views - tilt the sample or tilt the imaging device. As seen in Figure 2, tilting the imaging device has the huge advantage of producing maximum magnification at all tilt angles.

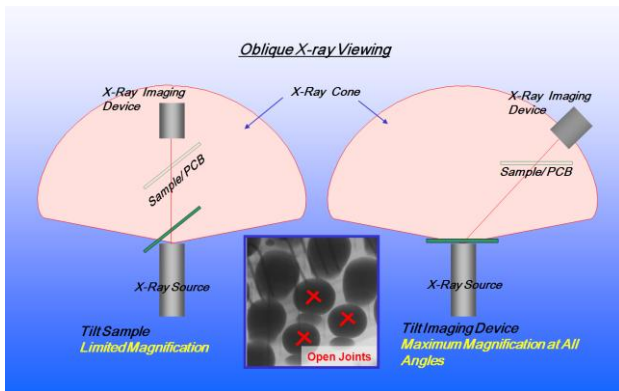
Figure 2. Oblique angle viewing

The modern X-Ray machine tilts the imaging device up to 70 degrees at the same time permitting images from 360 degrees around any inspection point. A sophisticated combination of software and hardware keeps the point of interest (for instance a defective joint) in the center of the field of view while the imaging device is rotating around and examining from all directions. Additional advantages of this method are that there is no need to secure the sample (PCB, component or another device) and no risk of dropping, damage or collision during sample manipulation.

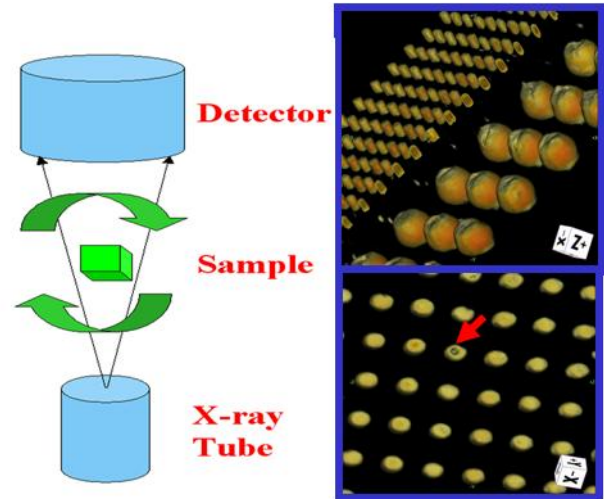
Figure 3. Typical layout of a CT system and an example of a CT model

The layout of a CT system is shown in Figure 3. Once the CT model has been produced, it enables ‘virtual microsectioning’ by allowing the operator to investigate any two-dimensional plane within the entire model as well as full, real time manipulation of the 3D model. In this way, different layers and different features within the package can be viewed whilst being isolated from other, potentially confusing, detail to enable improved analysis. This allows complete examination of features or defects within a device or package that would otherwise remain hidden by multi-level interconnections. For example, the tiny 100-micron solder bumps within the multi-layered device shown on Figure 3 would be obscured by the much larger 500-micron BGA balls.

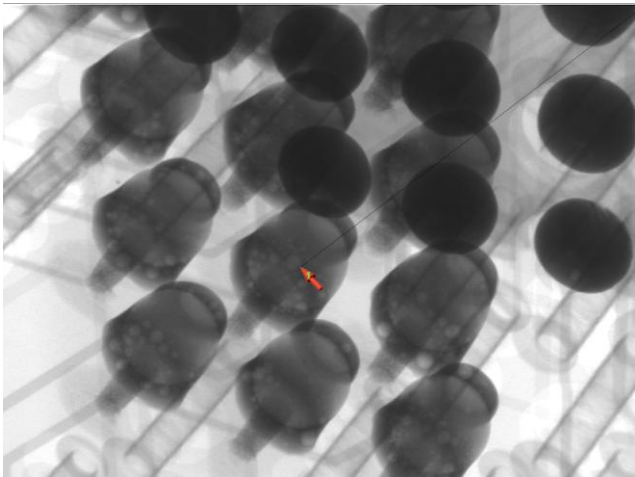
Figure 4. Angled/ oblique 2D X-Ray view showing interface voiding

Common BGA defects like voiding, shorts, cracks, and head-in-pillow (HIP) or head-on-pillow (HOP) usually occur during reflow. The oblique angle capability is critical for detecting cracks and HOP defects using viewing angles of 55 to 70 degrees. Voids and shorts are easily visible using a top-down view, but in order to determine the location of the voids oblique angle 2D viewing and 3D CT come very handy. The angled view on Figure 4 reveals

voiding concentrated on the joint interface making the particular connection less reliable and possibly more prone to failure in the field.

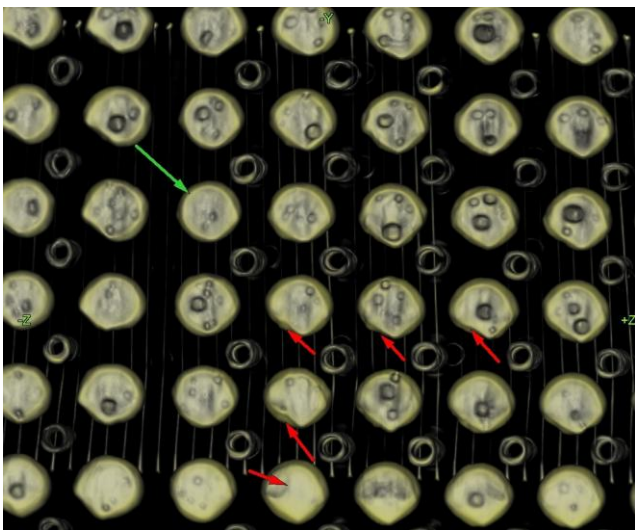
Figure 5. CT virtual section through the interface region of a BGA device.

The 3D CT technique permits virtual slicing or cross-sectioning through the devices revealing the exact location of the voids as seen on Figure 5.

Large amount of interfacial voiding is apparent and many BGA balls marked with red arrows are deformed/ cracked. The modern 2DX machine features automatic routines designed for precise measurement of diameter, voiding percentage, shape and area of the BGA balls. As seen in Figure 6, the BGA balls marked in red outline fail the requirement for shape or roundness, which is the first number accompanying each ball. The second number represents the total voiding percentage for each BGA ball. It is up to the operator to set up the acceptable levels and the machine will automatically flag any values which fall outside.

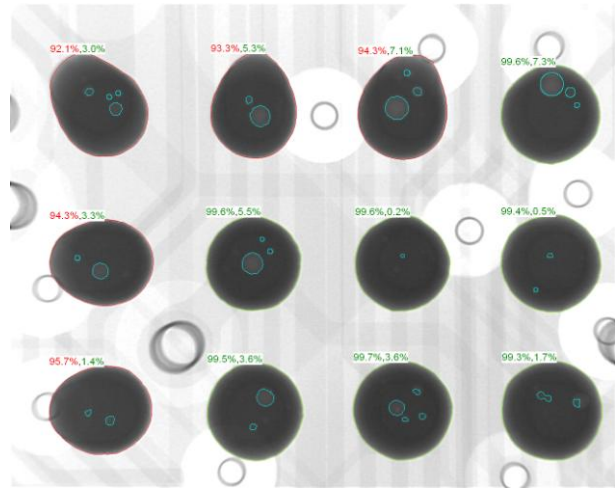
Figure 6. 2D X-Ray voiding and roundness calculation for a BGA device.

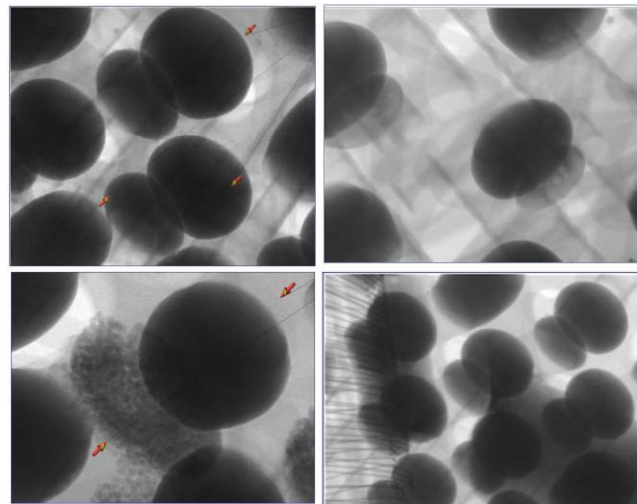
Figure 7. Various examples of HOP defects easily identifiable with off-axis 2D X-Ray inspection

lower performance 2D systems, they can be quickly and easily identified using modern high-performance 2D X-ray system with an oblique angle viewing (Figure 7). In addition the inspection process is completely *non-destructive*.

Figure 7 shows various examples of HOP defects. It is obvious why these defects are referred to as head-in-pillow, or better head-on-pillow. The defective BGA solder ball appears to be laying on the reflowed solder paste instead of forming a single joint after reflow. Figure 8 is a virtual CT micro-section through the BGA device revealing a 3D view of the HOP defect.

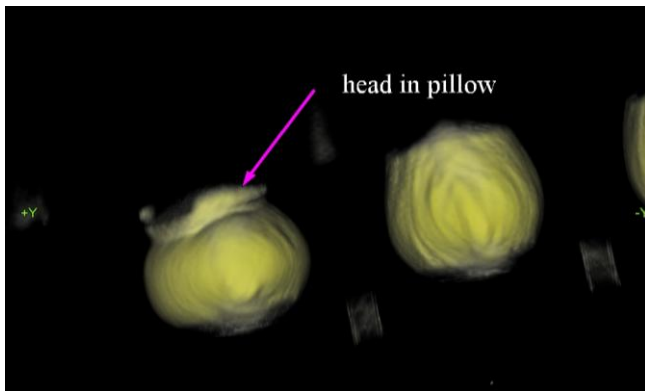
Figure 8. 3D CT section showing HOP defect in a BGA device

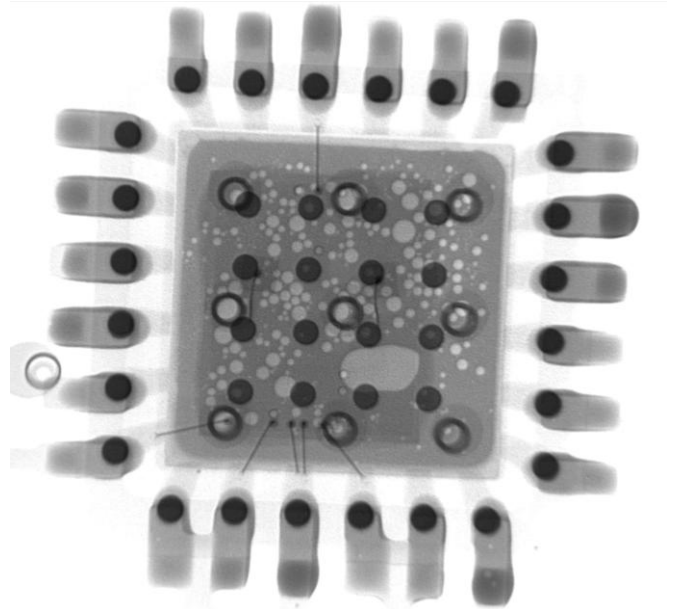
Figure 9. Top X-Ray view of QFN package

As shown on Figure 9, the package terminations are all located under the device. This makes the traditional Automatic Optical Inspection not practical. As with the BGA devices, cross section followed by SEM or optical evaluation is an alternative, but the method is destructive and permanently damages the device and PCB.

It is important to point out that in addition to the quality of the side connection, the voiding within the central large pad is also crucial in some cases when large amounts of heat need to be transferred out of the device in order to prevent overheating. The example (Figure 9) shows significant

voiding in the central area which would be a concern or reason for rejection in a high-power application.

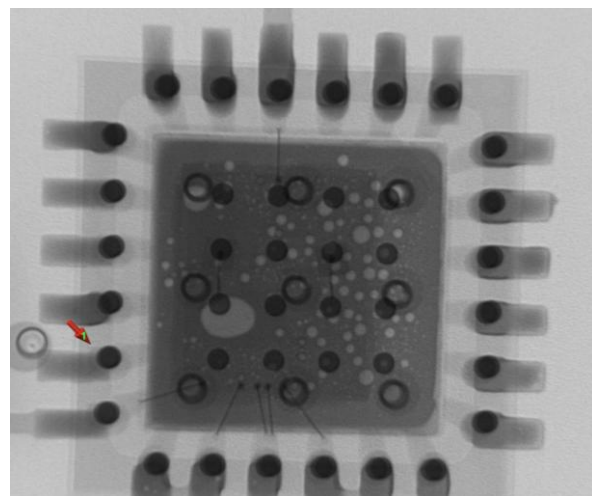
Figure 10. Top X-Ray view of LGA package. Suspected pin pointed by arrow.

Figure 10 shows a low magnification image of a QFN package with a red arrow pointing out to a suspect pin. Because of the high resolution and contrast sensitivity of the X-Ray system, a possible defect is apparent even at this low magnification image.

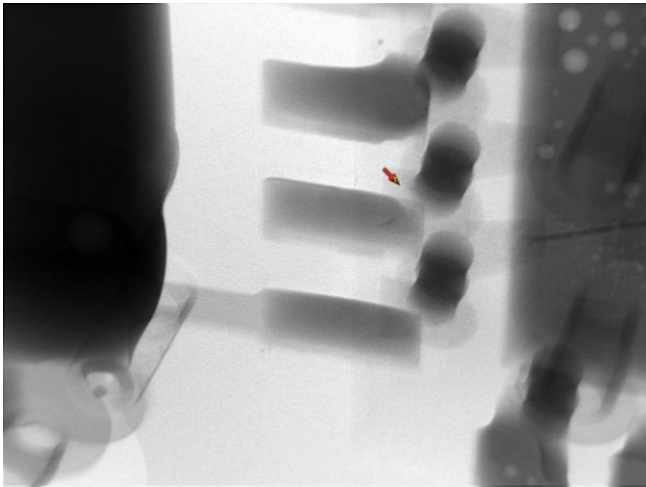
Figure 11. Higher magnification oblique angle view of defective pins from Figure 10.

Using oblique view and higher magnification one can study the open pins in detail as shown in Figure 11. However, even a low magnification oblique view is sufficient to confirm the defect as seen in Figure 12.

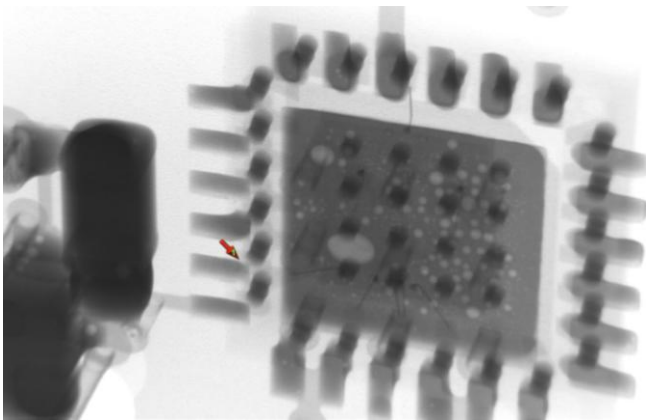
Figure 12. Low magnification oblique X-Ray image showing defective (open) pins in QFN device.

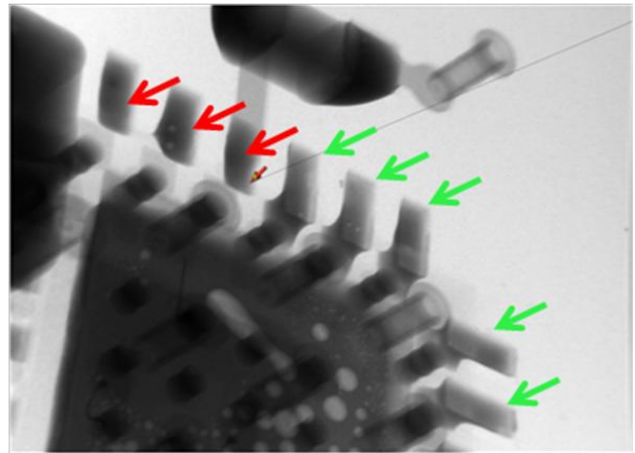
Figure 13. Oblique 2D X-Ray view of defective QFN device. Red arrows point toward open pins and the green arrows identify good pins.

The fact that the defective pins can be identified at such low magnification levels makes the X-Ray inspection process fast, efficient and reliable. Figure 13 represents an oblique angle 2D X-ray view of different QFN device. The red arrows are pointing towards open pins compared to the good pins (green arrows).

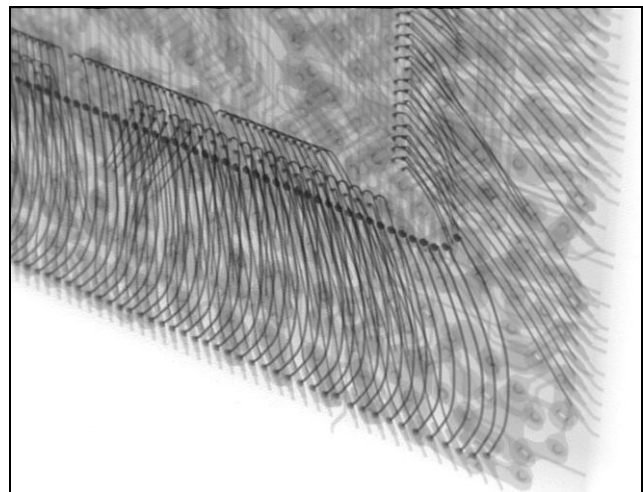
Figure 14. 2D X-ray oblique view of stacked device.

As seen on the 2D X-Ray image in Figure 14, the two wire bonding layers of this stacked device cannot be easily separated for analysis looking for shorted or open connections.

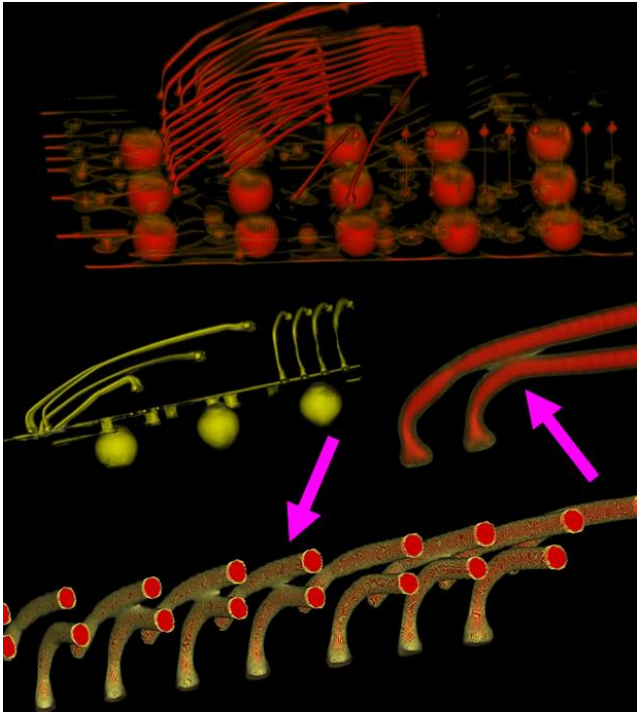
Figure 15. CT images of stacked devices showing shorted bond wires.

Figure 15 is a combination of CT images showing various stacked devices. The CT technique permits the operator to isolate the area of interest and carefully examine for potential failures using virtual micro-sectioning. As seen on Figure 15 the shorted wires are easily identified using CT and this cannot be easily and reliably accomplished using 2D methods.

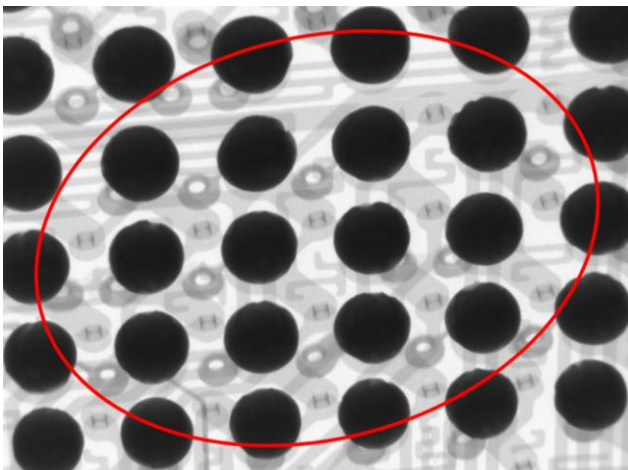
Figure 16. 2D X-Ray image of an area containing suspect shorted vias in a 3D package

The examined 3D device has shorted vias in the region covered by the 2D X-Ray image on Figure 16. Clearly identifying the defect is quite difficult due to the complexity of the 2D X-Ray image. The CT model of the same package is shown on Figure 17. The CT model is also quite complicated, but once the micro-sectioning capability is engaged the shorted vias pop up easily detected -- see inset of Figure 17 representing a virtual micro-section through the CT model.

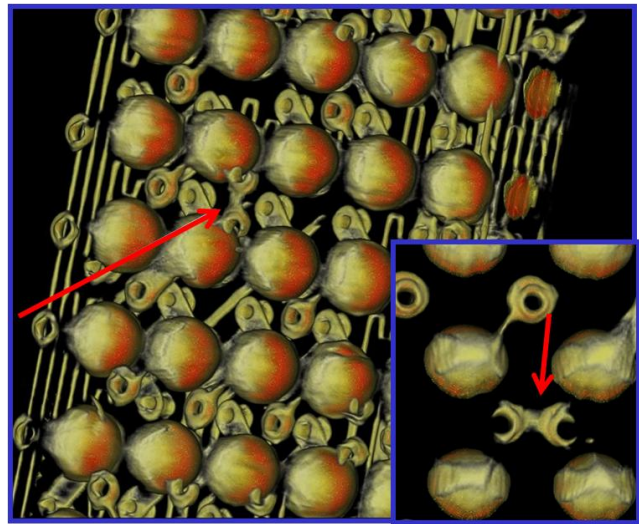
Figure 17. CT model of the 3D device shown on Figure 16. The inset is a virtual cross-section easily detecting the two shorted vias.

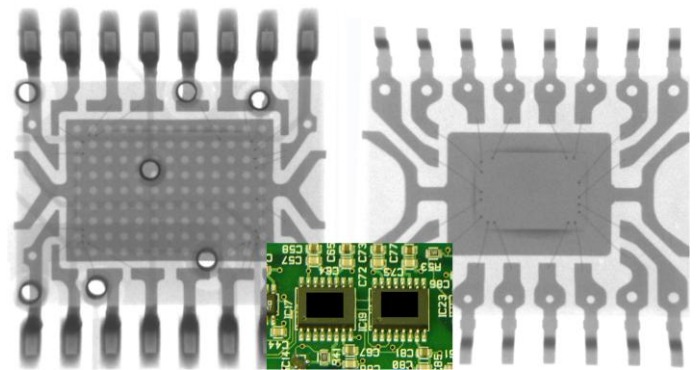
Figure 18. 2D X-Ray image revealing big differences between components looking similar optically, thus easily identifying the counterfeit.

As shown in Figure 18, the real and fake components might look very similar optically, but an X-Ray image reveals big differences. The modern 2D X-Ray inspection provides a fast and effective method to identify counterfeit components. Being *non-destructive* and offering high magnification, resolution and contrast sensitivity it makes it easy and straightforward for the operator to identify the fake components by observing die placement, internal wiring and comparing to known good samples.
