Characterization of Solder Defects in Package on Packages with AXI Systems for Inspection Quality Improvement

Zhen (Jane) Feng, Ph. D., David Geiger, Weifeng Liu, Ph.D., Anwar Mohammed, Murad Kurwa
AEG, FLEXTRONICS International Inc.
847 Gibraltar Drive, Milpitas, CA, USA 95035

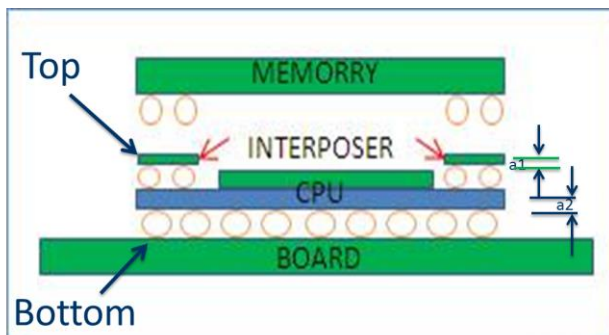
Figure 1. Structure of 3 BGA layers POP on Customer Board

The inspection quality of AXI not only depends on the AXI machine design, but also on the structural complexity of a given POP. Figure 1 illustrates the 3 layers POP we utilized in this study which is assembled on a customer board. We do not test middle interposer ball layer of the POP on AXI as no SMT process is required on these pins. The POP structural information is tabulated in Table 1.

a1 (Substrate1) = 0.122 ±0.022 mm

a2 (Substrate 2) = 0.262 ±0.022 mm

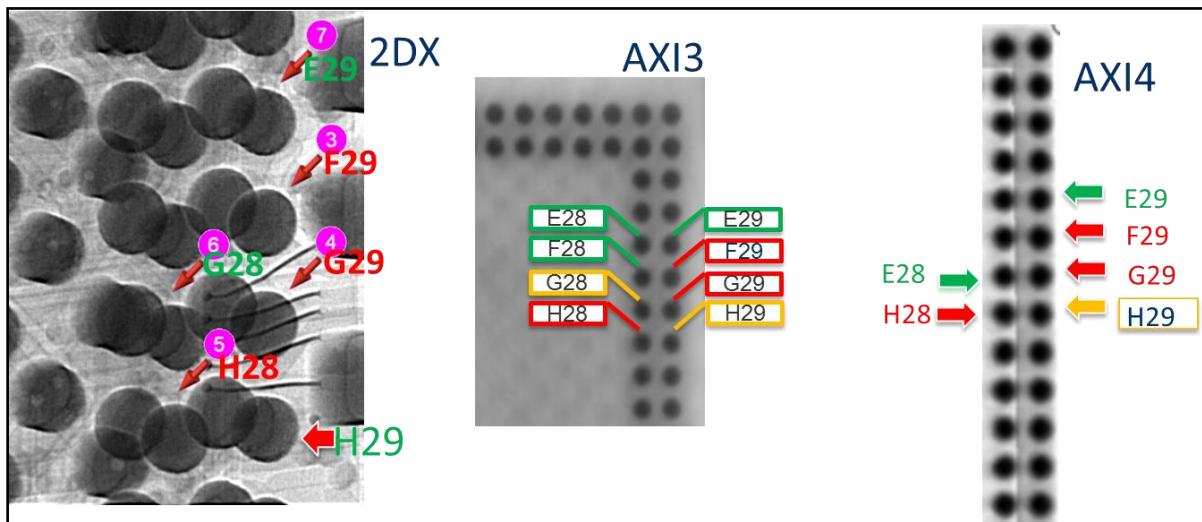
Figure 3. X-ray images for Detected HIP, Good solder, False Call pins from 2DX, AXI3, and AXI4.

Figure 3 shows X-ray images for Defective HIP, Good solder, and False Call pins on top BGA ball layer of the POP from 2DX, AXI3, and AXI4, where green, red, and yellow colors stand for Good solder joint, HIP/Open defective pin, and False Call pin respectively. It is obvious to see the difference for good solder and open solder on 2DX images. Based on the observed images, the big challenge in AXI is that there is no clear visible difference visible between the images of good solder joint versus defective HIP/Open pins. This is true for both AXI3, and AXI4 machines.

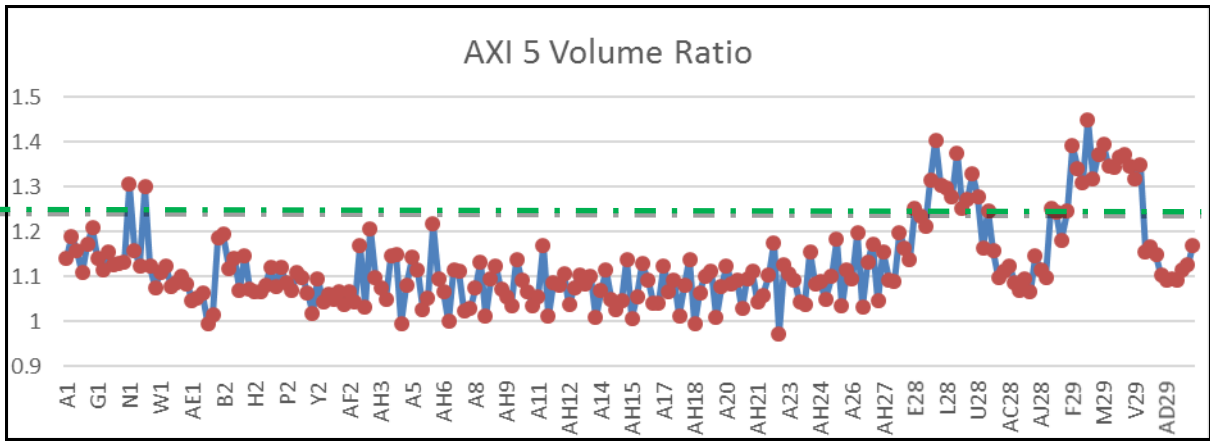
Figure 5. AXI 5 Volume Ratio Measurement Data for the Top Layer of POP, Volume Ratio Threshold ≥ 1.25 .

The total number of pins for top layer POP is 216. The Volume Ratio threshold is set as ≥ 1.25 . The average Volume Ratio ($V_{ld}/V_{ud} = 1.13$) with maximum ($V_{ld}/V_{ud} = 1.45$) and minimum ($V_{ld}/V_{ud} = 0.97$). Figure 5 shows the Volume Ratio measurement data for the top layer of POP from AXI 5. There is separation between good pins and bad pins with the 216 pins of Volume Ratio measurement data.

With the threshold as ≥ 1.25 , total fail pins is 30 with 4 pins as false call, and 1 pin as a defect escaped based on the 2DX as the adopted Reference. Table 3 is the comparison between 2DX and AXI 5 for these 5 pin discrepancy. When we look at details for these pins with X-ray measurement data, three pins are considered as on the borderline of adopted threshold in the earlier study.

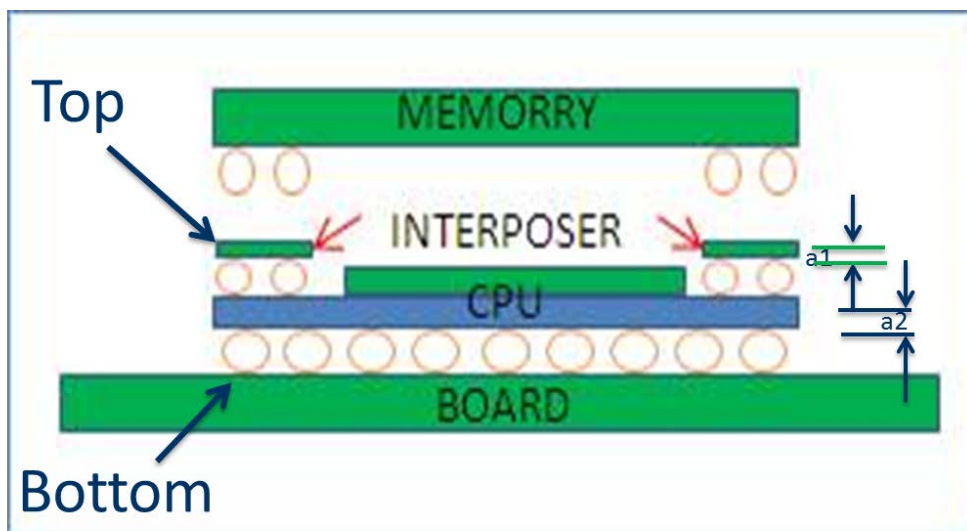
a_1 (Substrate1) = 0.122 ± 0.022 mm
 a_2 (Substrate 2) = 0.262 ± 0.022 mm

POP1 Customer Board	Layer (Unit)	Size
Size	Top (mm ²)	12x12
	Bottom (mm ²)	12x12
Pitch	Top (mm)	0.4
	Bottom (mm)	0.4
Bump height	Top (mm)	0.18
	Bottom (mm)	0.2
Ball Diameter	Top (mm)	0.25
	Bottom (mm)	0.25
Number I/O	Top	216
	Bottom	617
Bump material	Top	SAC 105
	Bottom	SAC 105

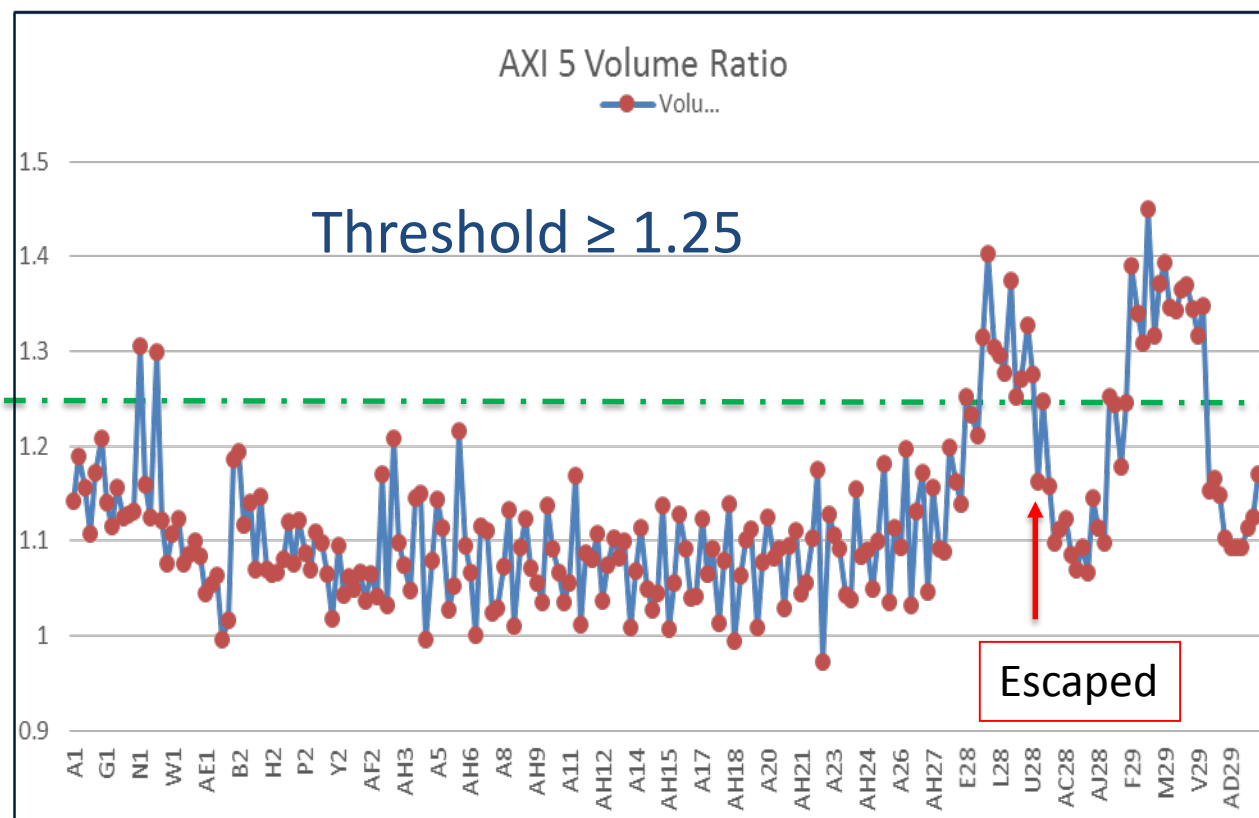
AXI 5 Measured Data and Analysis

Location	Volume Ratio
N1	1.30506956577301
T1	1.29900074005127
E28	1.25168776512145
F28	1.23386991024017
H28	1.31479179859161
J28	1.40314400196075
K28	1.30343699455261
L28	1.29658579826355
M28	1.27765071392059
N28	1.37462639808655
P28	1.25267803668976
R28	1.27175939083099
T28	1.32759273052216
U28	1.27619671821594
V28	1.16227817535400
W28	1.24721777439117
B29	1.25169289112091
C29	1.24433279037476
E29	1.24623227119446
F29	1.39087891578674
G29	1.34031951427460
H29	1.30938339233398
J29	1.44988083839417
K29	1.31733870506287
L29	1.37213814258575
M29	1.39306640625000
N29	1.34641396999359
P29	1.34342718124390
R29	1.36603772640228
T29	1.37070751190186
U29	1.34503495693207
V29	1.31714832782745
W29	1.34790050983429

Volume Ratio	Ratio Range
W28	1.24721777439117	≥1.20 , < 1.25
L28	1.29658579826355	≥ 1.25, < 1.30
N1	1.30506956577301	≥1.30
